# Comprehensive Environmental Inc.

## Study of Urban Non-Point Source Pollution Stump Pond Brook Subwatershed

### PENNICHUCK WATER WORKS SUMMER/FALL 2002

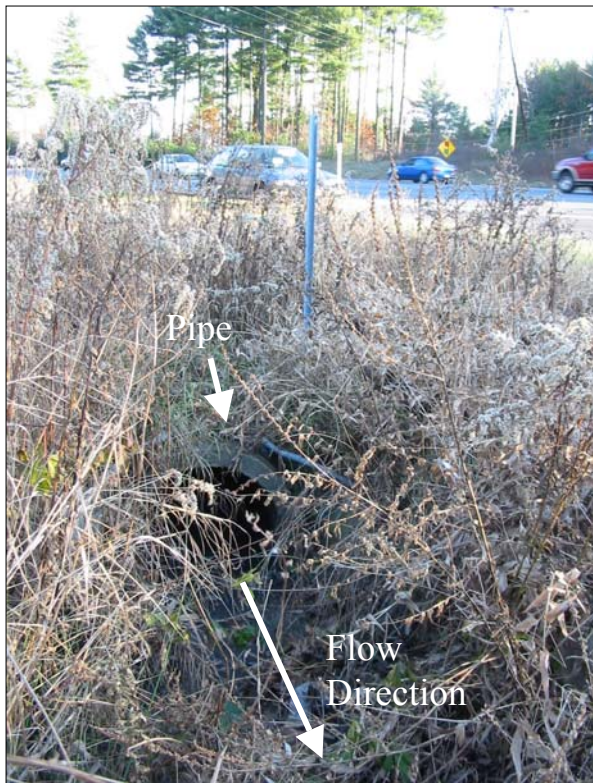
**Figure 3-2.** Route 101A 24” Discharge Looking Southeast Facing Road

A pond/wetland basin with a shallow sediment forebay constructed near the current discharge point would reduce flow velocities, increase infiltration and precipitate many suspended particles before allowing water to enter the existing wetland. Figure 4-2 is a conceptual drawing provided for the purpose of illustration.

Installation of two check dams downstream of the discharge pipe will further slow and trap sediment before it enters the wetland (Figure 4-2). These dams will serve as secondary treatment removing even more sediment. Check dams will also maintain a smooth controlled flow through the channel, preventing unnecessary scouring and streambed deterioration.

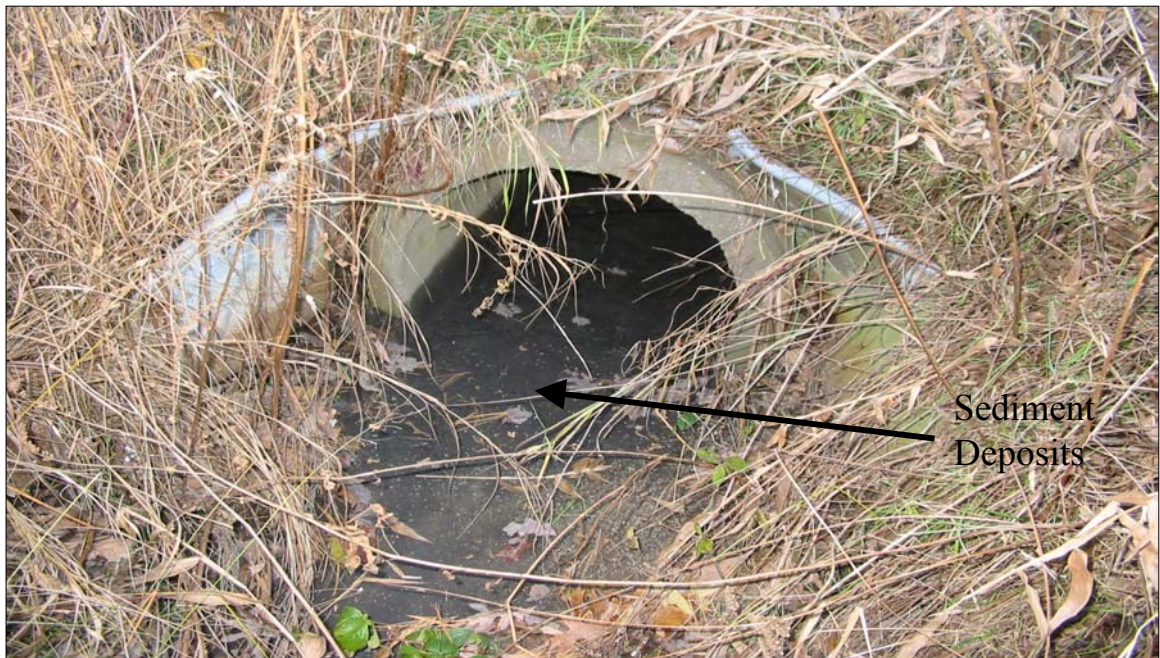
**Figure 3-3.** Route 101A 24” Discharge Upgradient of the SPB Outlet Wetland (Note heavy sediment deposits at pipe bottom)

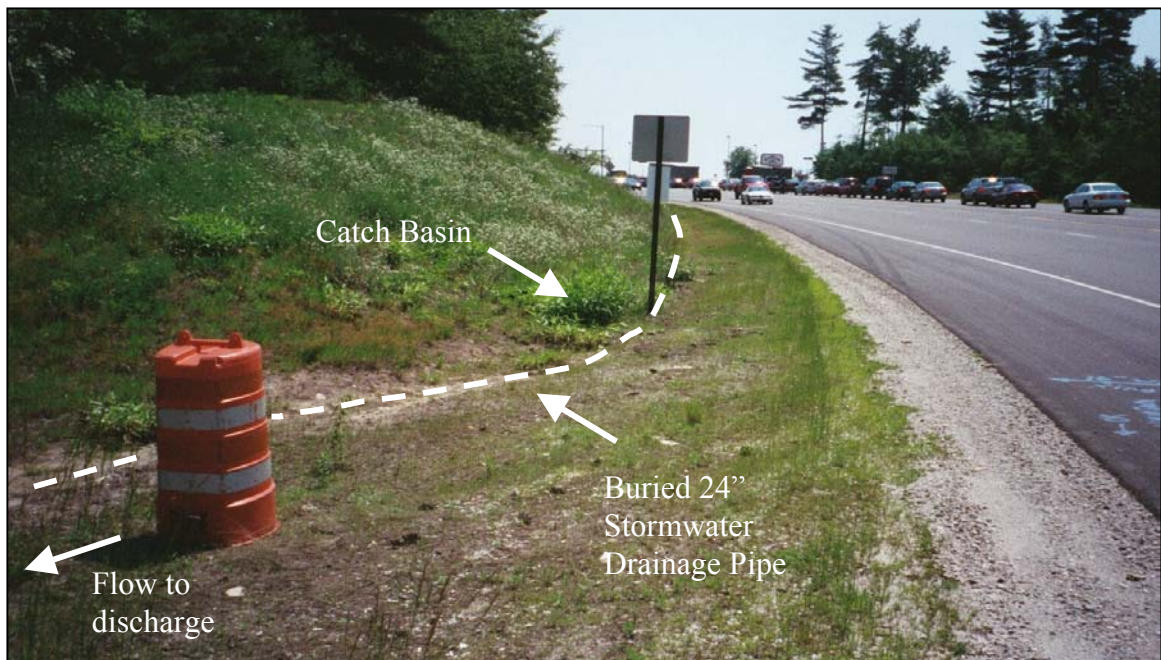
Another source of stormwater to the Stump Pond outlet wetland is overland flow not captured by the catch basins. The majority of this water will enter as sheet flow leaving the road surface downgradient of the last two catch basins (Figure 3-4). While some infiltration occurs in the sandy soils that underlie the shoulder, it appears that much of the runoff flows through at a significant velocity during large runoff events. There is little vegetation on the road's shoulder most likely due to road salt, winter plowing and from recent grading activities.

**Figure 3-4.** Shoulder of Route 101A Upgradient from 24" Discharge Pipe

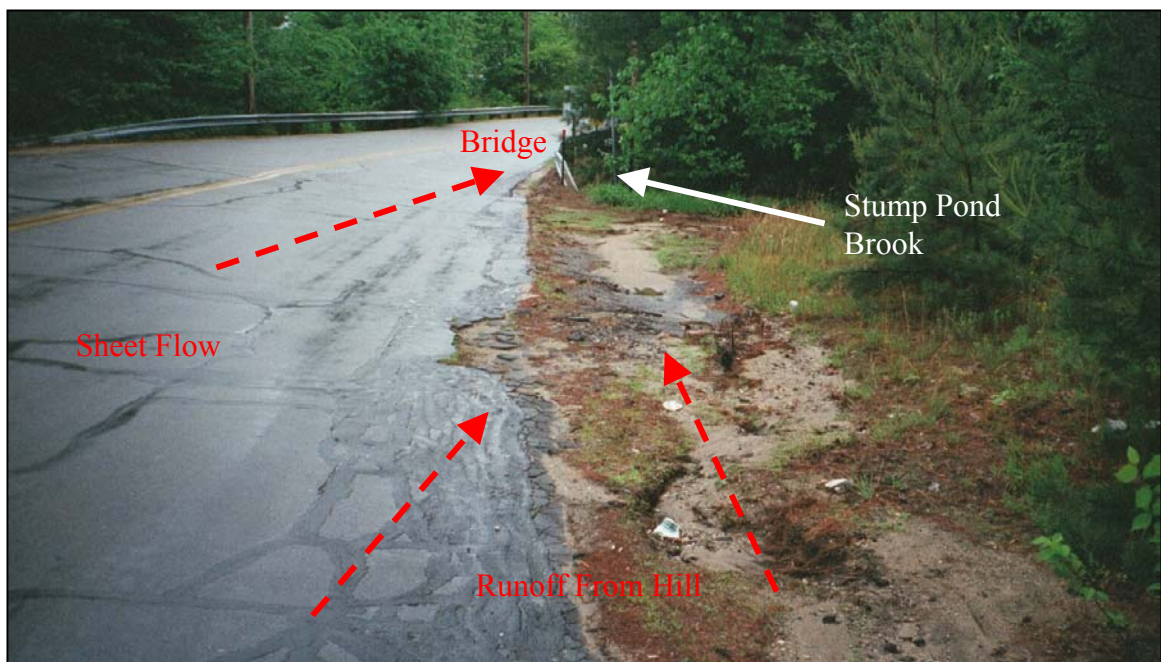
**Figure 3-5.** Shoulder on Craftsman Lane Eroded by Stormwater

Containment swales should be installed on the shoulders of Craftsman Lane (on either side of the bridge) in the areas that are currently free of trees to capture and infiltrate the diverted roadside runoff (Figure 4-3). By working around the existing landscape, the impacts of the project will be reduced, resulting in less surface disturbance and habitat destruction. The swales can be dug with a loader and only need to be a foot deep. The grade should be sufficient to carry water away from the road. The swales should be constructed in a manner that will release excess water evenly across a wide path rather than one spillway, in order to reduce any scouring. Excess water will overflow into the surrounding vegetated areas. Appendix A describes in more detail the design and function of a containment swale. The proposed containment swale for this location is a simpler version of the one described in Appendix A.

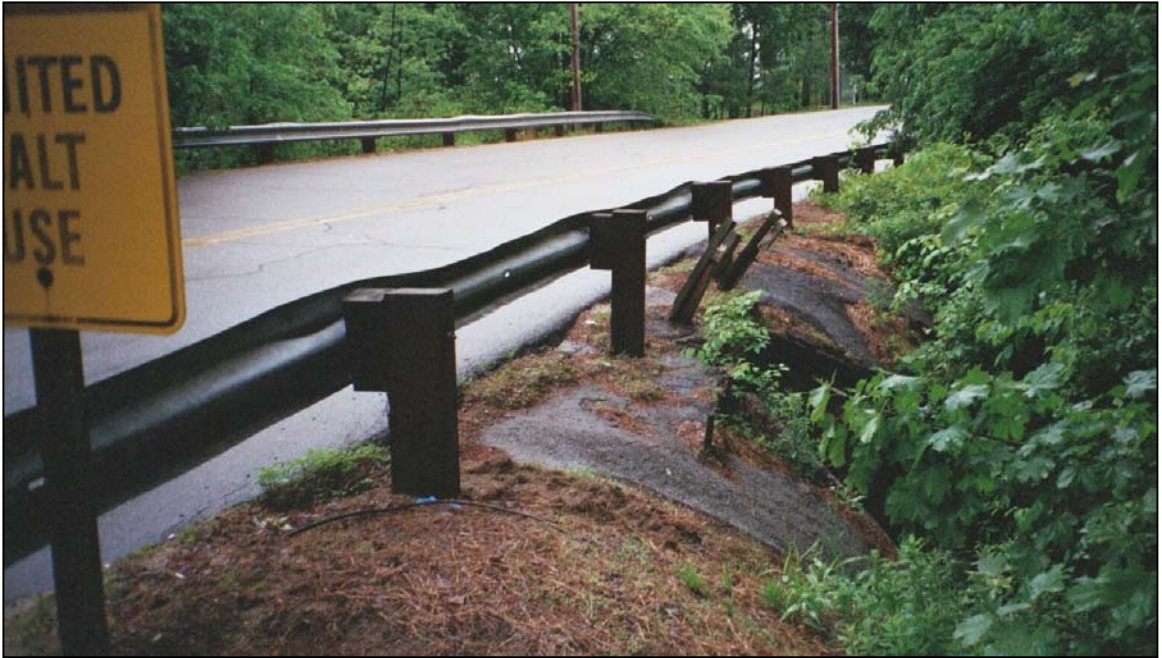
**Figure 3-6.** Asphalted bank Around Culvert of Craftsman Lane Bridge

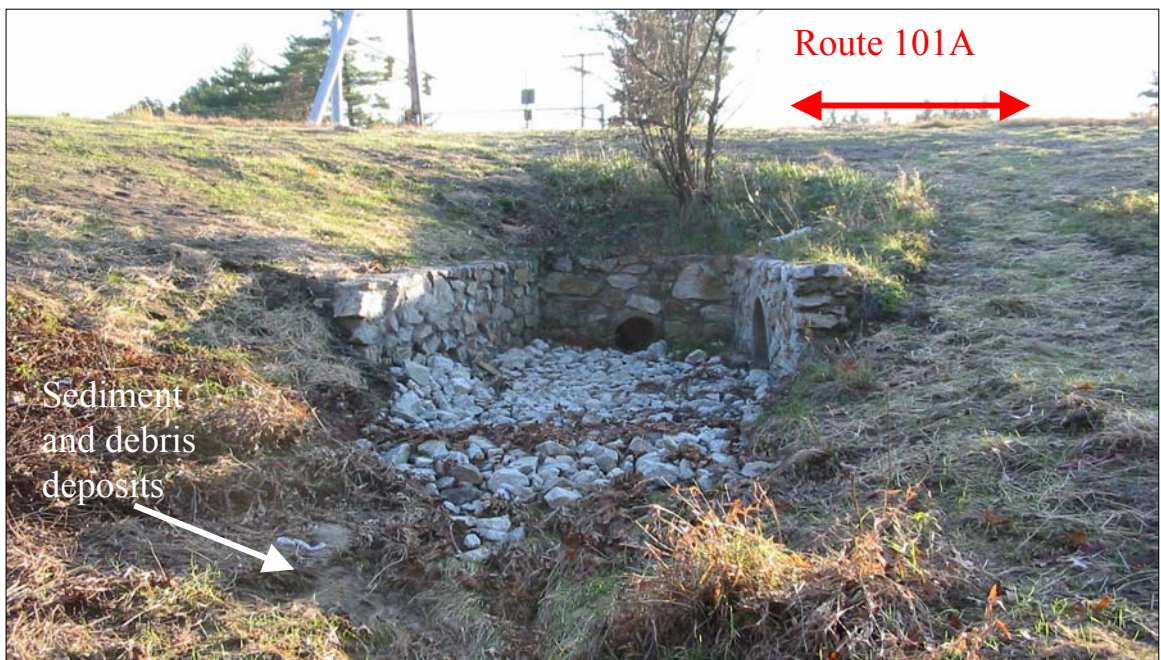
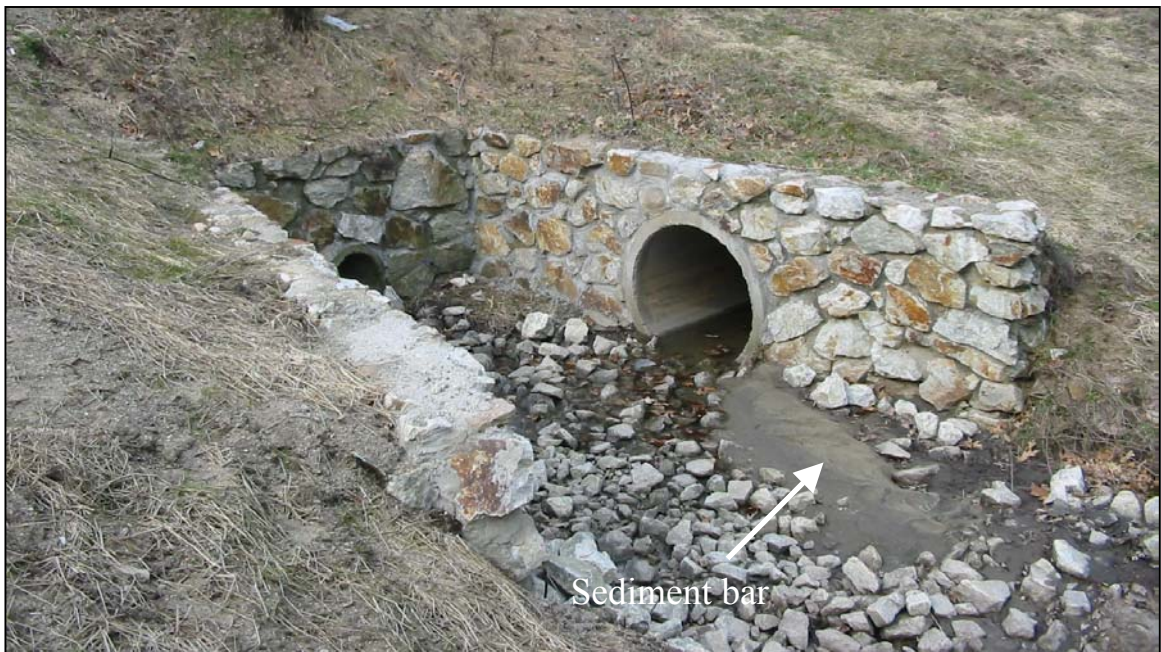
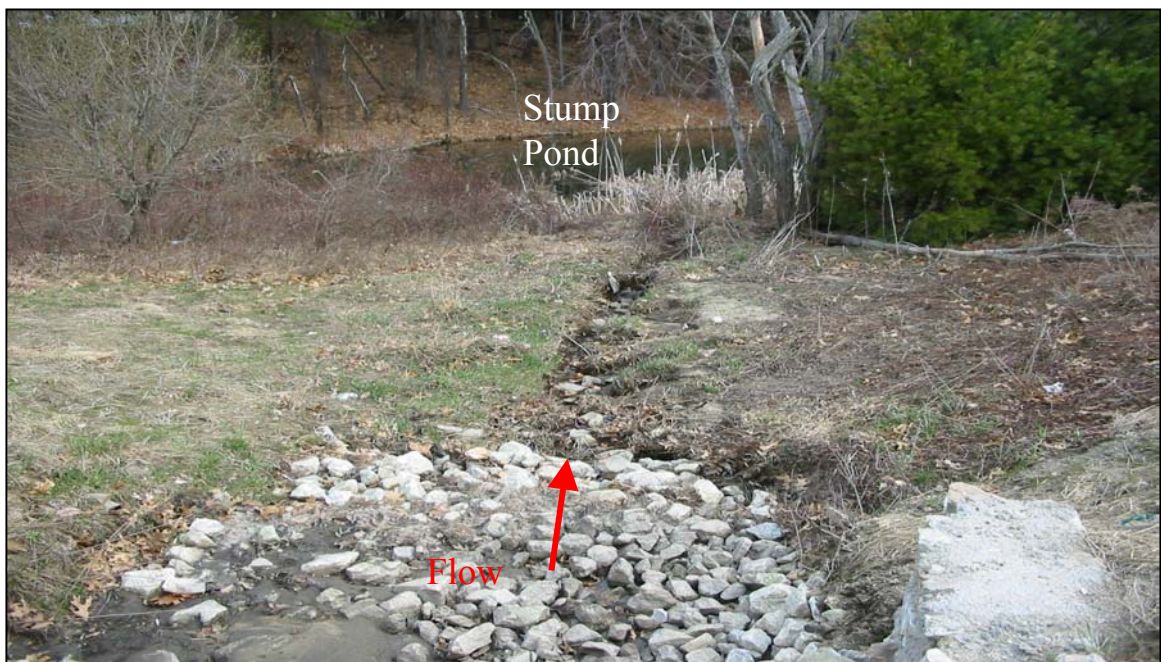
pipes that discharge within 30 feet of Stump Pond at the bottom of a steep bank into a small marshy area (Figure 3-7, 3-8, and 3-9). Additionally, stormwater from a portion of the roof and the entire front parking lot (five catch basins) of the commercial plaza called Heritage Place (located directly across from the discharge point) is collected and discharged into the drainage system. High velocity flows have caused a foot deep gully to form between the outfall area and the pond. Drainage in this area includes stormwater from the 101A drainage system along with any areas that contribute overland flow.

**Figure 3-7.** Route 101A Discharge to Stump Pond Facing Road

**Figure 3-8.** Route 101A 24" Discharge Pipe

**Figure 3-9.** Route 101A Discharge to Stump Pond Facing Pond

Pennichuck should encourage the installation of bio-cells around the five catch basins located in Heritage Place plaza parking lot and a drywell to contain and infiltrate the roof runoff. Bio-cells are landscaped depressions designed to contain and infiltrate runoff. (plaza is located directly across 101A from Stump Pond) Excess water flows into the existing catch basins. Appendix B and C describe in more detail the design and operation of the bio-cell and drywell.

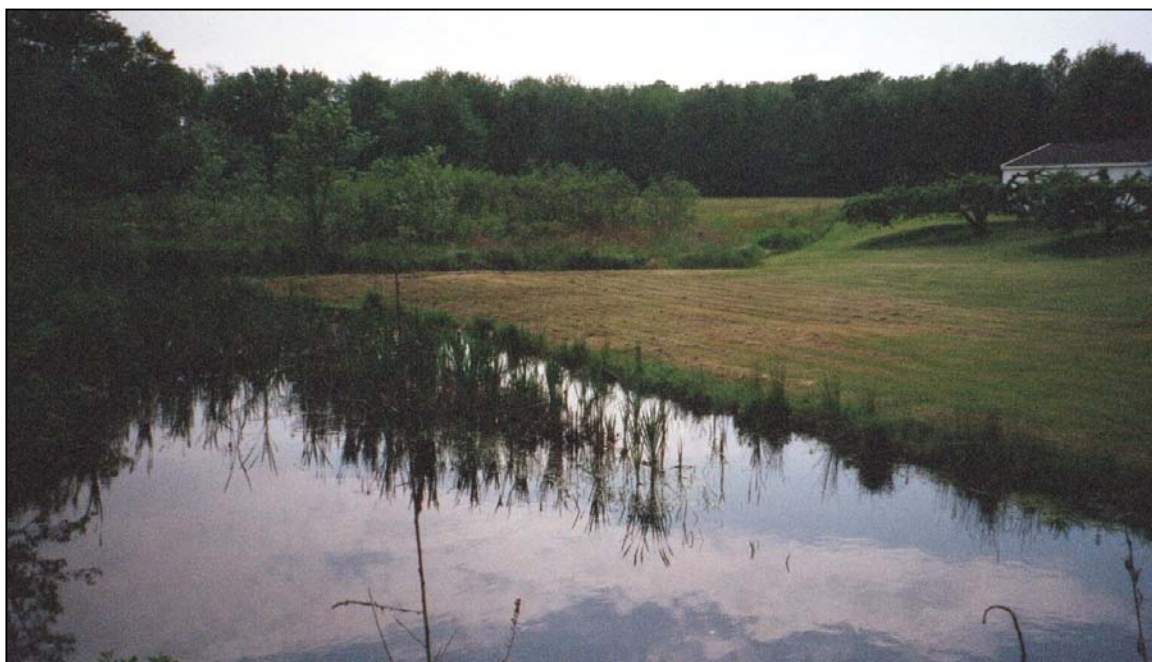
**Figure 3-11.** Stump Pond Brook without Buffer

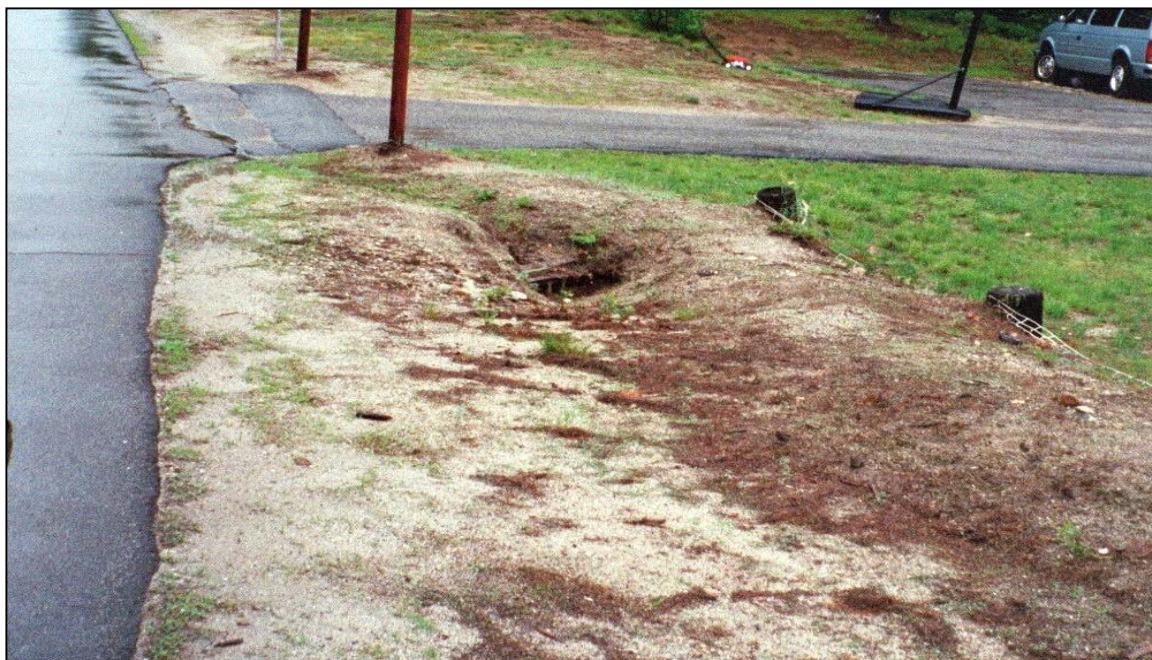
**Figures 3-12.** Clogged Catch Basin on Willow Road

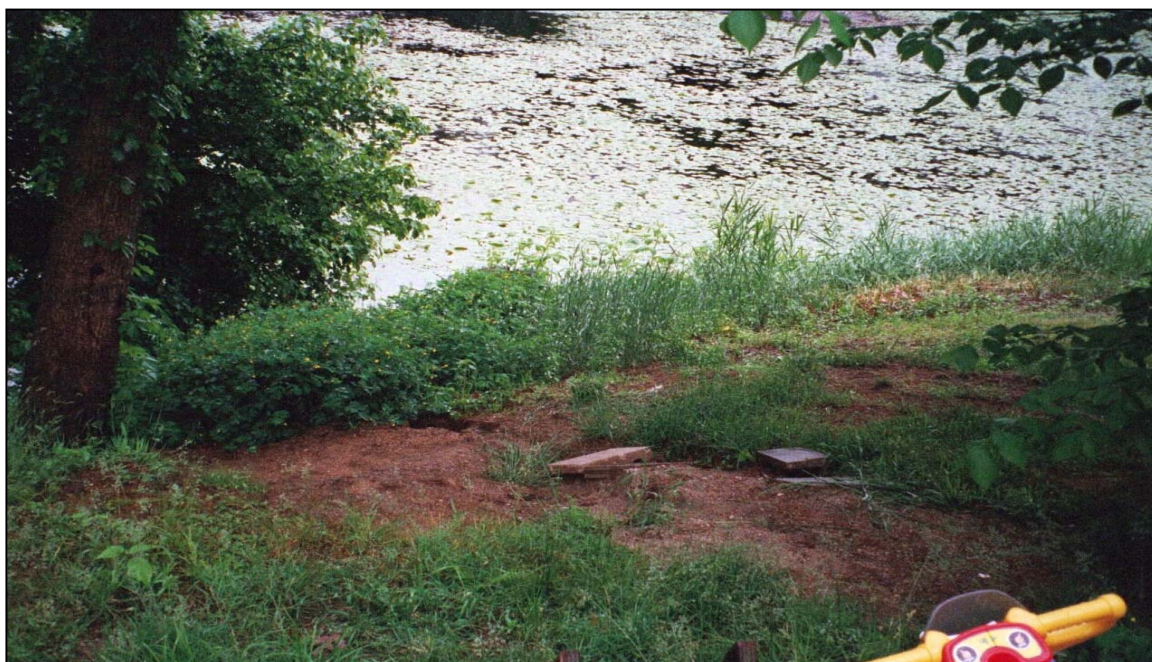
Throughout the subwatershed, unstable roadside shoulders are eroding and washing into nearby wetlands and waterways, eventually reaching Stump Pond Brook. A dramatic example can be found at the bend in Willow Lane. Unstable shoulders on both sides of the road contribute a large amount of sediment to two nearly clogged catch basins that discharge to a short, steep slope fifteen feet from Stump Pond. (Figures 3-12, 3-13) There is no vegetated buffer on the slope and as a result, runoff has scoured the bare ground, washing the soils into the pond.

**Figure 3-13.** Willow Road Drainage Discharges into Stump Pond  
(Steep unstable bank is being eroded)

Planting vegetation such as grass and groundcovers suitable to the site conditions can stabilize roadsides effectively. Re-vegetation of roadsides provides root structure for soil stabilization, can enhance infiltration, beautifies the area and provides shade to keep the area cool.

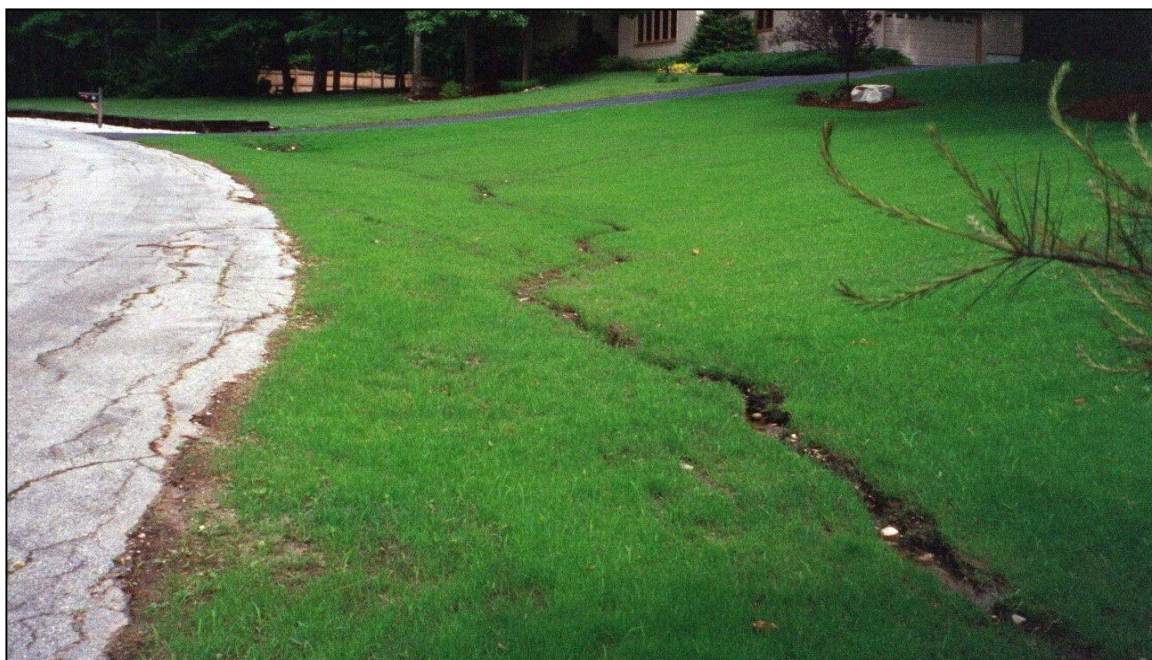
A graphic illustration of the fate of sites without sufficient erosion and sediment controls was found on Wildwood Lane. The Wildwood Lane subdivision has a series of problems that culminate in the discharge of significant amounts of sediment to the wooded buffer area immediately downgradient of the subdivision. Wildwood Lane slopes down away from Seaverns Bridge Road. The first property on the south side of the Lane landscaped their lawn in May 2002. This lawn was only beginning to establish when spring rainstorms arrived in late May 2002. The freshly graded soil was easily eroded and a network of small channels formed as the sediment was carried off the property (Figure 3-14). A considerable portion of this sediment fell out of suspension where water was pooling in front of the next driveway, clogging that culvert (Figure 3-15). The runoff overtopped the driveway and carved a wide channel through the neighbor's property before slowly dissipating in the wooded buffer at the end of the lane.

**Figure 3-14.** Scouring of Recently Seeded Lawn on Wildwood Lane

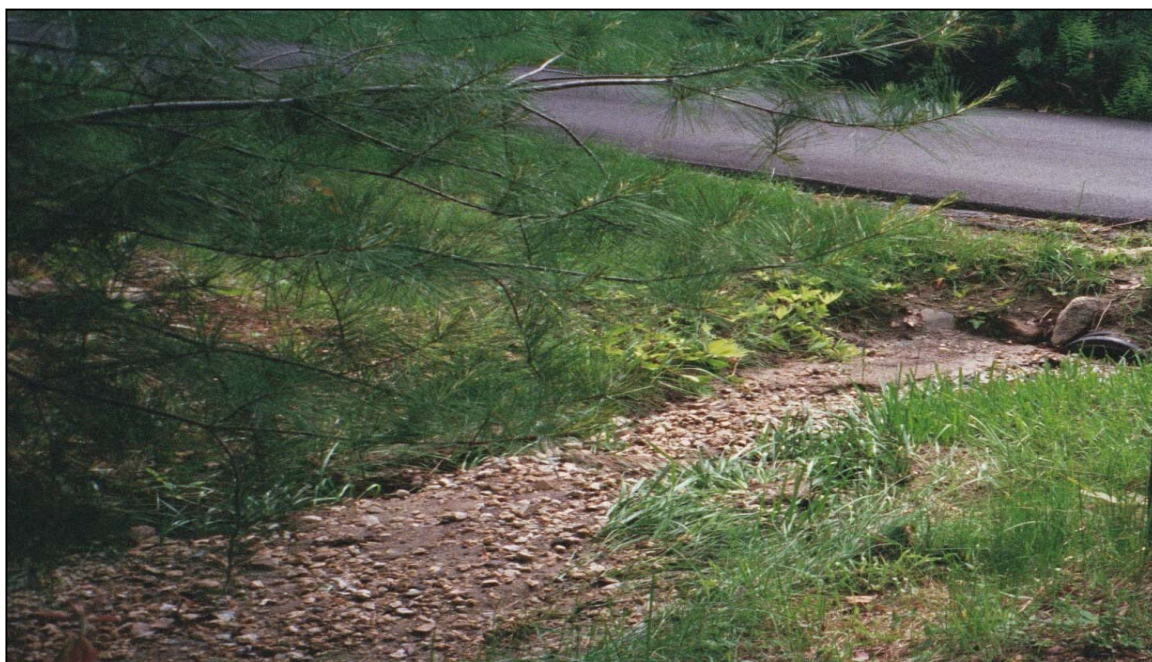
**Figure 3-15.** Wildwood Lane Clogged Driveway Culvert
