## PENNICHUCK WATER WORKS BOIRE FIELD BROOK SUBWATERSHED EVALUATION 2019

**PENNICHUCK**

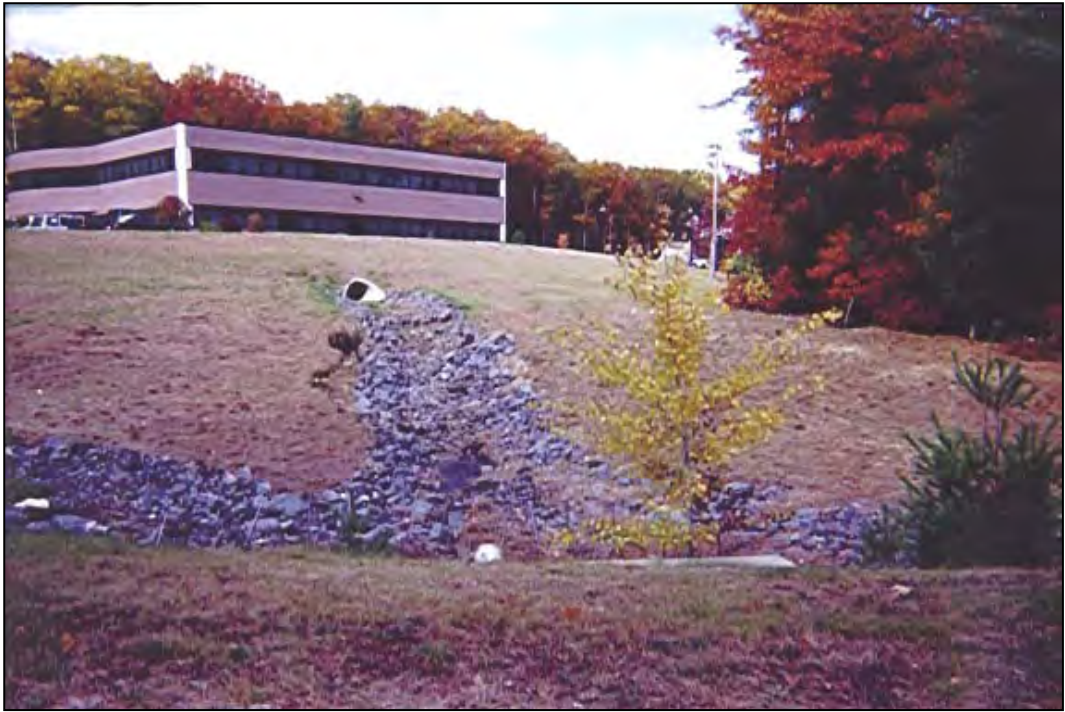
Figure 2-18. Stormwater Collection Junction for the Cornerstone Site

This discharge site (Figure 2-17) and an upstream collection junction (Figure 2-18) were picked for installation of BMPs and are described in greater detail in section 3.1.

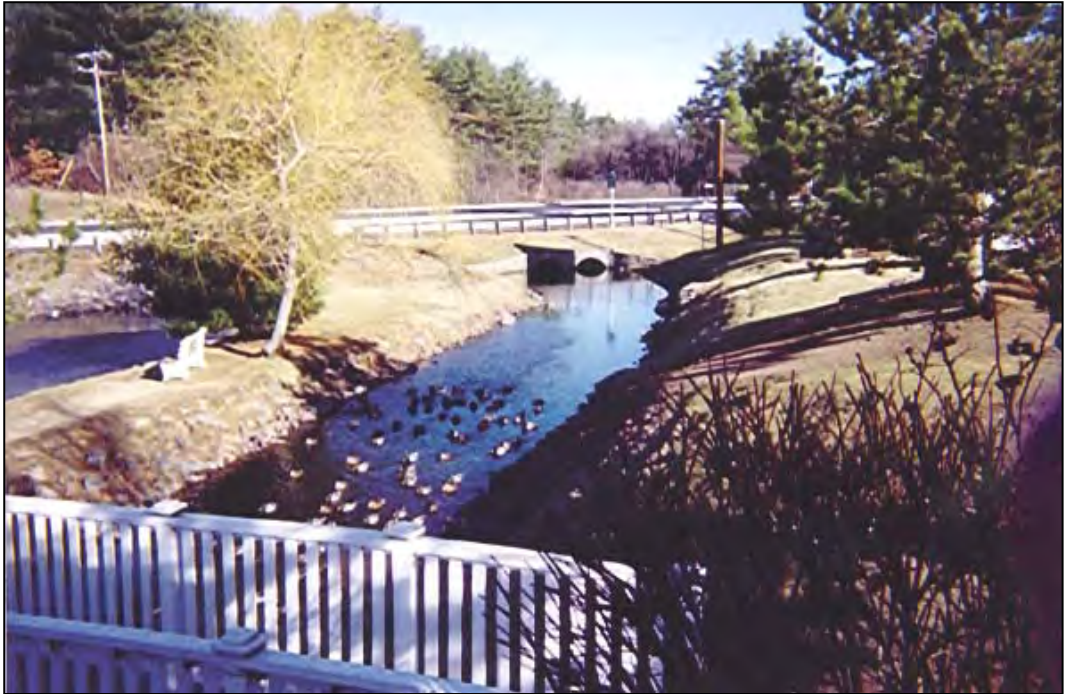
Figure 3-7. In both winter and summer, ducks preferred this narrow pond. Installation of physical deterrents here are less costly.

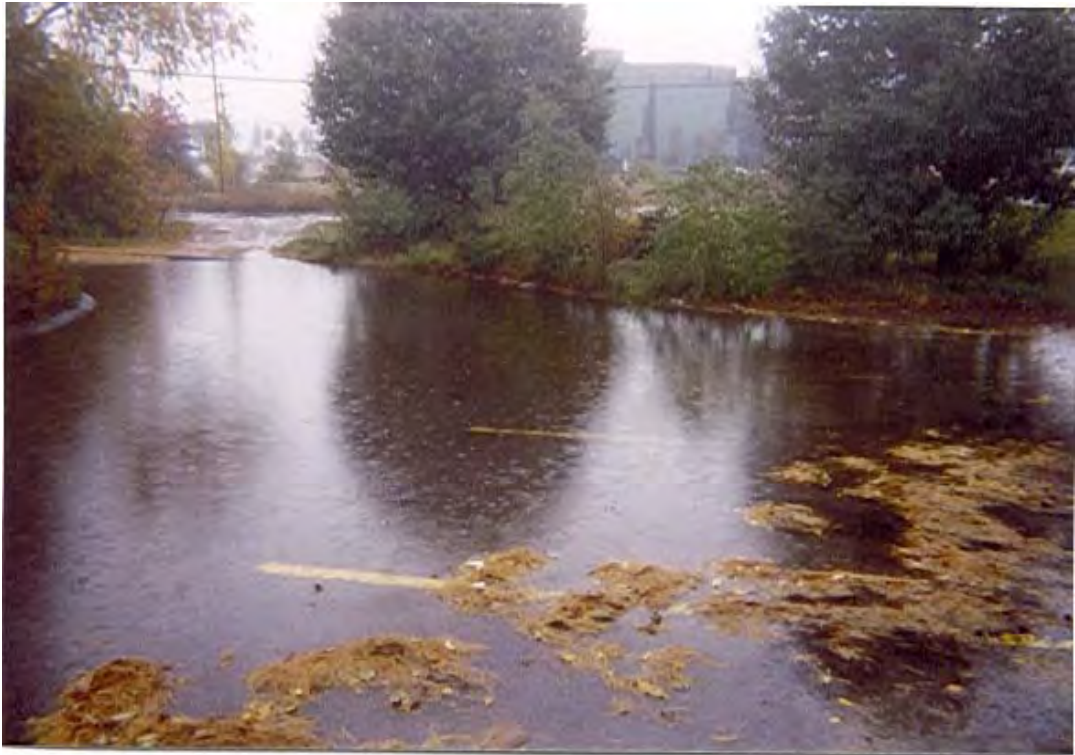
Figure 4-1. Ponding Problem at Sullivan Tire

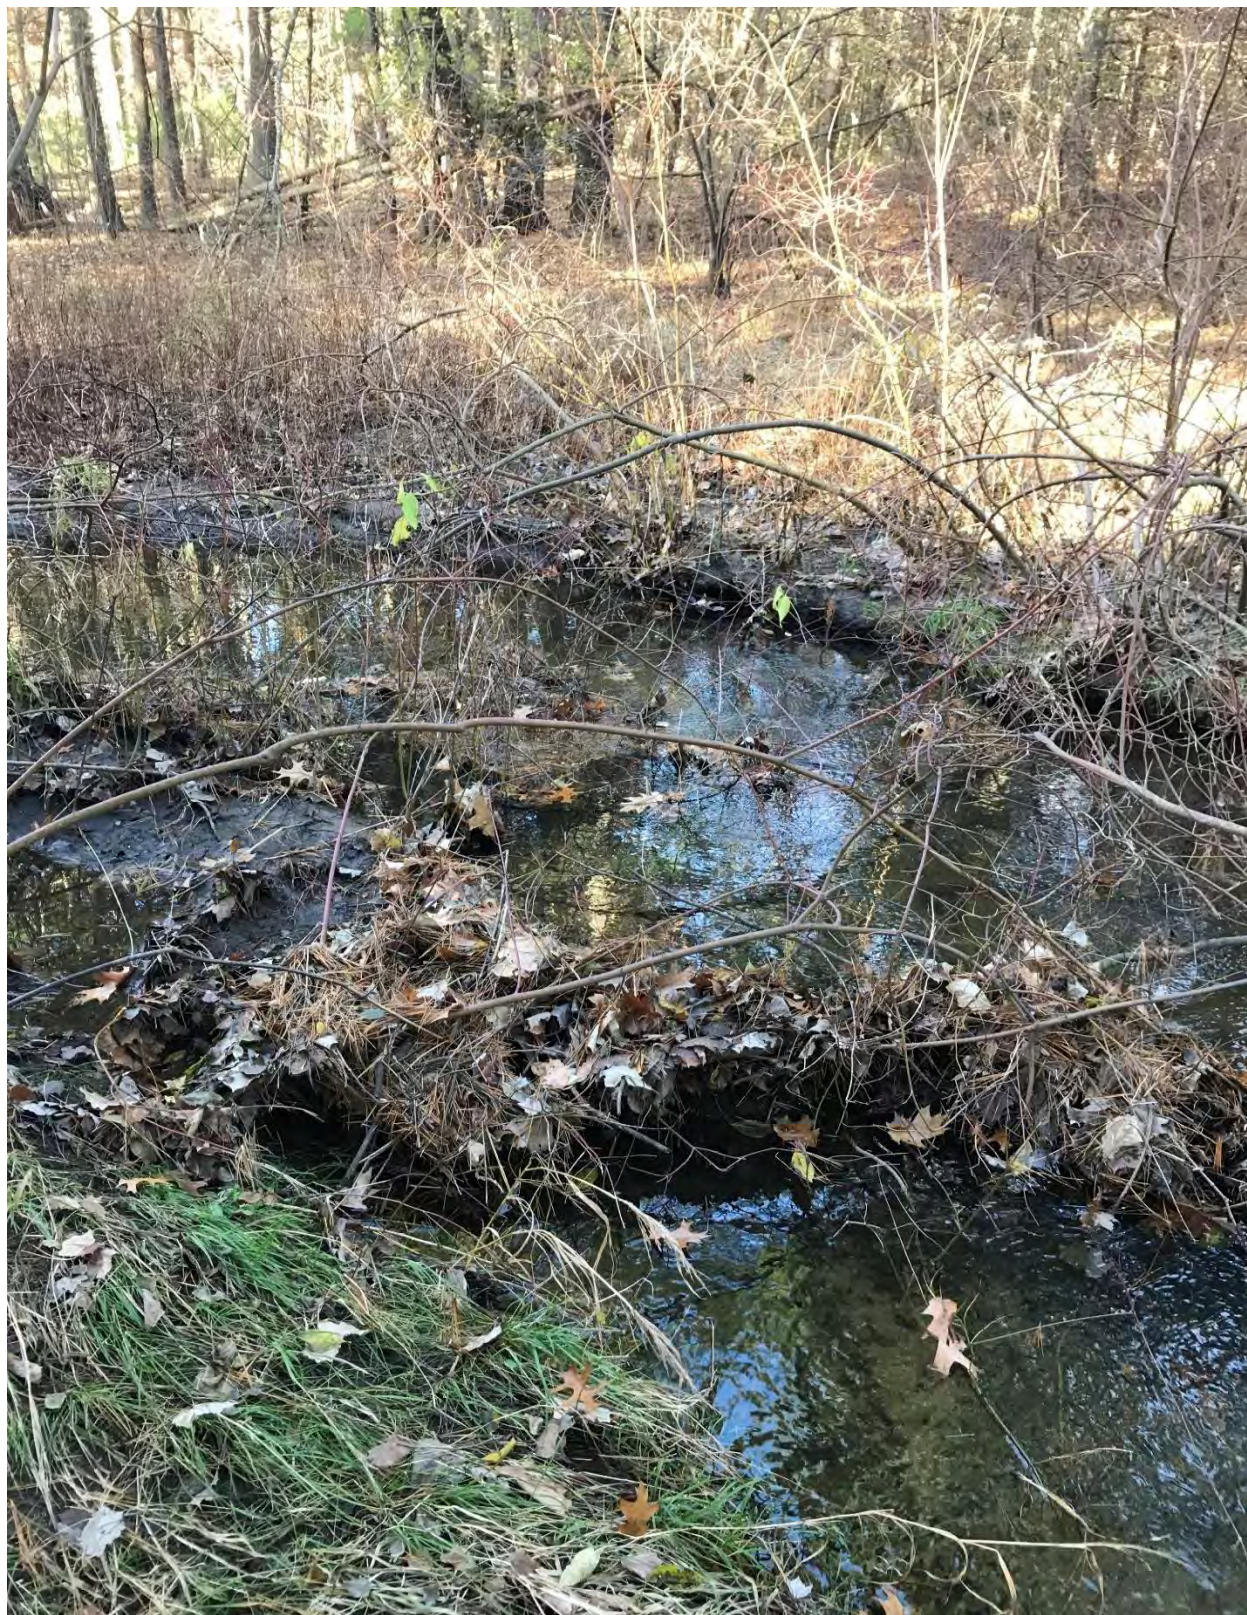
**Corridor Site 6: Sediment deposit/debris build-up within the stream; possible beaver activity**

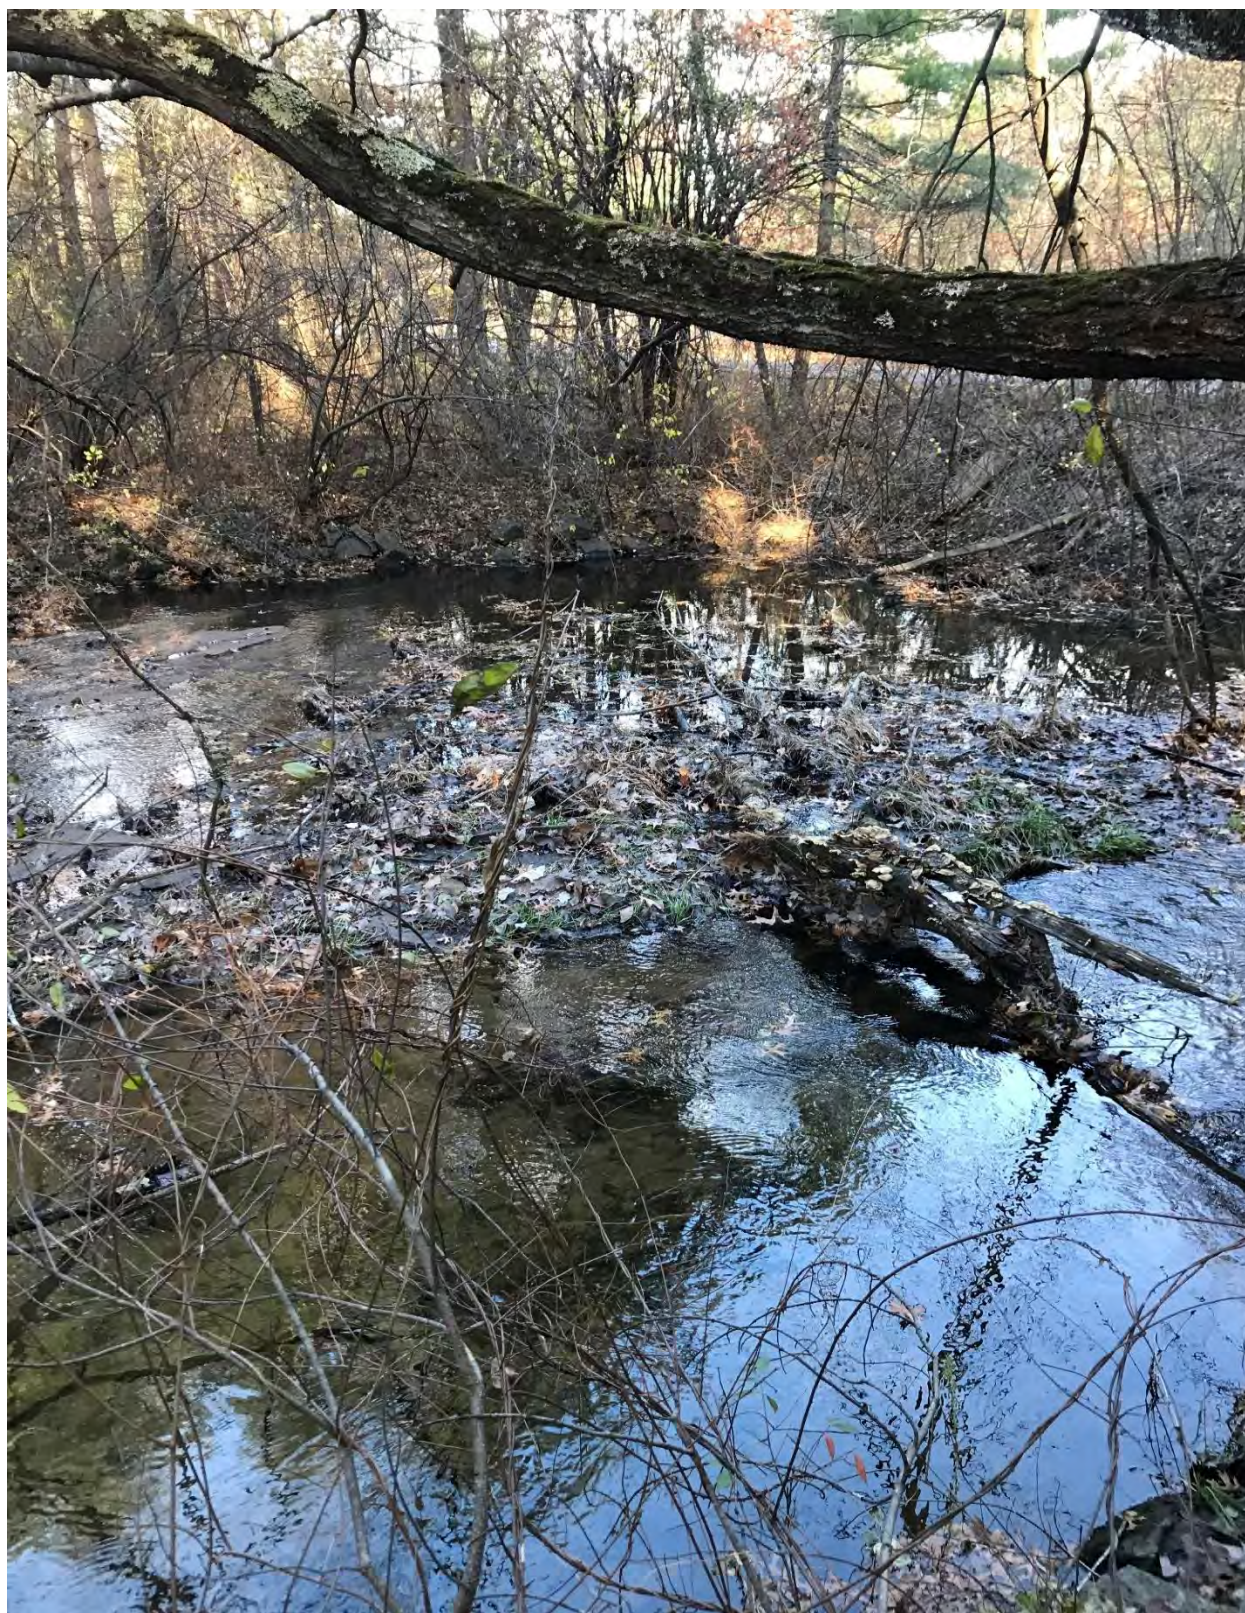
**Corridor Site 7: Sediment deposit/debris build-up within the stream; possible beaver activity**

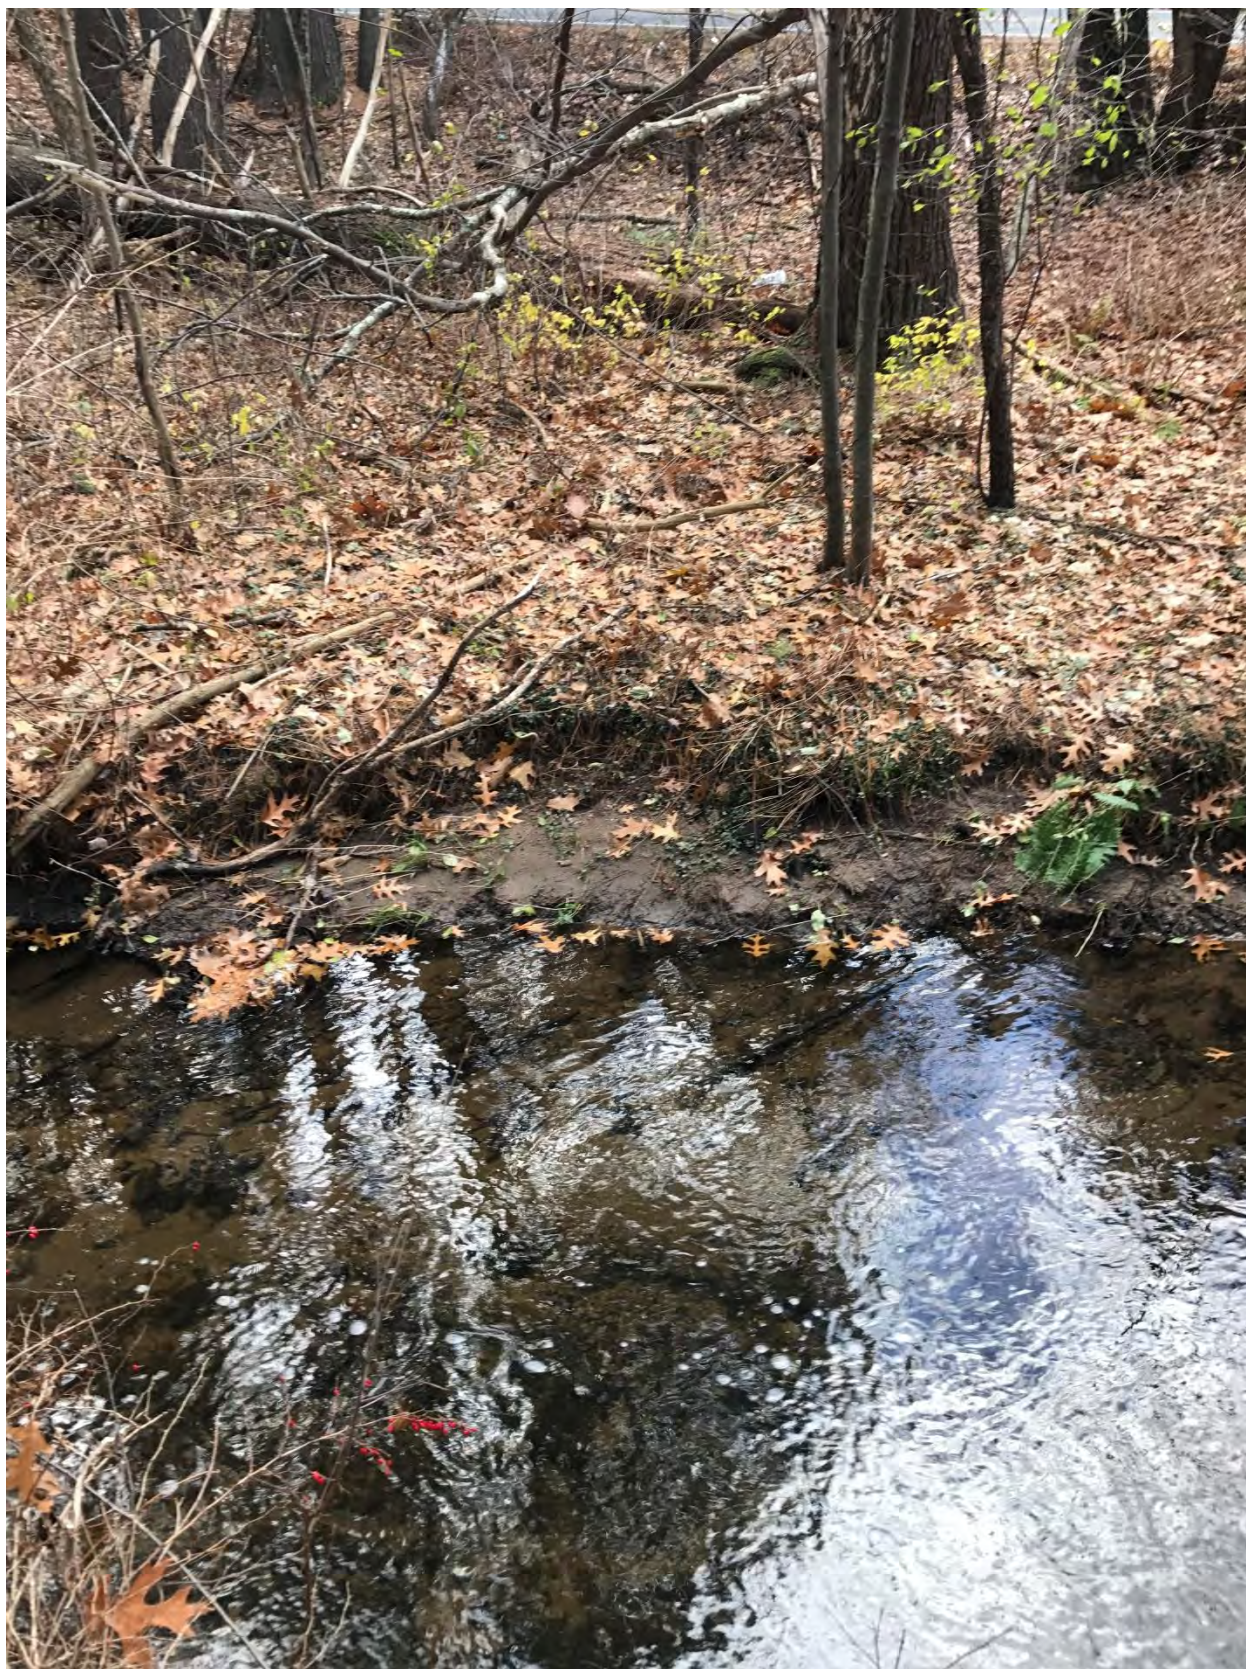
**Corridor Site 10: Bank erosion and undercutting due to larger flows**

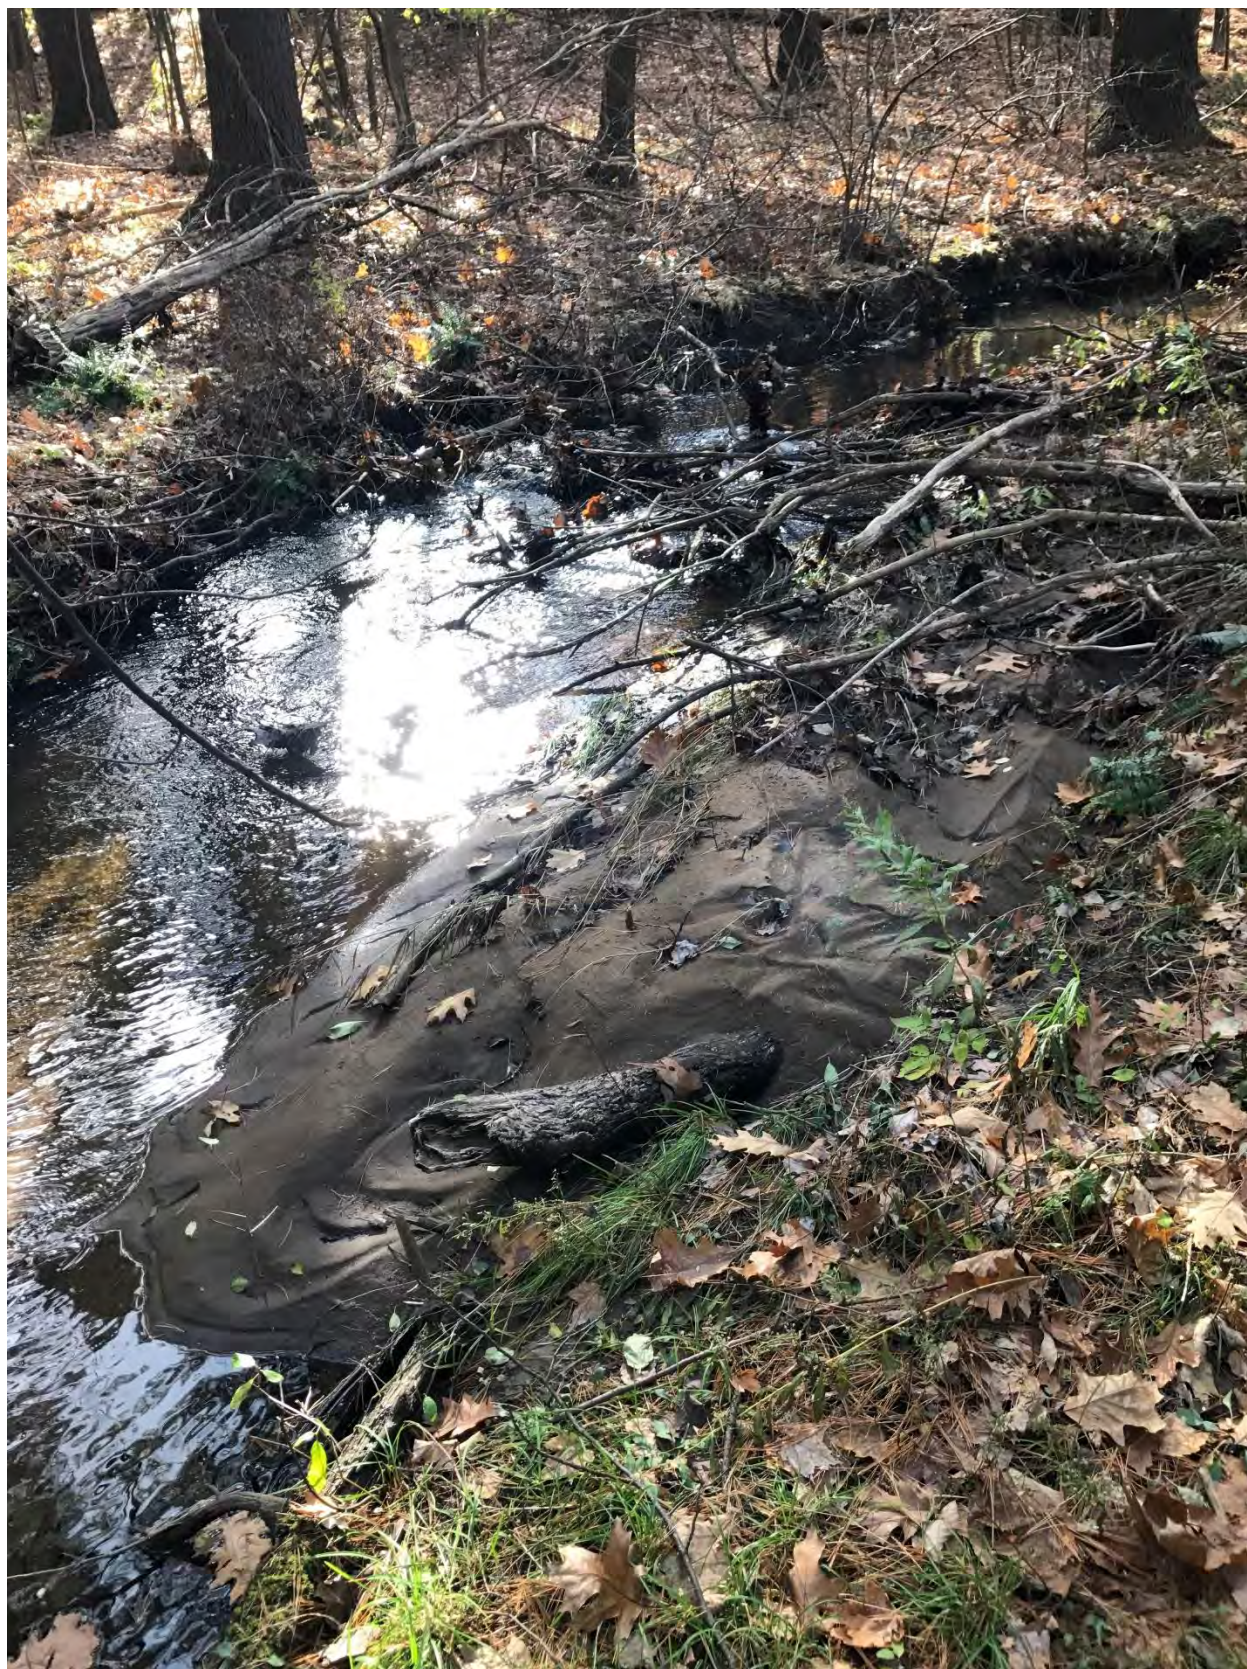
**Corridor Site 11: Sediment deposit within the stream**

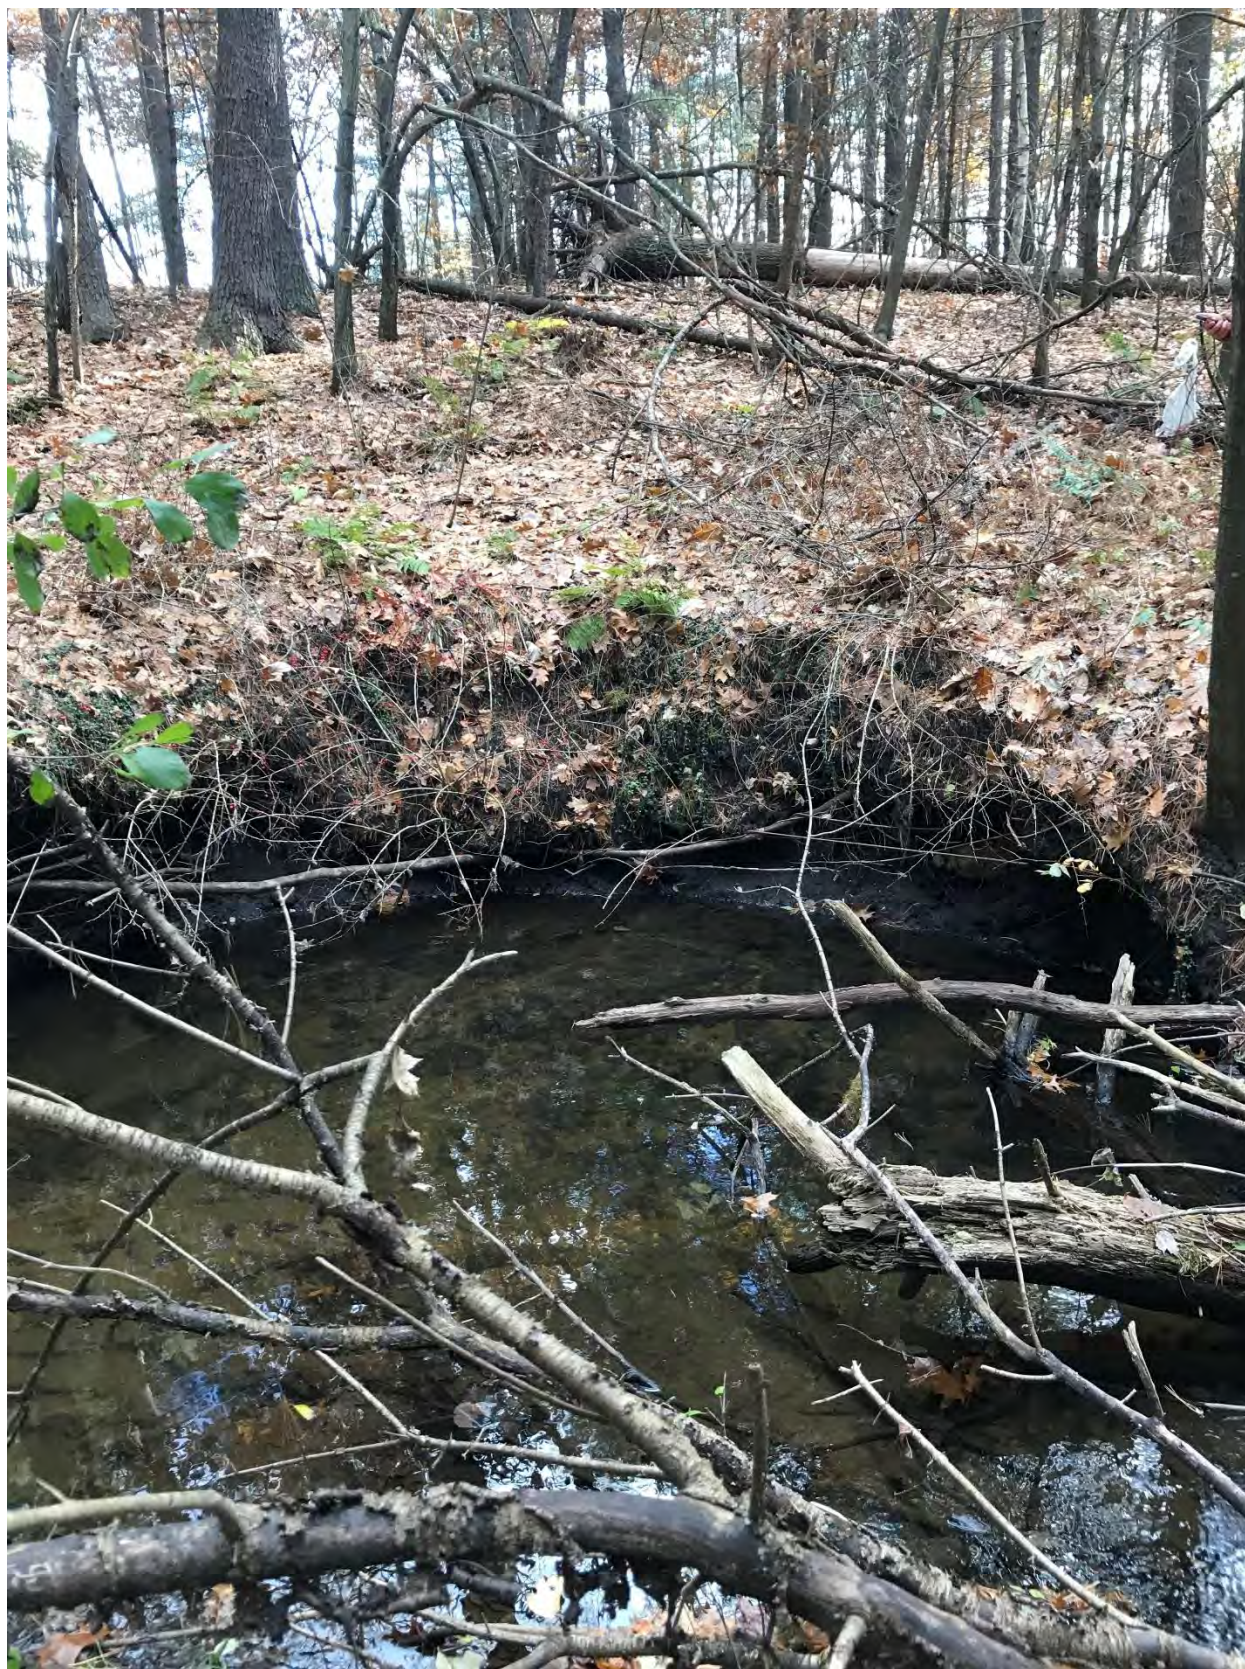
**Corridor Site 12: Bank erosion and undercutting due to larger flows**

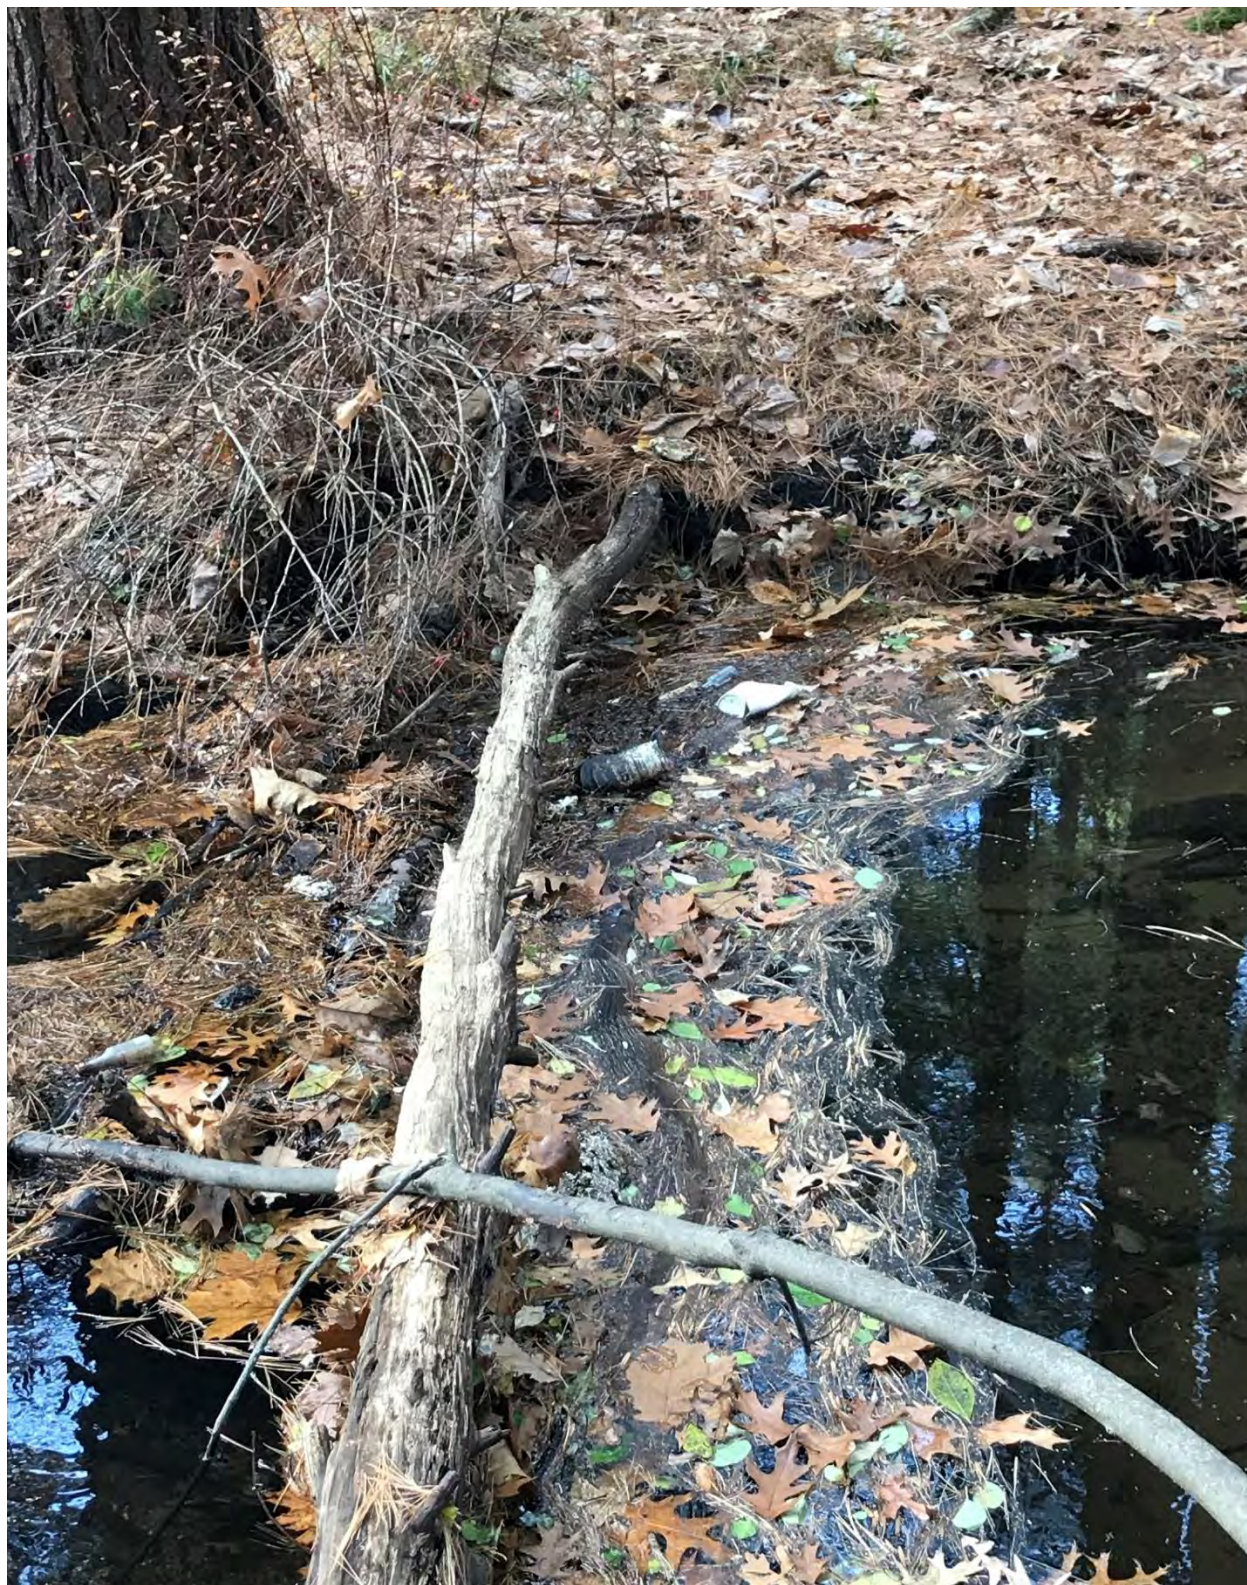
**Corridor Site 13: Trash/debris build-up within the stream; possible beaver activity**

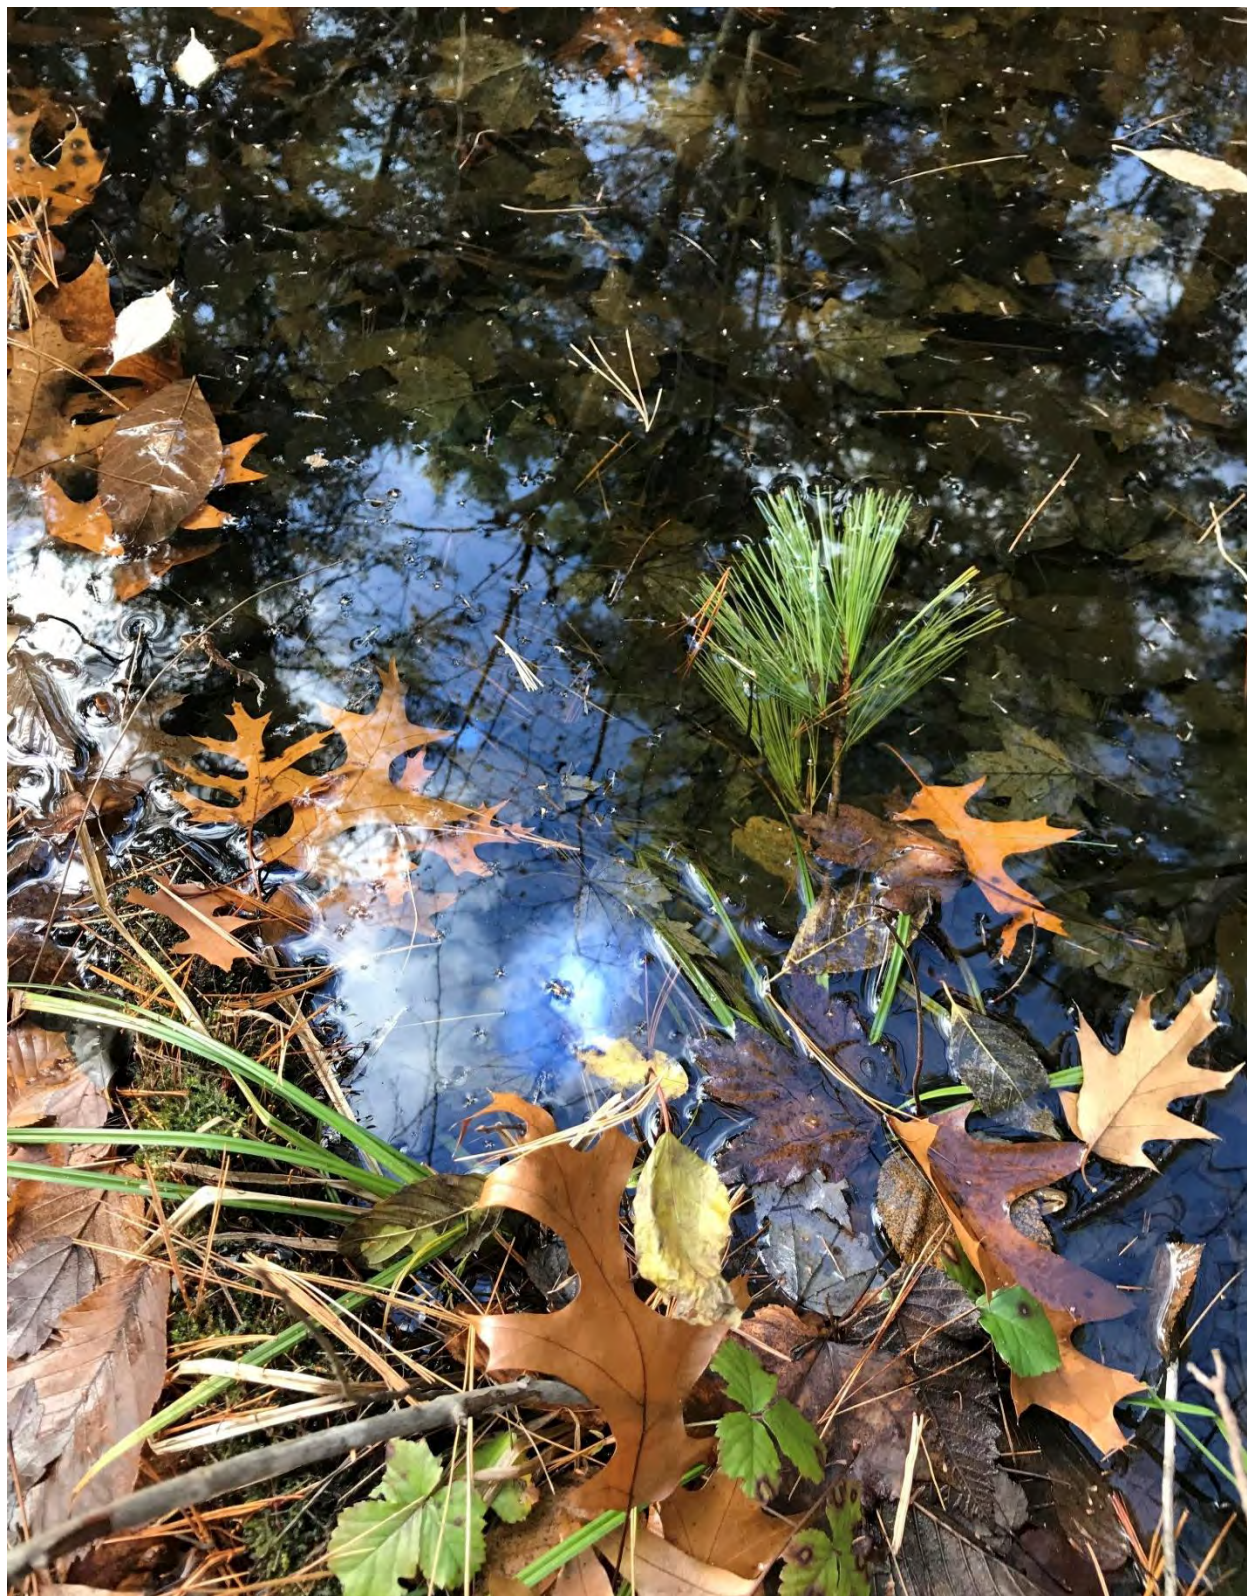
**Corridor Site 14: Discolored water/oily sheen; likely from stormwater runoff from major roadways, including Everett Turnpike**

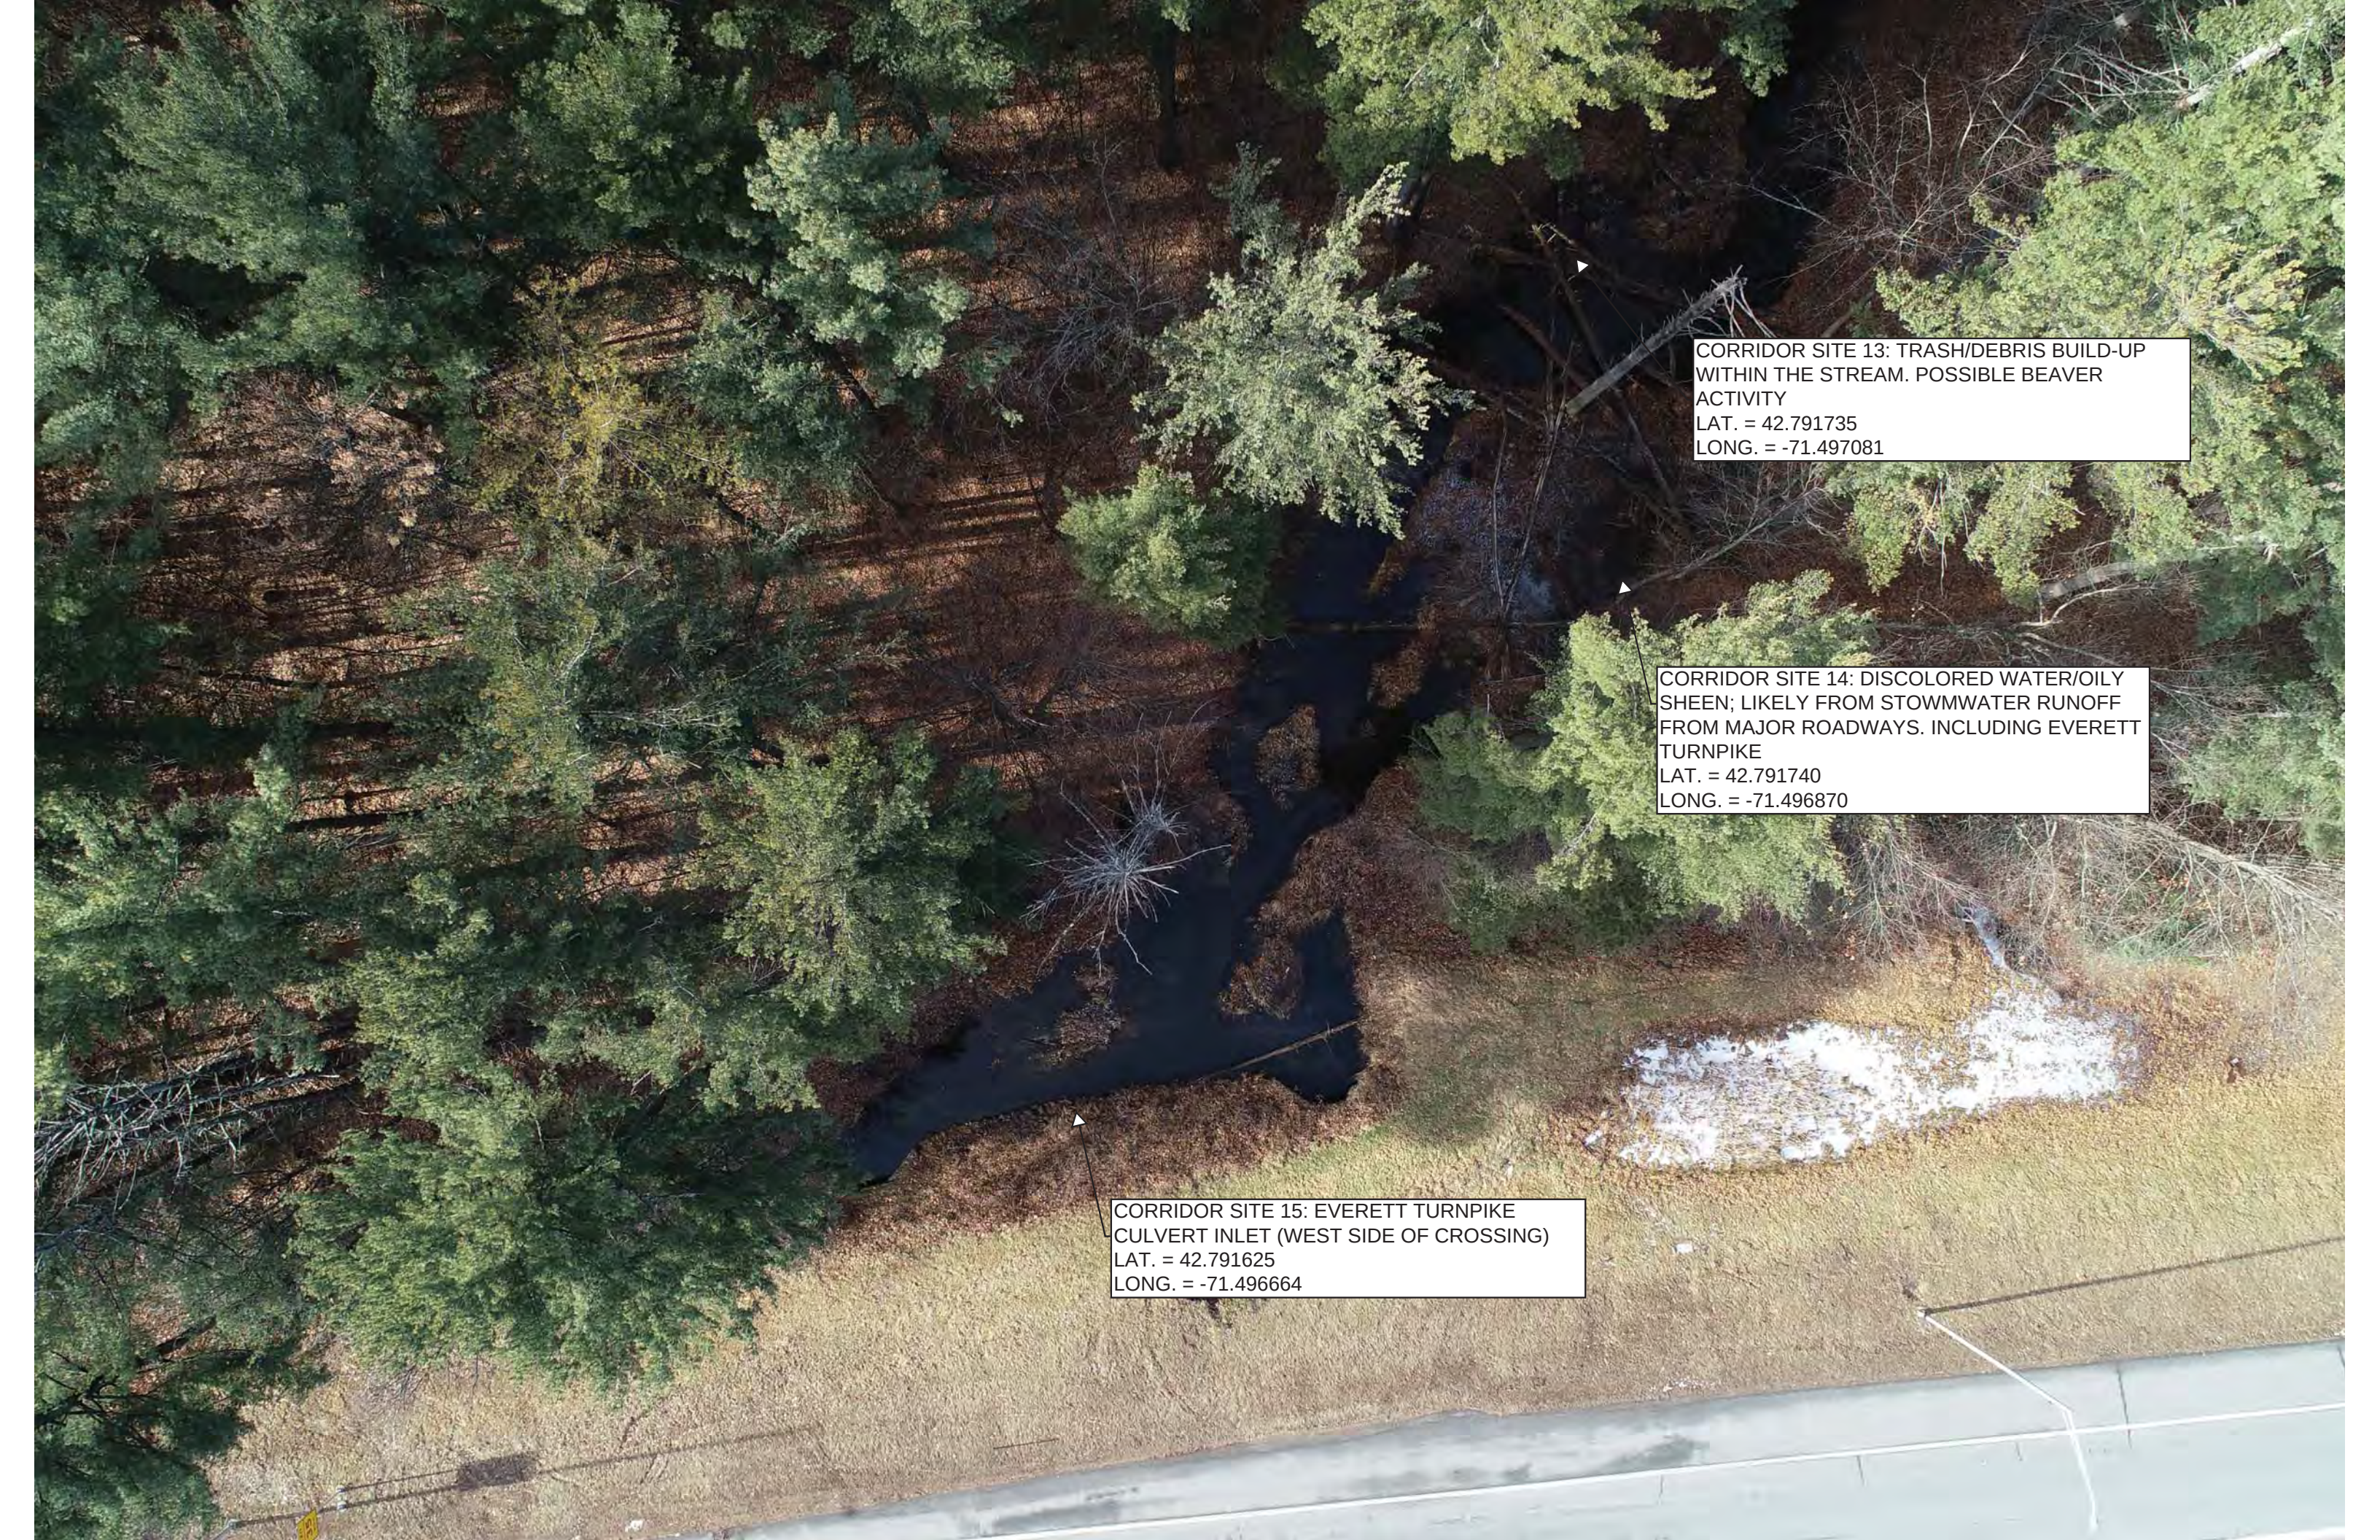
CORRIDOR SITE 13: TRASH/DEBRIS BUILD-UP  
WITHIN THE STREAM. POSSIBLE BEAVER  
ACTIVITY  
LAT. = 42.791735  
LONG. = -71.497081

CORRIDOR SITE 14: DISCOLORED WATER/OILY  
SHEEN; LIKELY FROM STOWMWATER RUNOFF  
FROM MAJOR ROADWAYS. INCLUDING EVERETT  
TURNPIKE  
LAT. = 42.791740  
LONG. = -71.496870
