## PENNICHUCK WATER WORKS BOIRE FIELD BROOK SUBWATERSHED EVALUATION 2019

**PENNICHUCK**

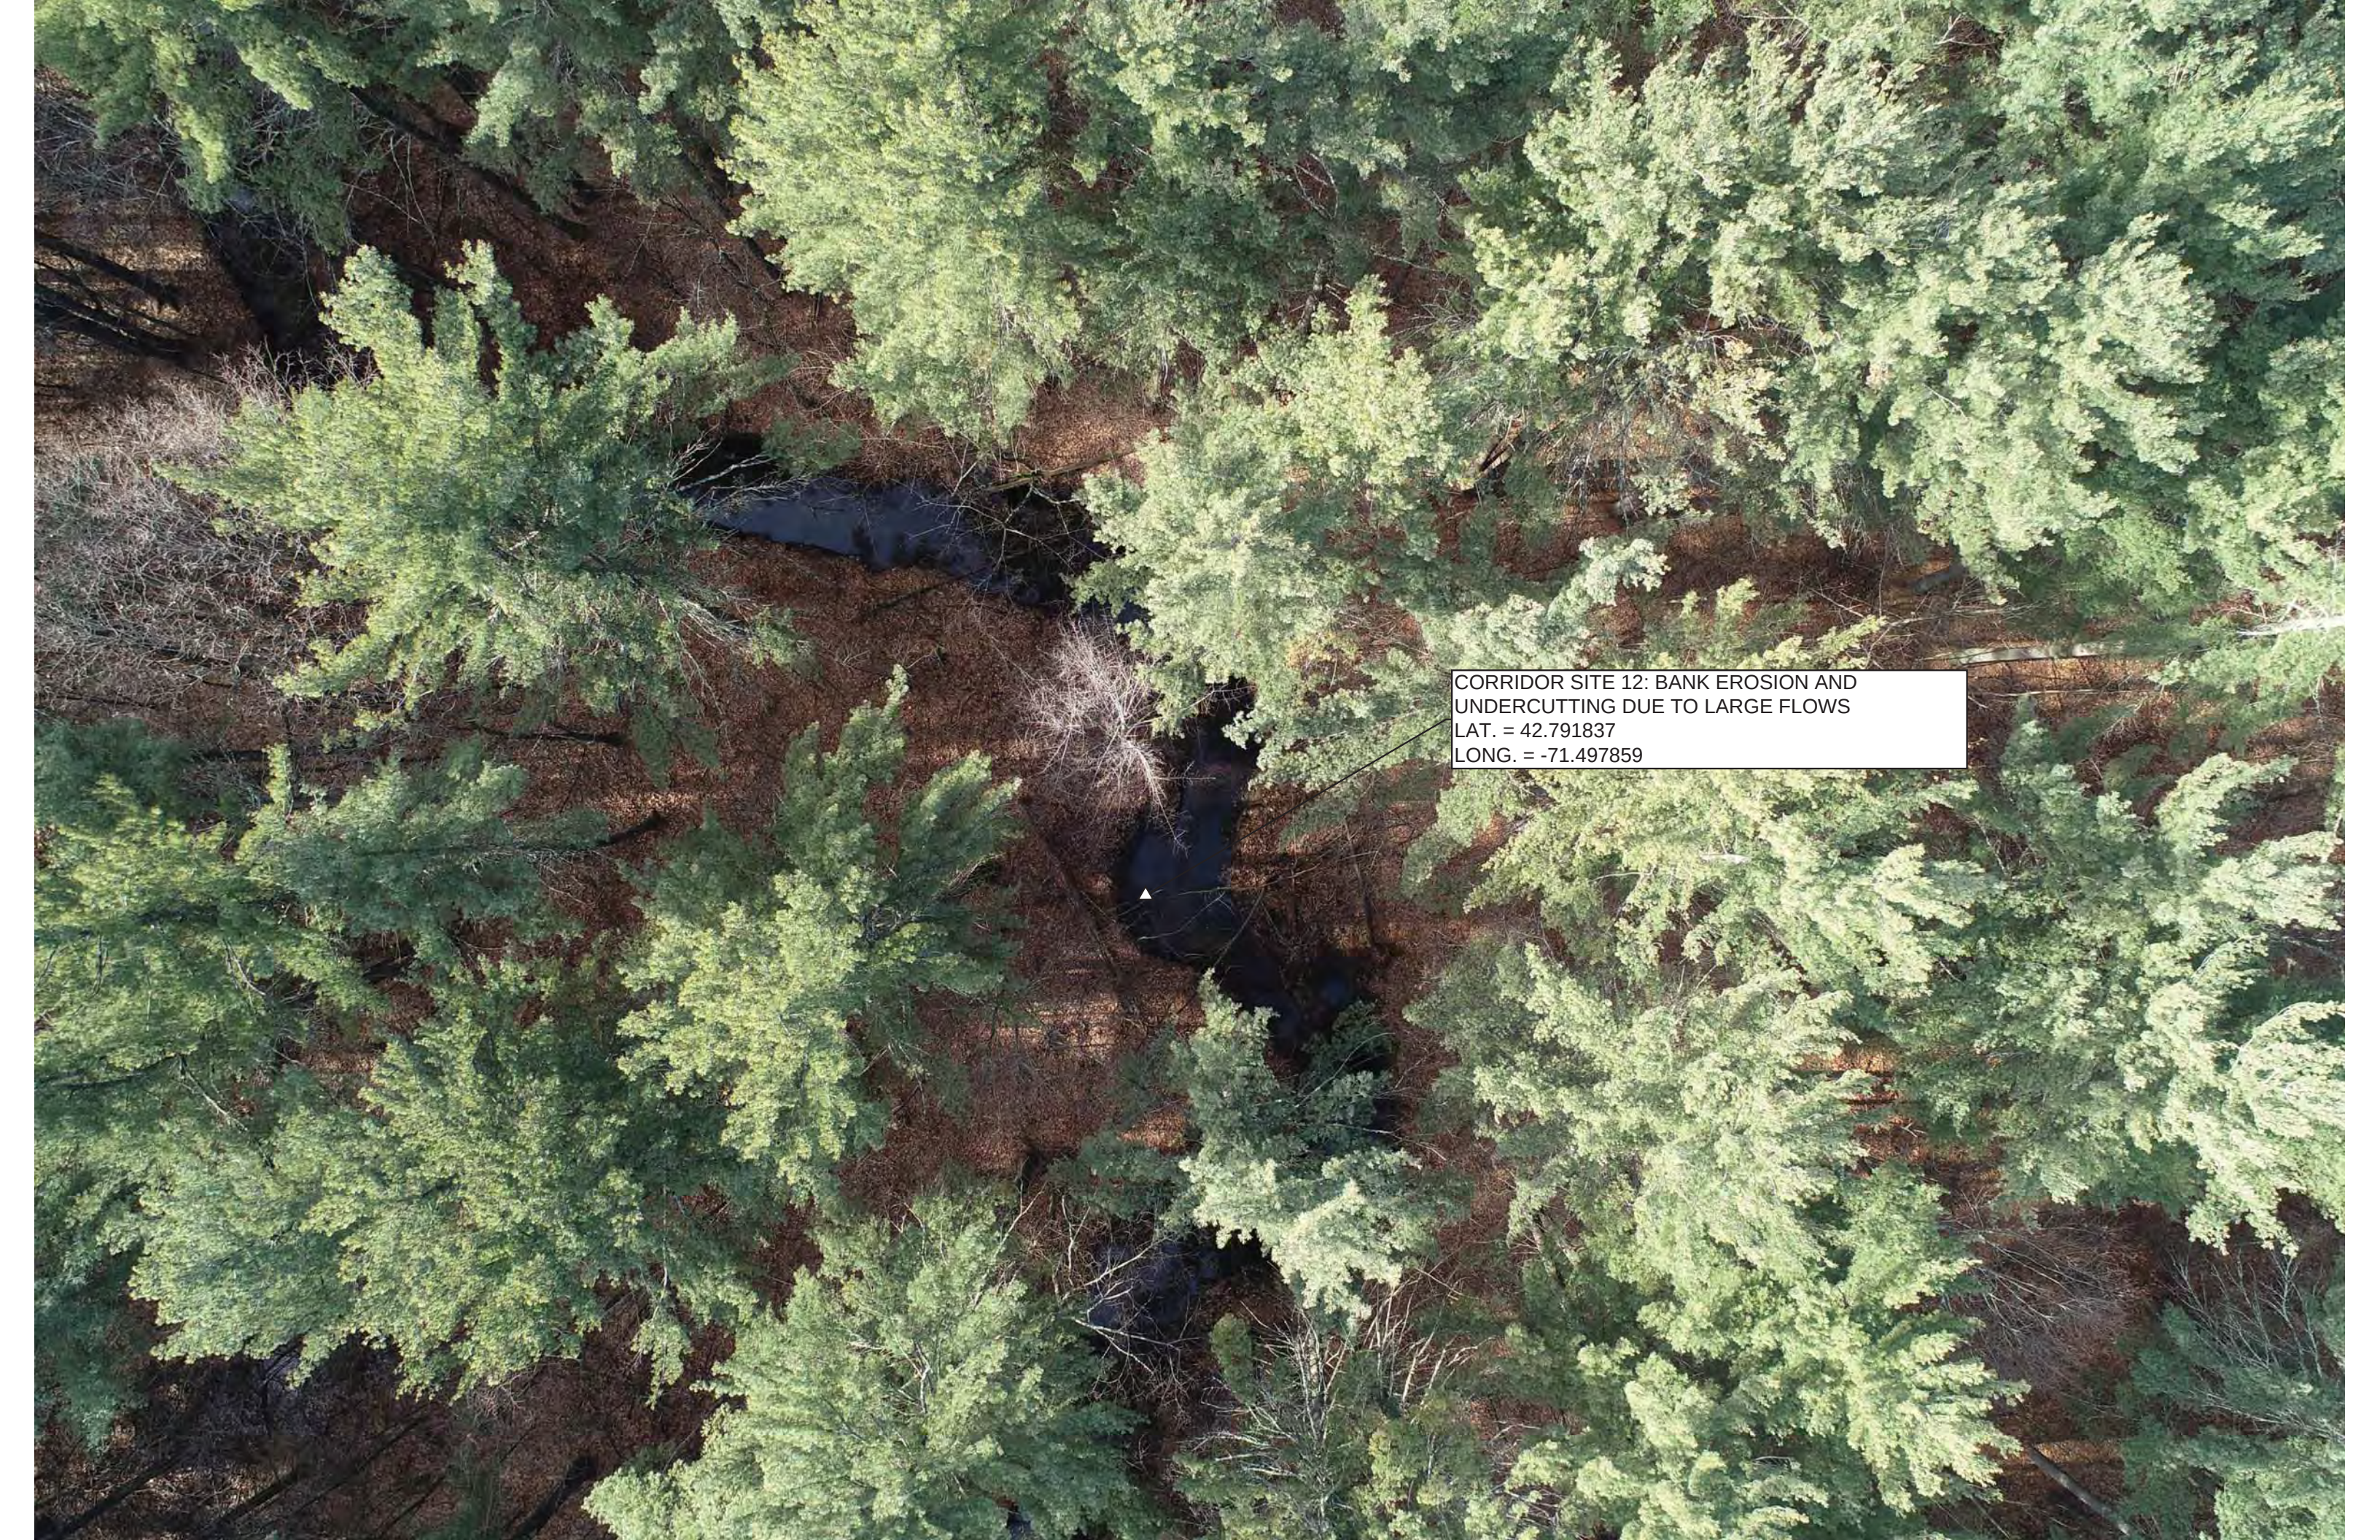
CORRIDOR SITE 12: BANK EROSION AND  
UNDERCUTTING DUE TO LARGE FLOWS  
LAT. = 42.791837  
LONG. = -71.497859

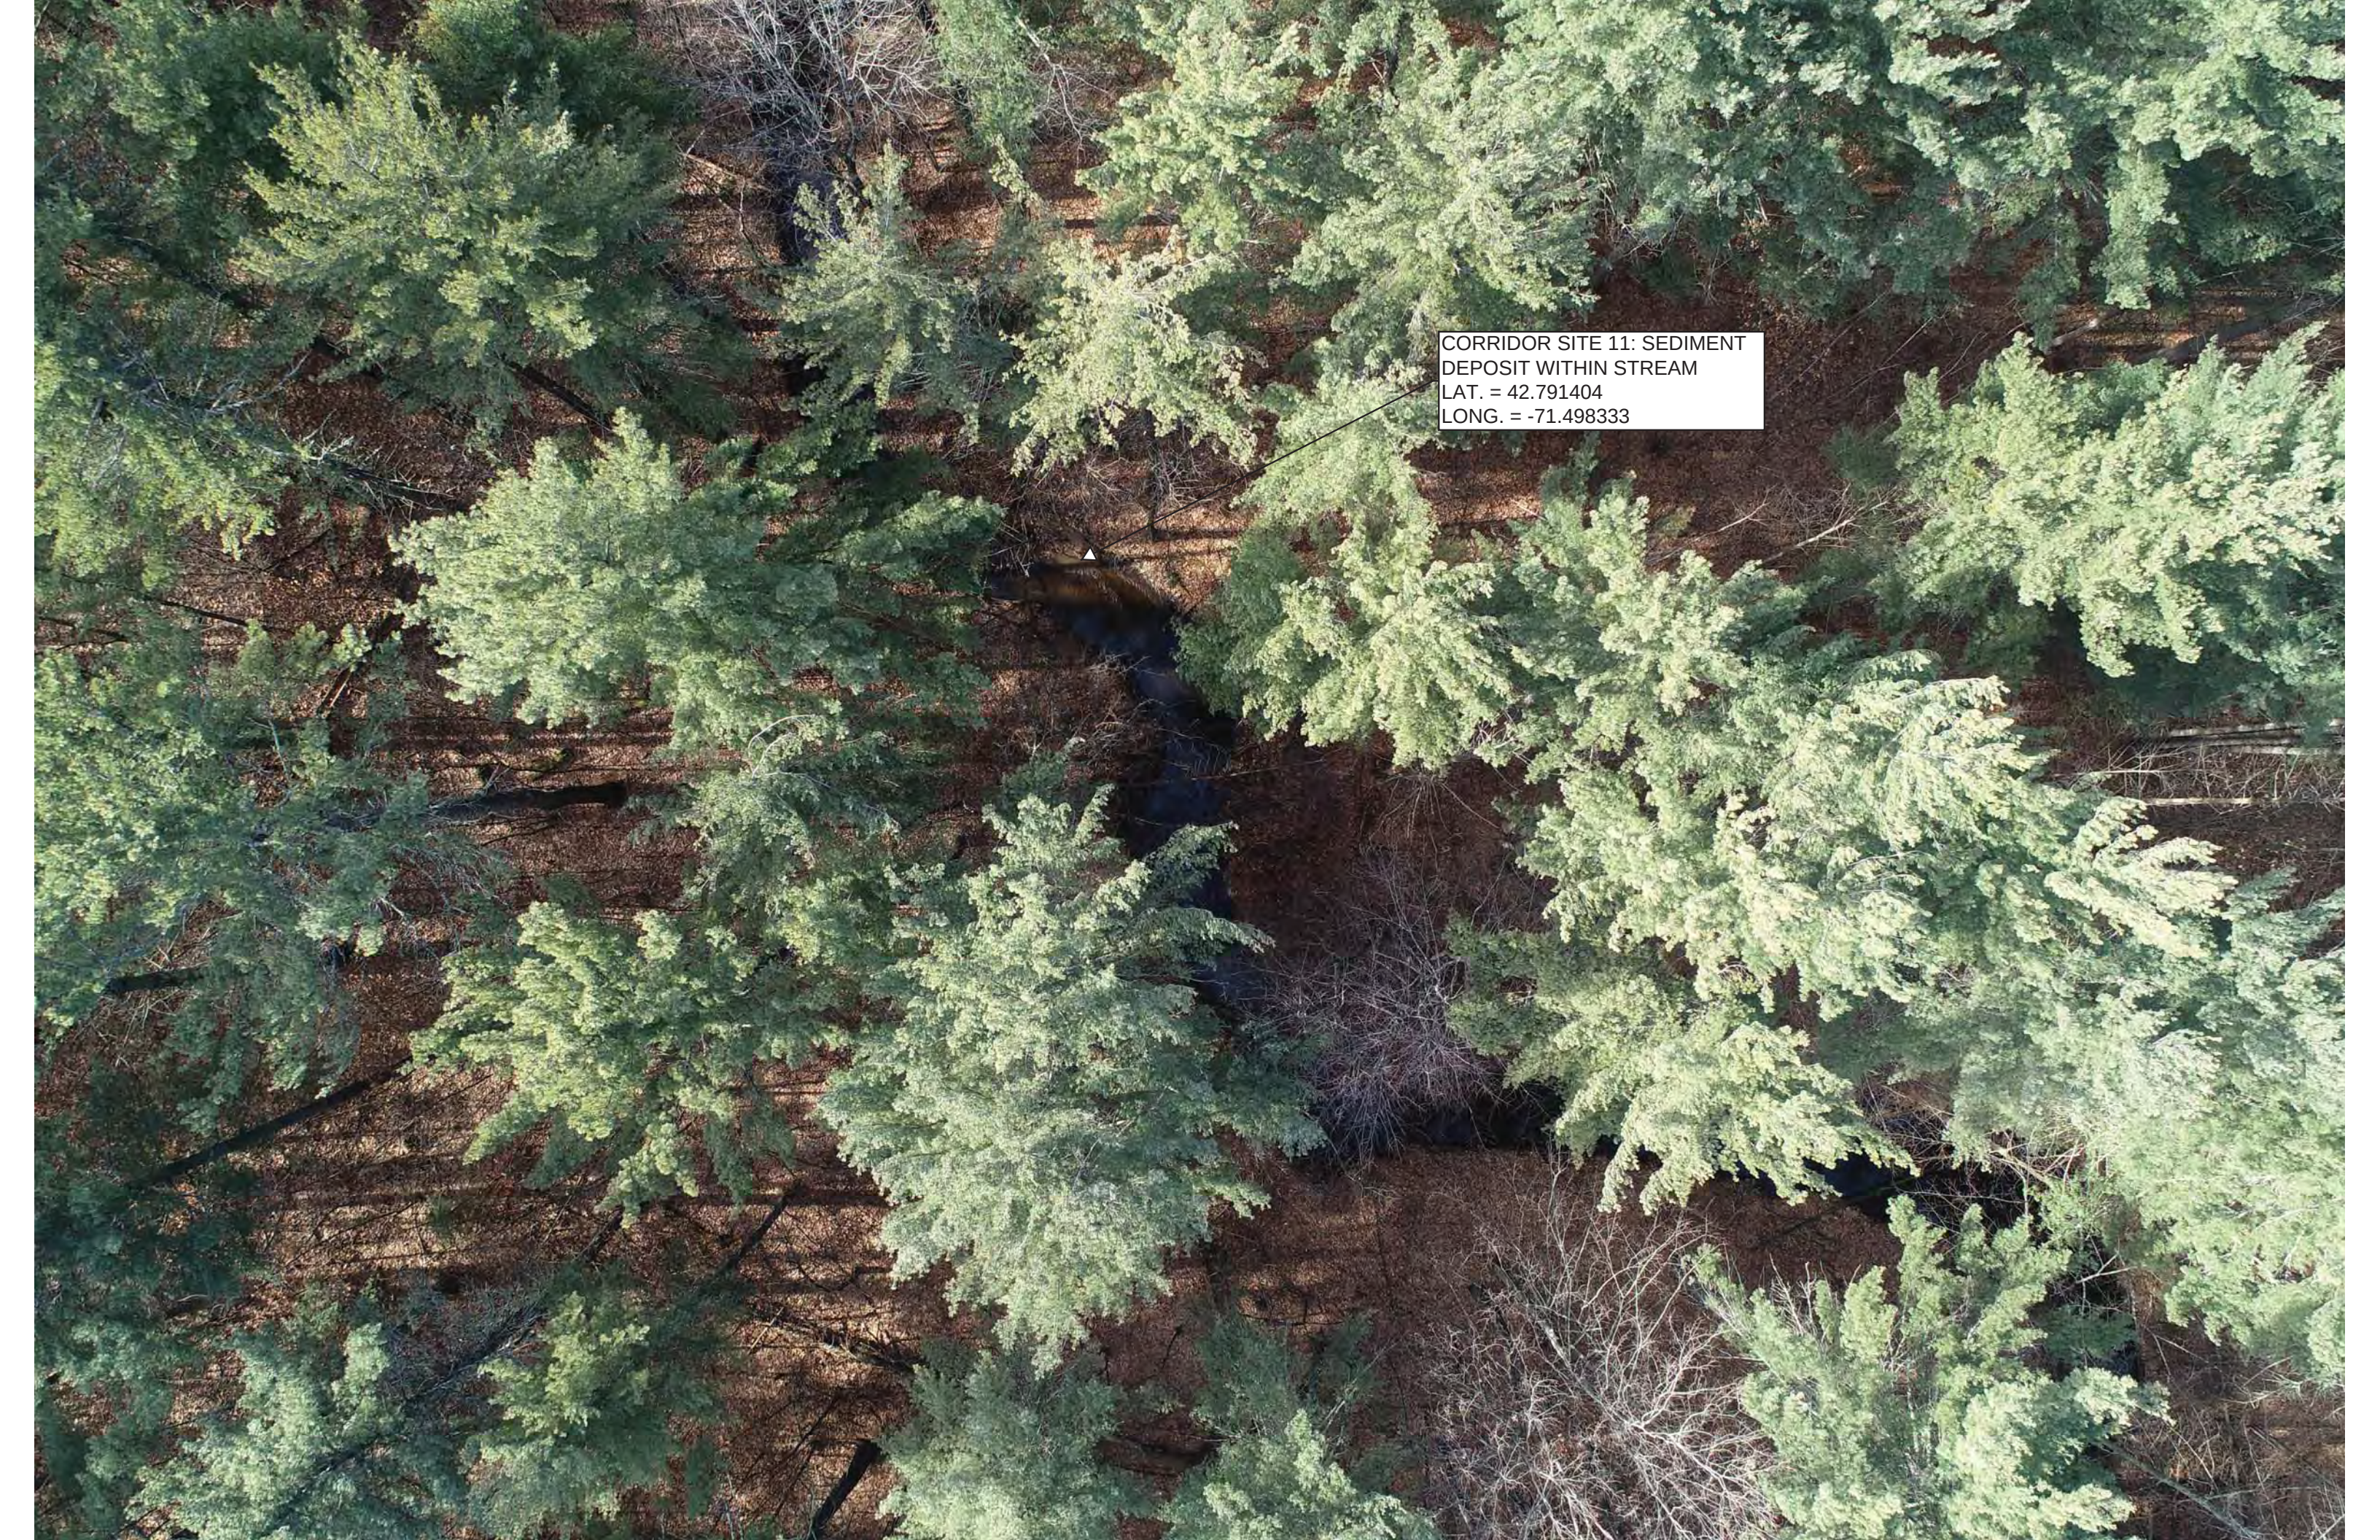
CORRIDOR SITE 11: SEDIMENT  
DEPOSIT WITHIN STREAM  
LAT. = 42.791404  
LONG. = -71.498333

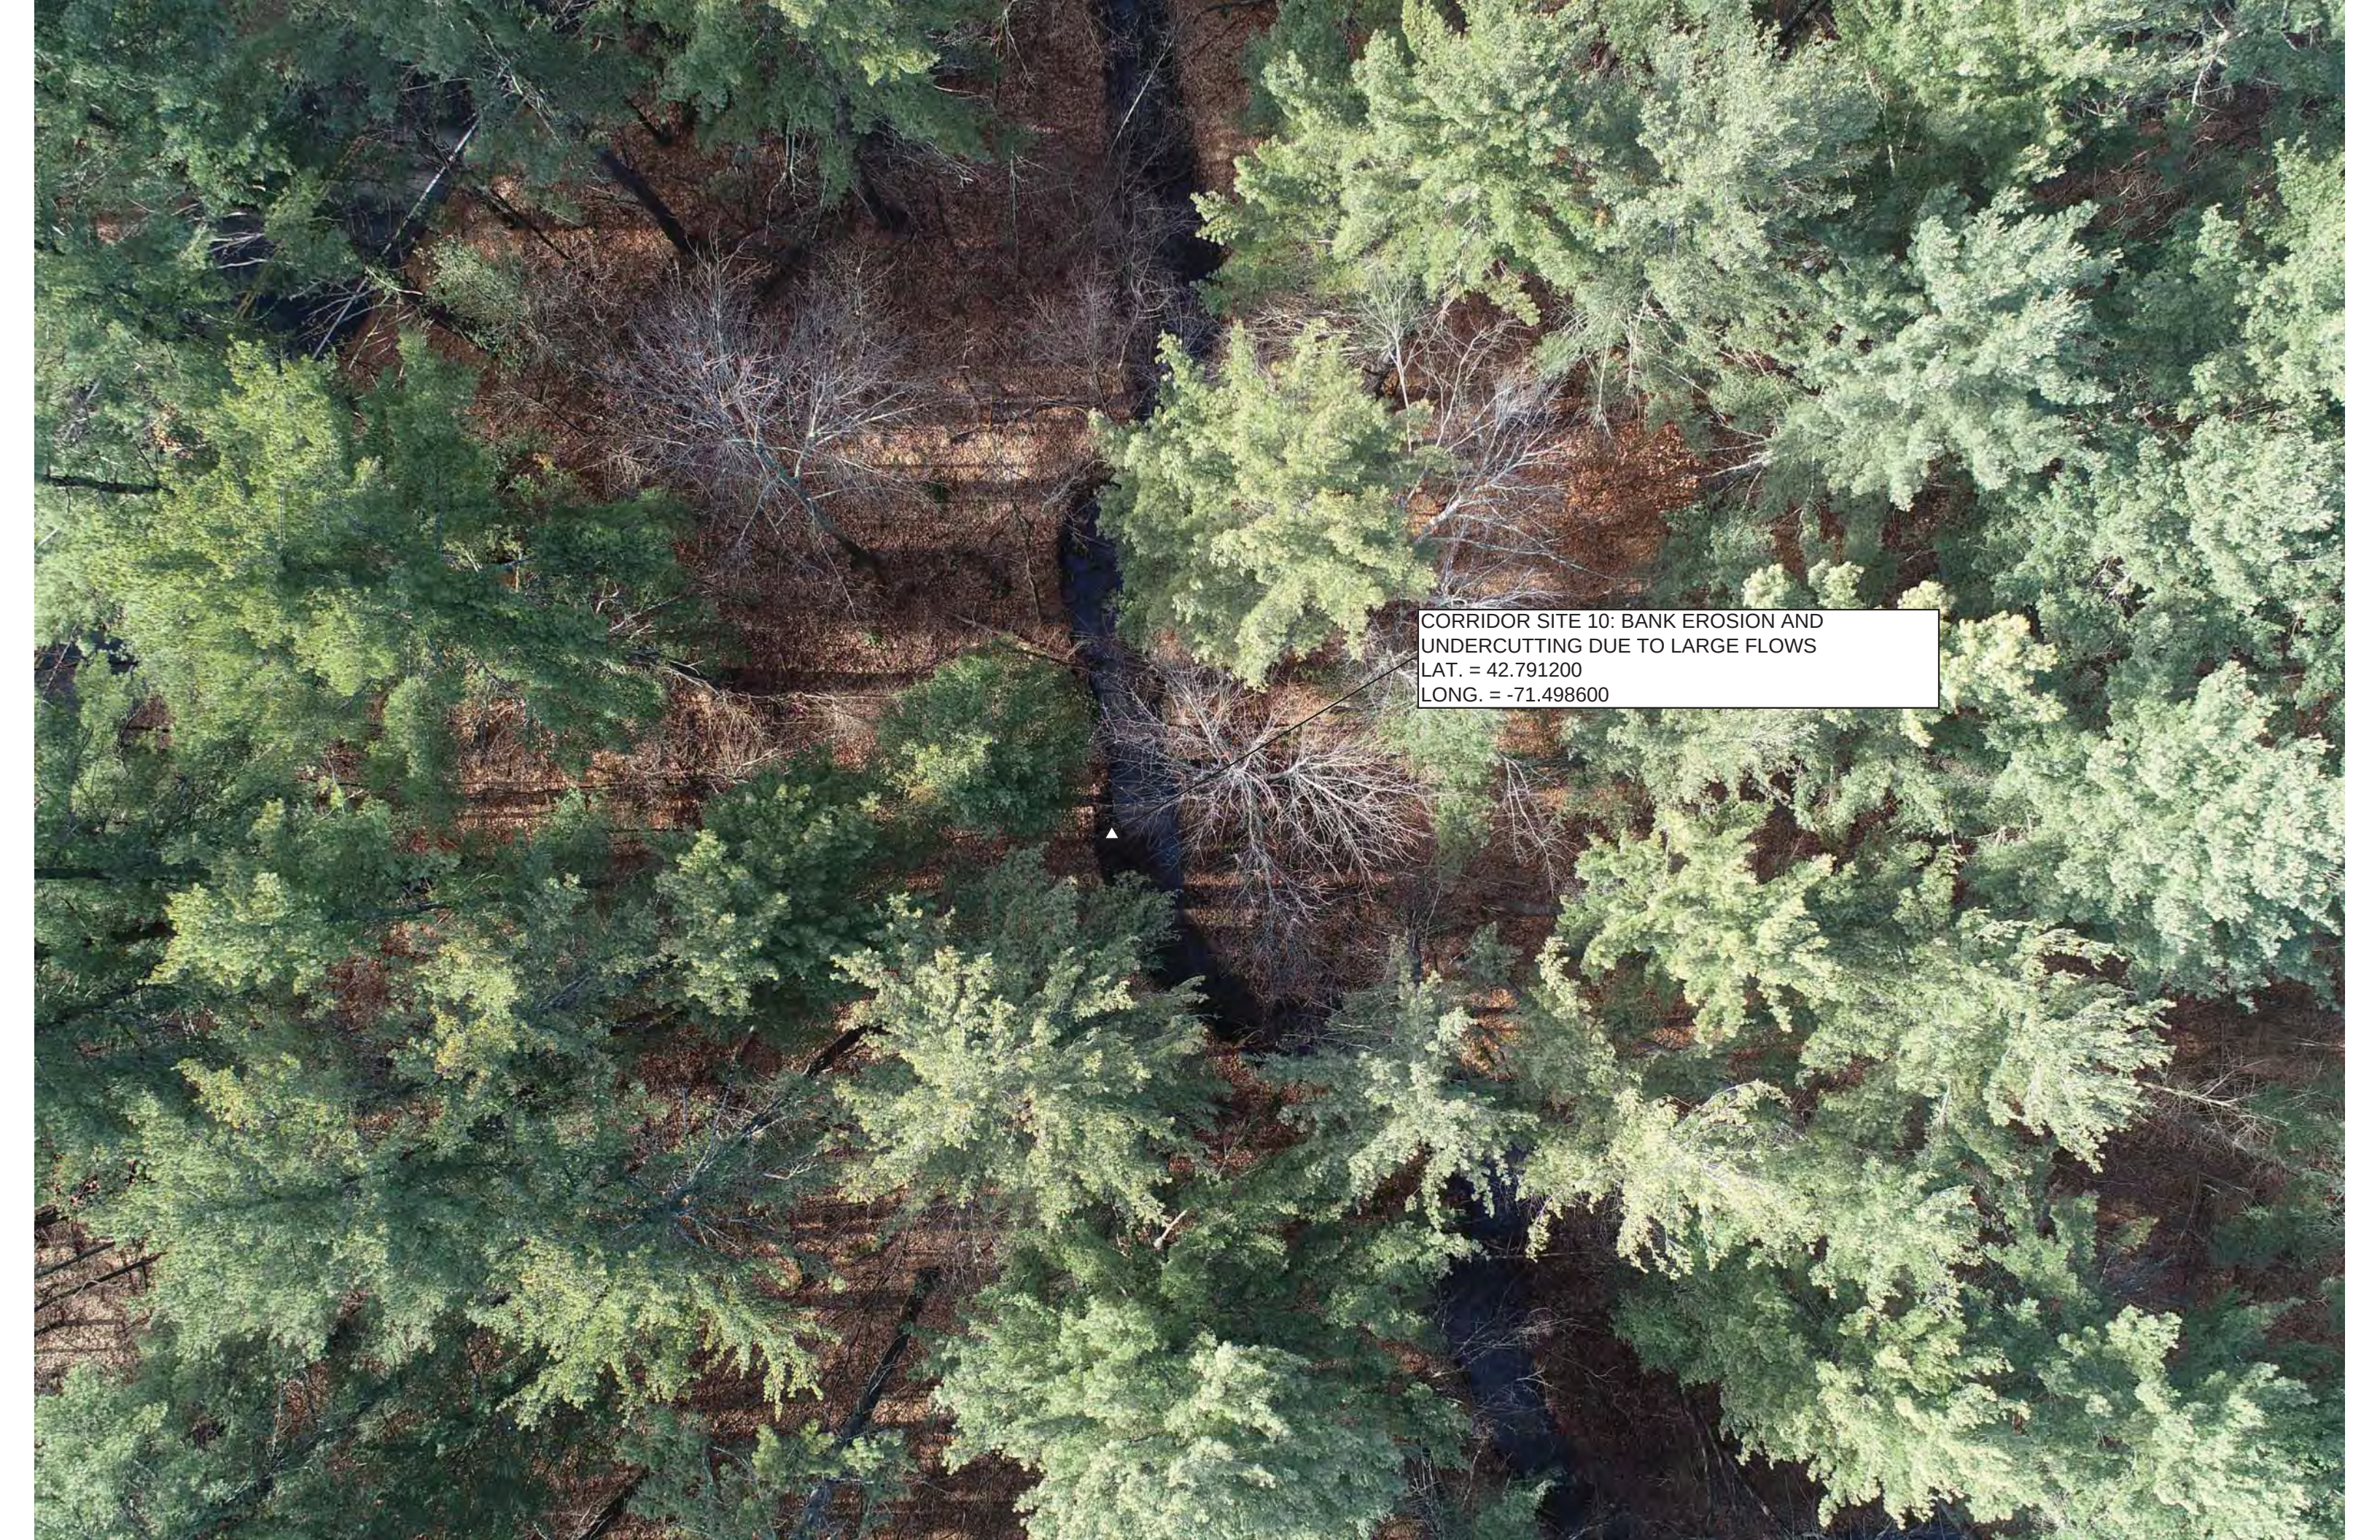
CORRIDOR SITE 10: BANK EROSION AND  
UNDERCUTTING DUE TO LARGE FLOWS  
LAT. = 42.791200  
LONG. = -71.498600

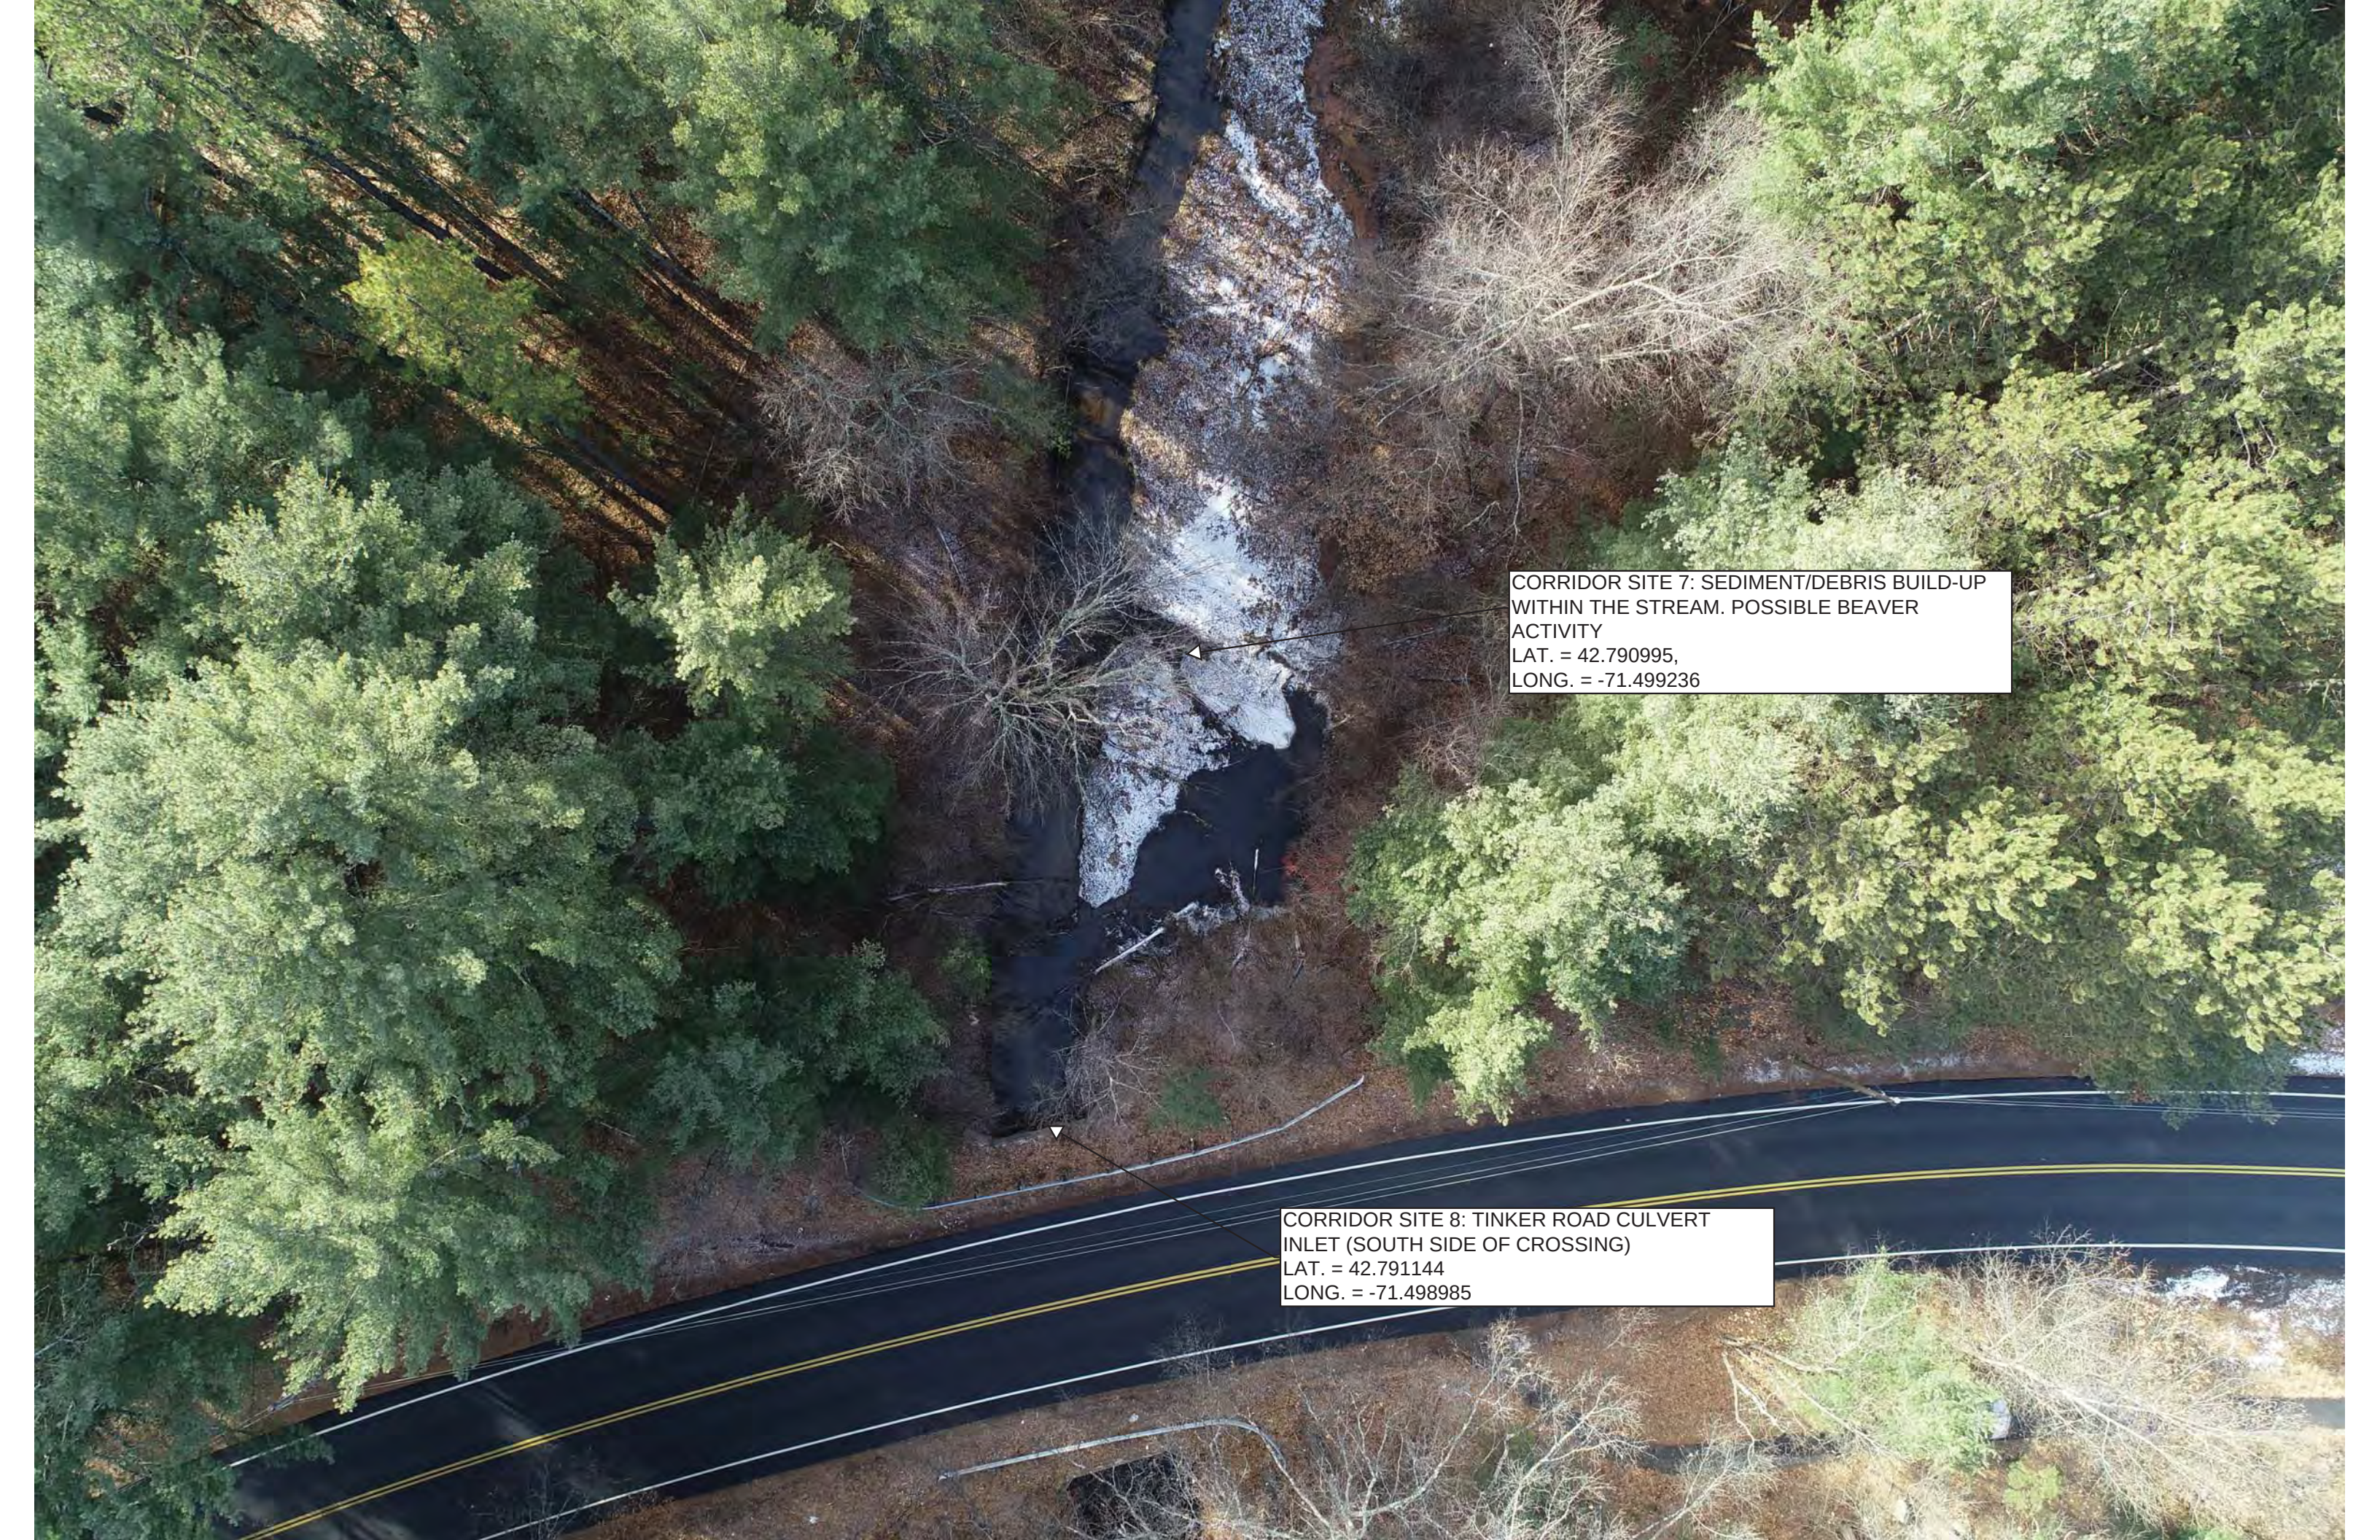
CORRIDOR SITE 7: SEDIMENT/DEBRIS BUILD-UP  
WITHIN THE STREAM. POSSIBLE BEAVER  
ACTIVITY  
LAT. = 42.790995,  
LONG. = -71.499236

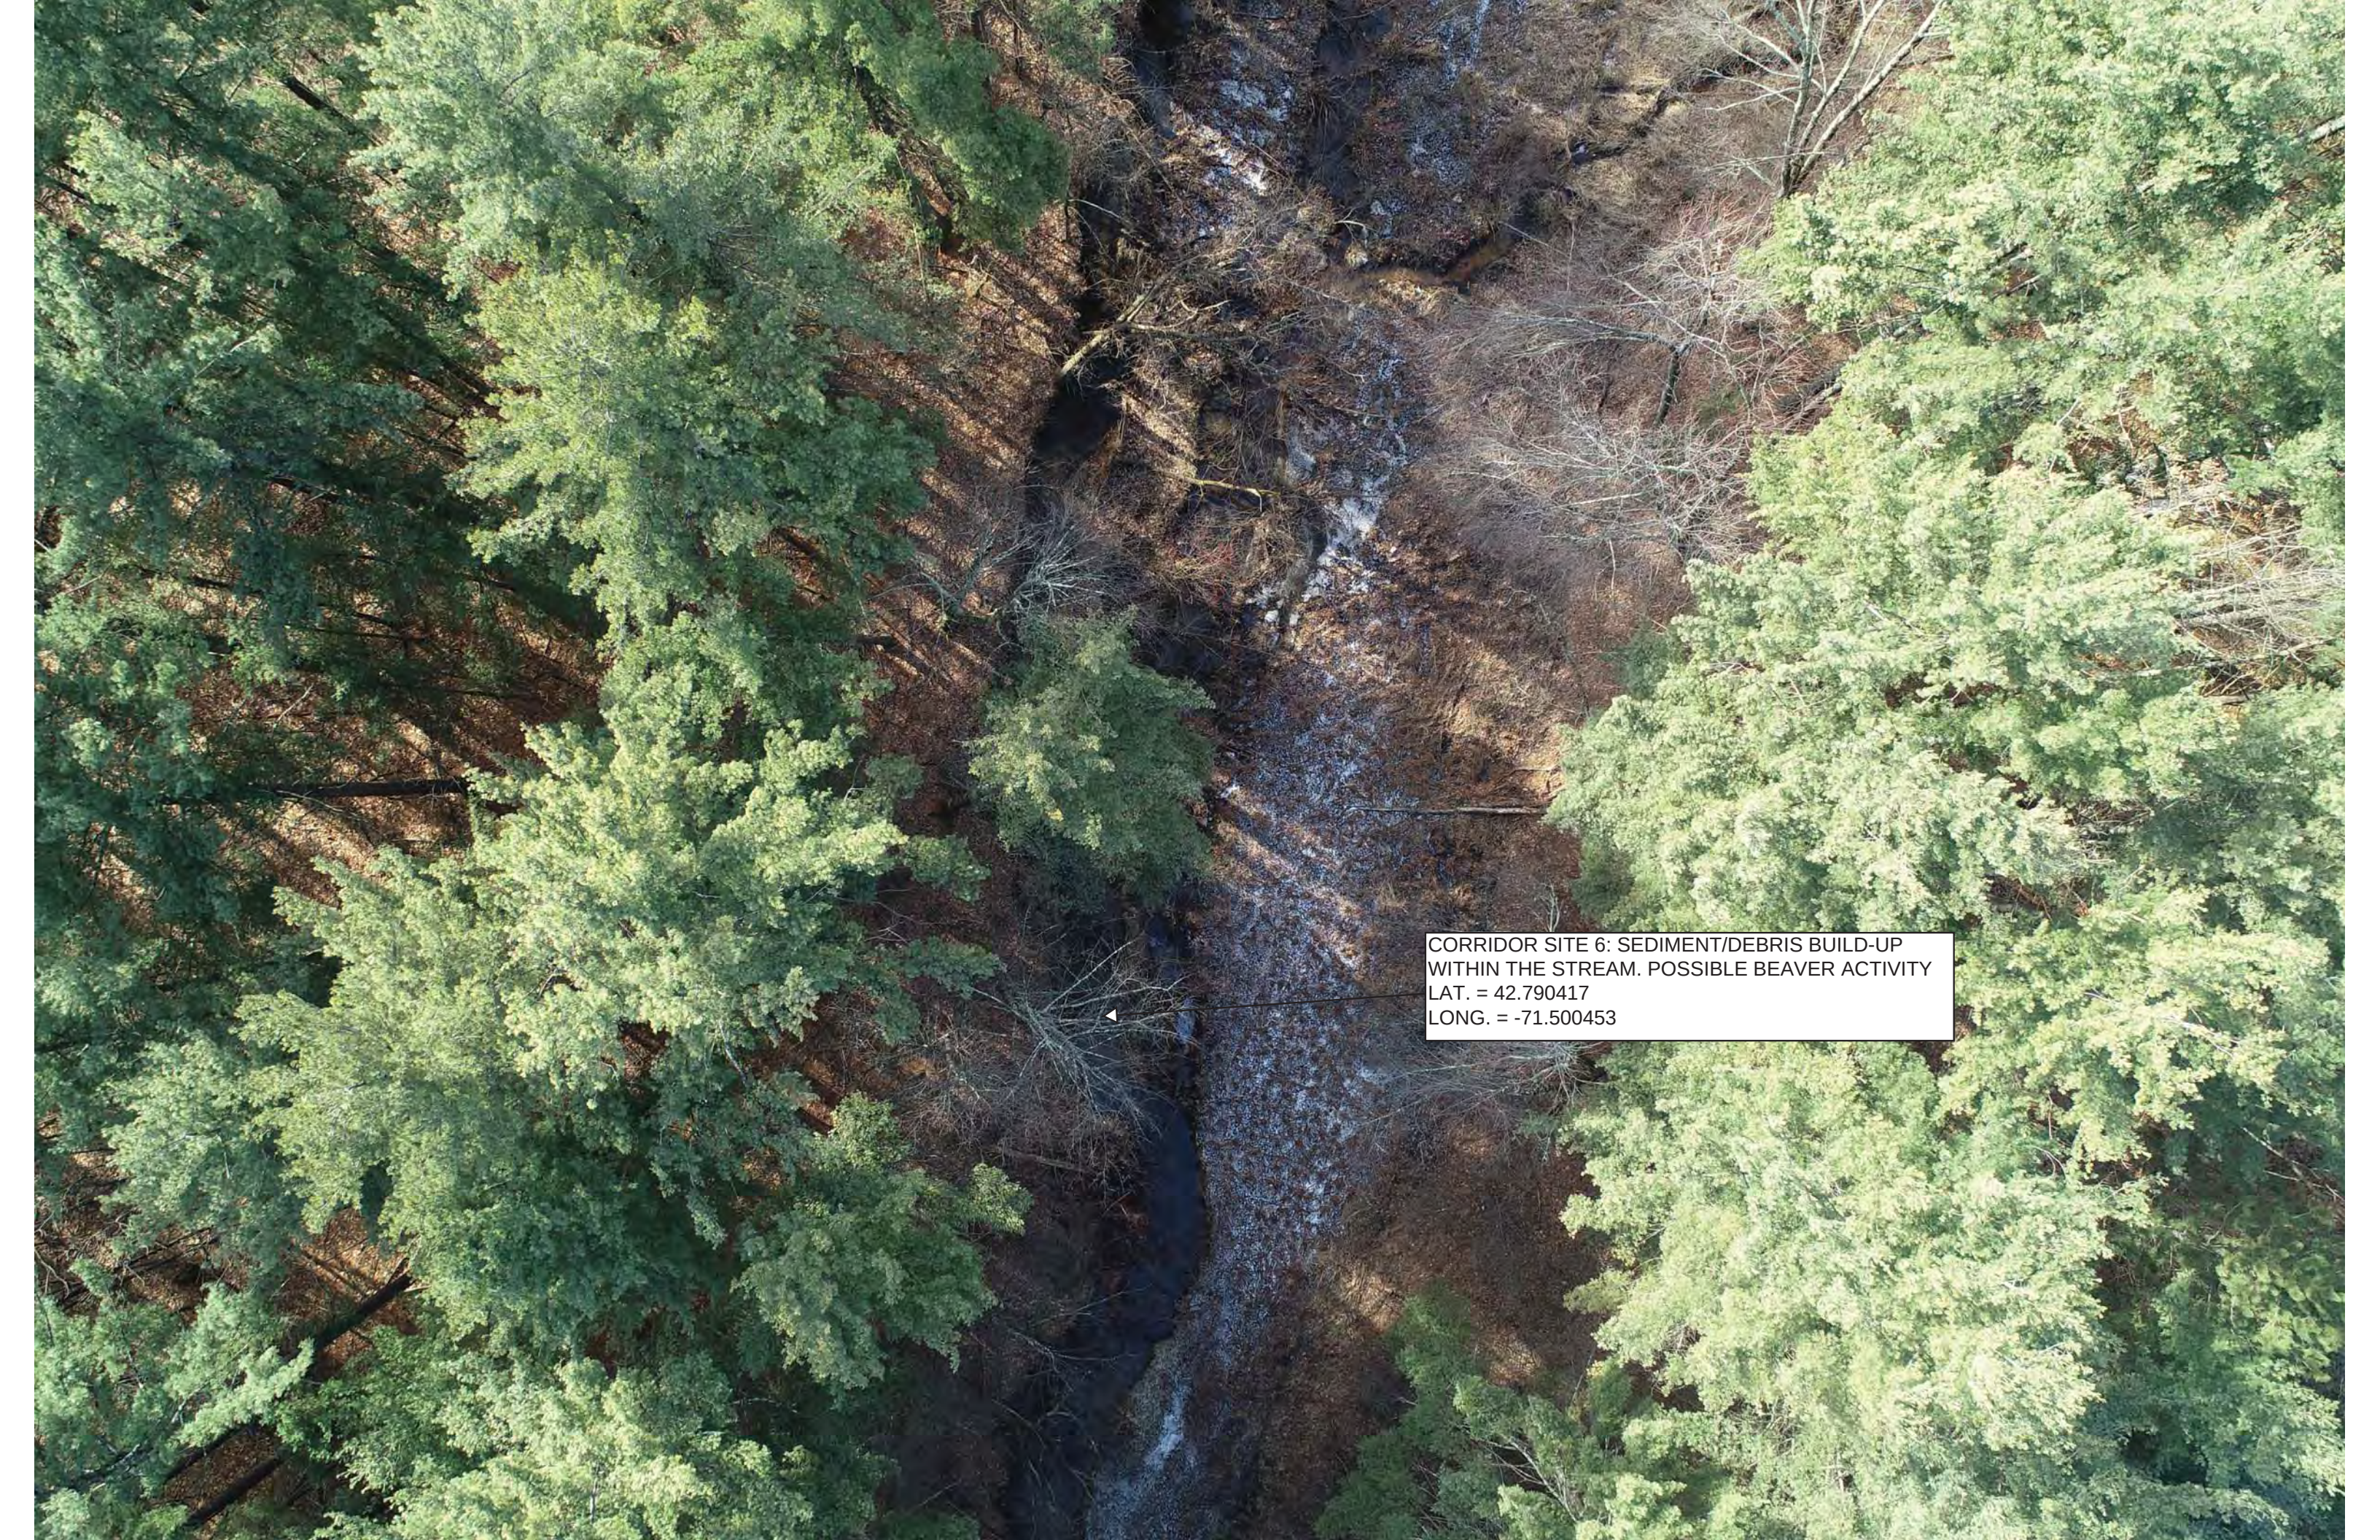
CORRIDOR SITE 6: SEDIMENT/DEBRIS BUILD-UP  
WITHIN THE STREAM. POSSIBLE BEAVER ACTIVITY  
LAT. = 42.790417  
LONG. = -71.500453
