# Comprehensive Environmental Inc.

## Study of Urban Non-Point Source Pollution Witches Brook North Subwatershed

## PENNICHUCK WATER WORKS SUMMER 2002

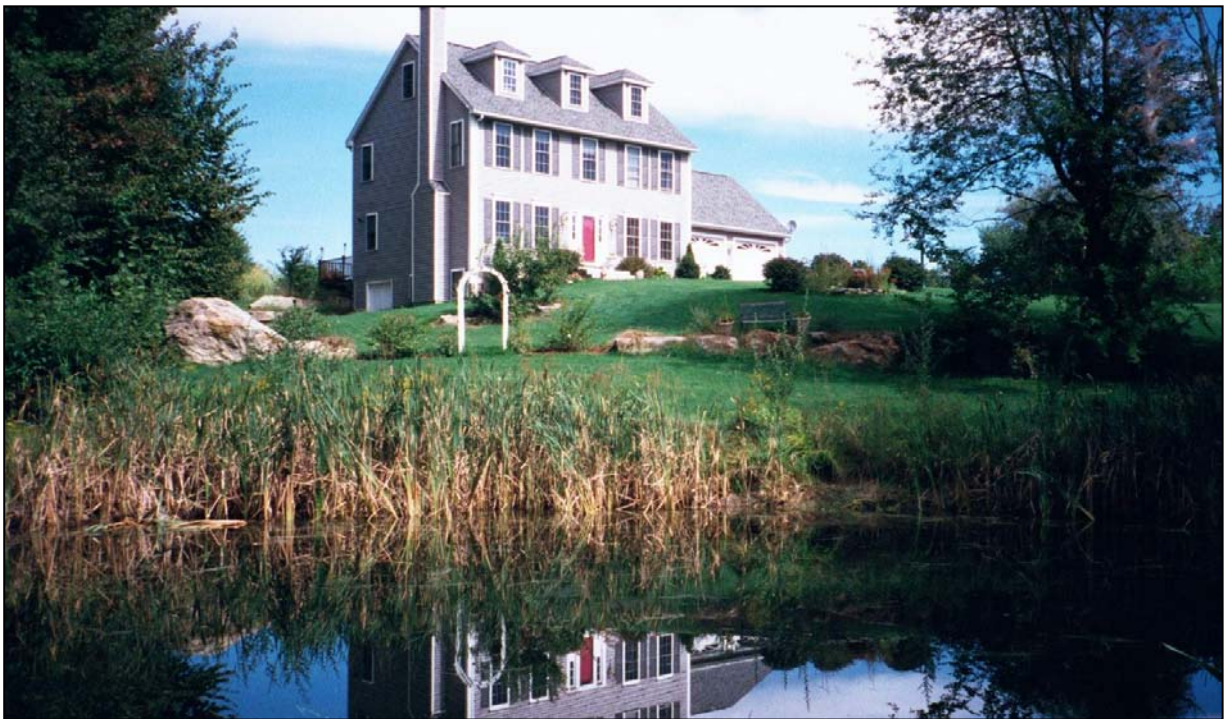
The pond at the beginning of the Stable Road Brook in Milford receives runoff from Crestwood Lane, surrounding residential properties, and Stable Road. The pond appears to be in good condition and it functions as a good detention area for stormwater. However, the residential property abutting the pond has a well-manicured lawn (Figure 2-7) that may be a potential source of nutrients and pesticides in the event of over-fertilization or excess pesticide application. Although it does not appear to be an issue at the present time, its potential influence from these sources is high since the lawn constitutes a significant portion of the pond's edge.

Figure 2-7. Pond along Stable road. Although the pond is presently in good condition, the residential lawn abutting the pond is a potential source of nutrients and pesticides.

Recommendations to address these concerns can be found in Section 3.1.1.

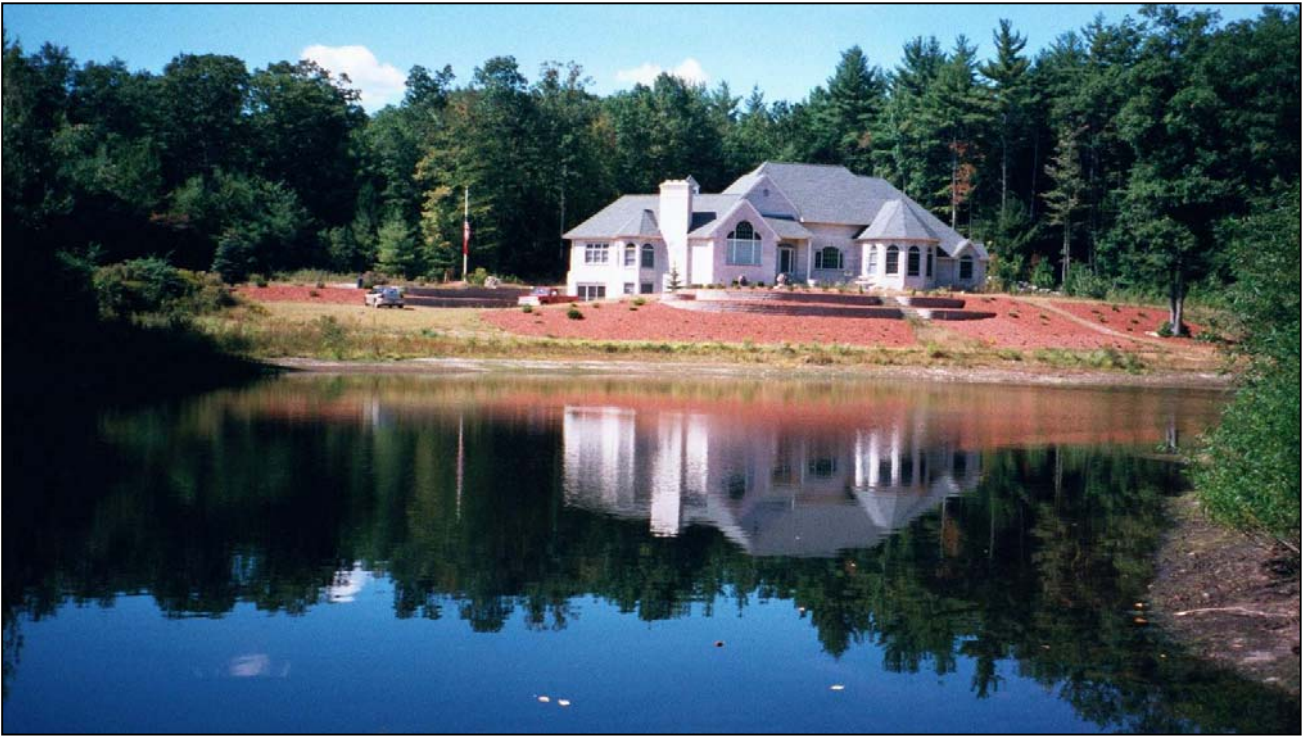
The location where Peacock Brook enters Golden Pond in Amherst appears to have been diverted under the driveway for the adjacent residential property. The brook enters Golden Pond at the southwest portion of the pond, which drains south under Golden Pond Lane. Golden Pond appears to be in good condition and serves as a detention area for runoff from the eastern portion of Stable Road and Town Farm Road. However, activities at the abutting residential property may pose a potential hazard to water quality since the yard extends to the edge of the pond. Currently, there is minimal risk other than that of erosion due to the undeveloped state of the yard (Figure 2-8). Due to the size and style of the home, there is a potential that this residential property will have a well-manicured lawn and elaborate landscaping in the future that may pose a potential risk to water quality in the form of over fertilization or pesticide application.

Figure 2-8. Golden Pond. Although the pond is currently in good condition, there is a potential risk to water quality from fertilization or pesticide application in the future if a lawn is developed.

Recommendations to address these concerns can be found in Section 3.1.1.

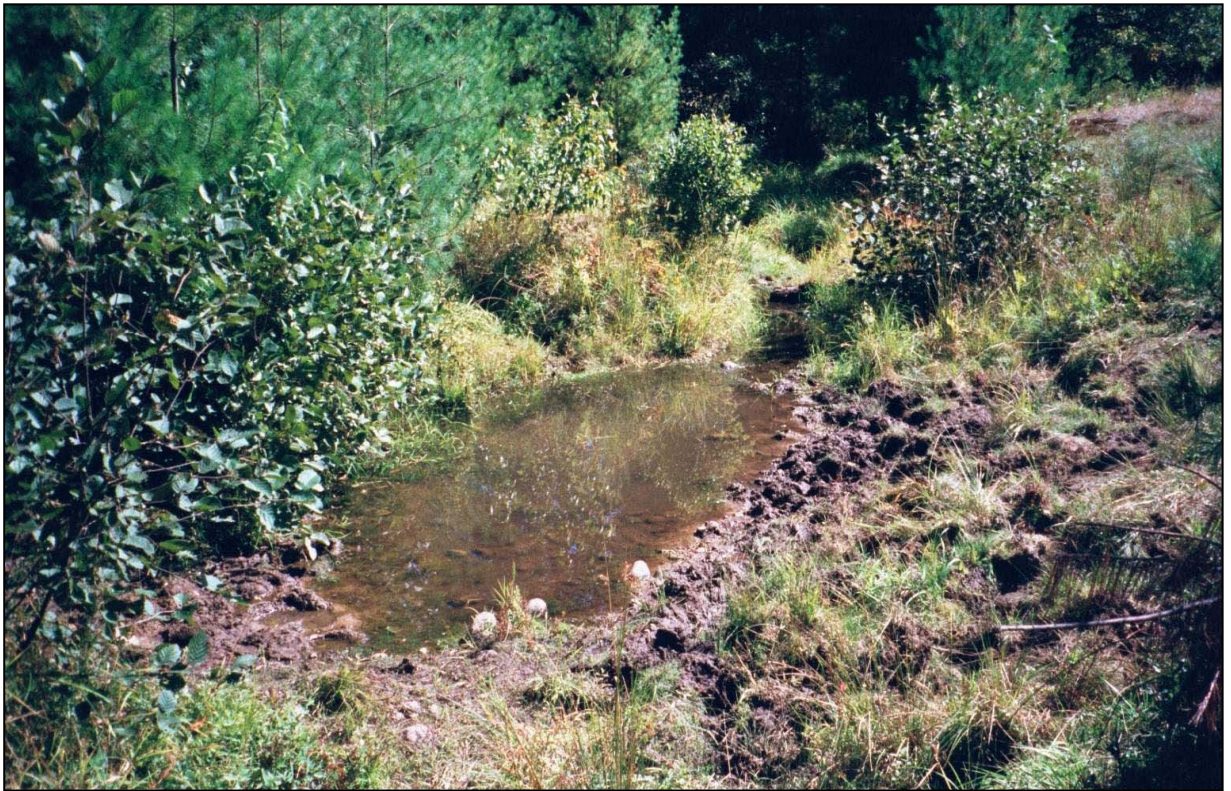
Figure 2-9. Degradation - erosion and sedimentation of the land along Peacock Brook. Animal activities are also likely to serve as a direct source of bacteria.

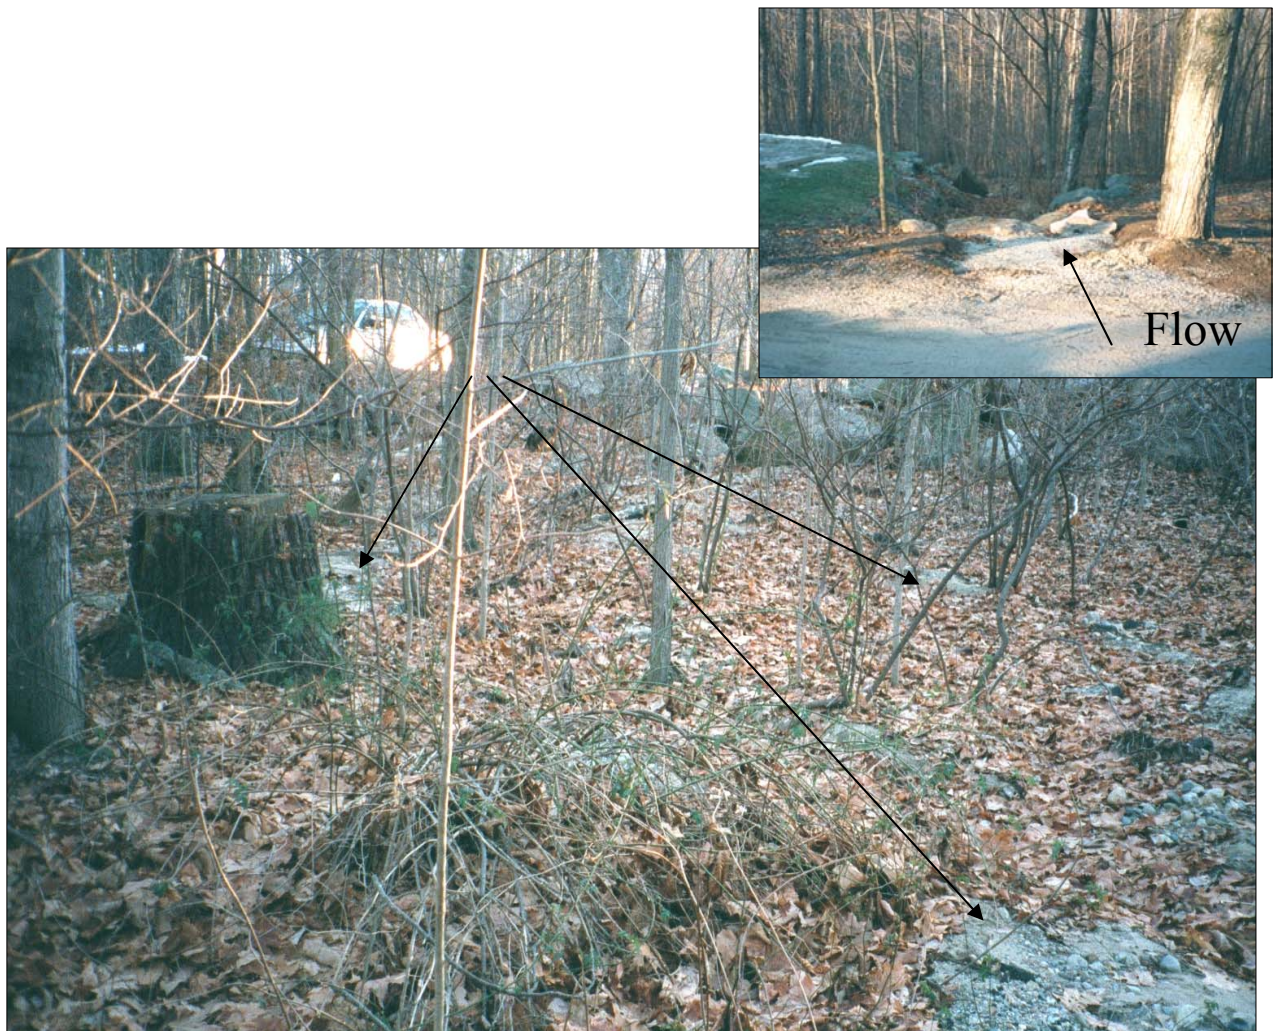
Immediate improvements occurring at the time of observation included increasing the size of pipes connecting catch basins, repairing the roadway and riprap swale, and installing hay bales alongside the road and riprap swale. Apparently, pipe size within and between drainage structures limited the flow of water, forcing runoff to back up within and travel past catch basins. This led to the undermining of the road and the observed sediment deposits throughout the forested area downgradient. Public Works employees indicated that this section of Ponemah Hill Road has a history of runoff control problems due to the steep grade.

Figure 2.14. Forested area laden with sediment.

Recommendations to address these concerns can be found in Section 3.2.2.

It is recommended that where riprap exists it should be left in place. The remaining portions of the ditch on the west and the entire ditch on the east should be recontoured and cover with a non-woven filter fabric. Then riprap should then be hand placed over the filter fabric.

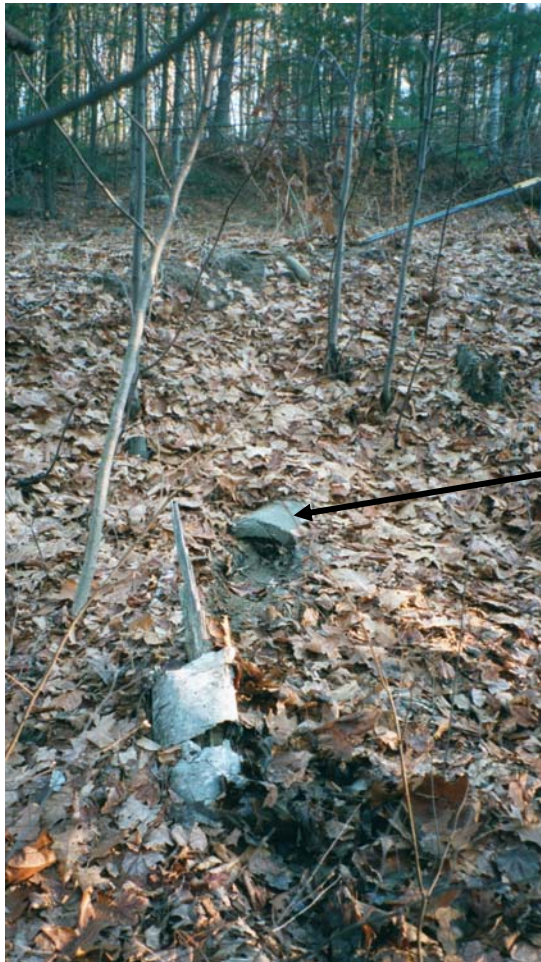
**Outlet**

Figure 2-16. The outlet is nearly buried in the hillside due to sedimentation.

Recommendations to address these concerns can be found in Section 3.2.3

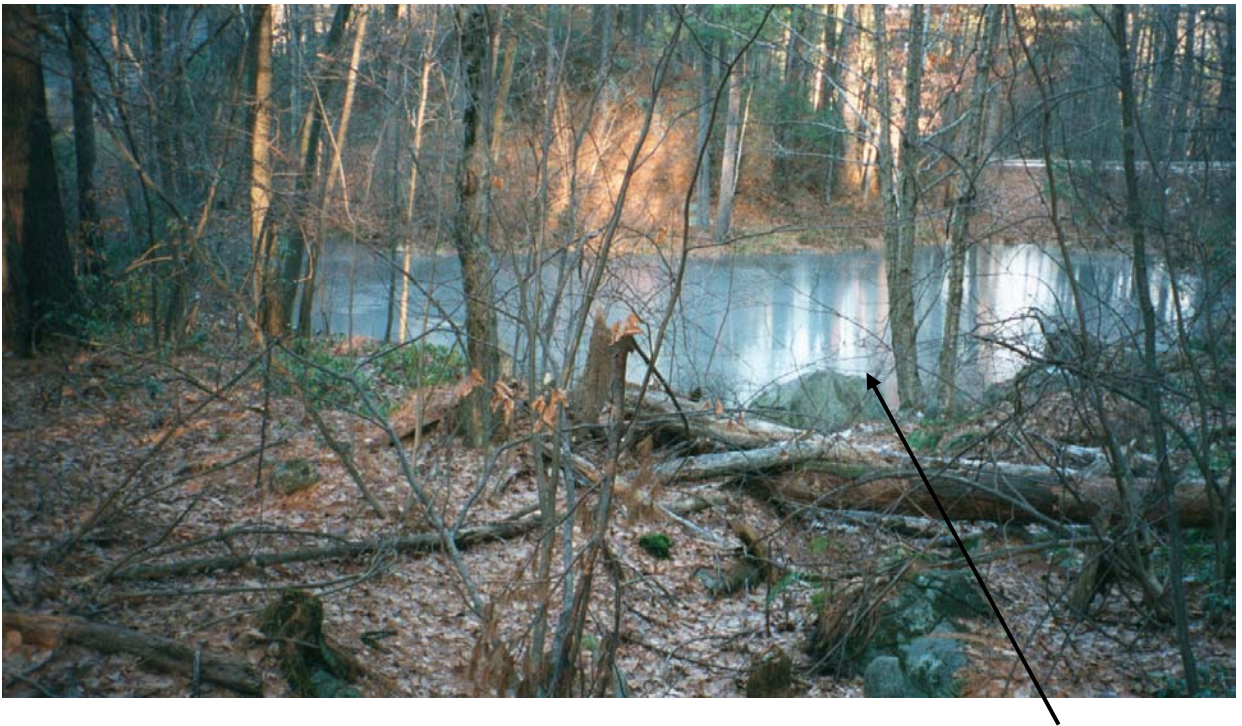
Figure 2-17. A small detention pond adjacent to Rocky Hill Road. Minimal impact due to sedimentation is observed in this area. Road is at the upper right hand side of picture.

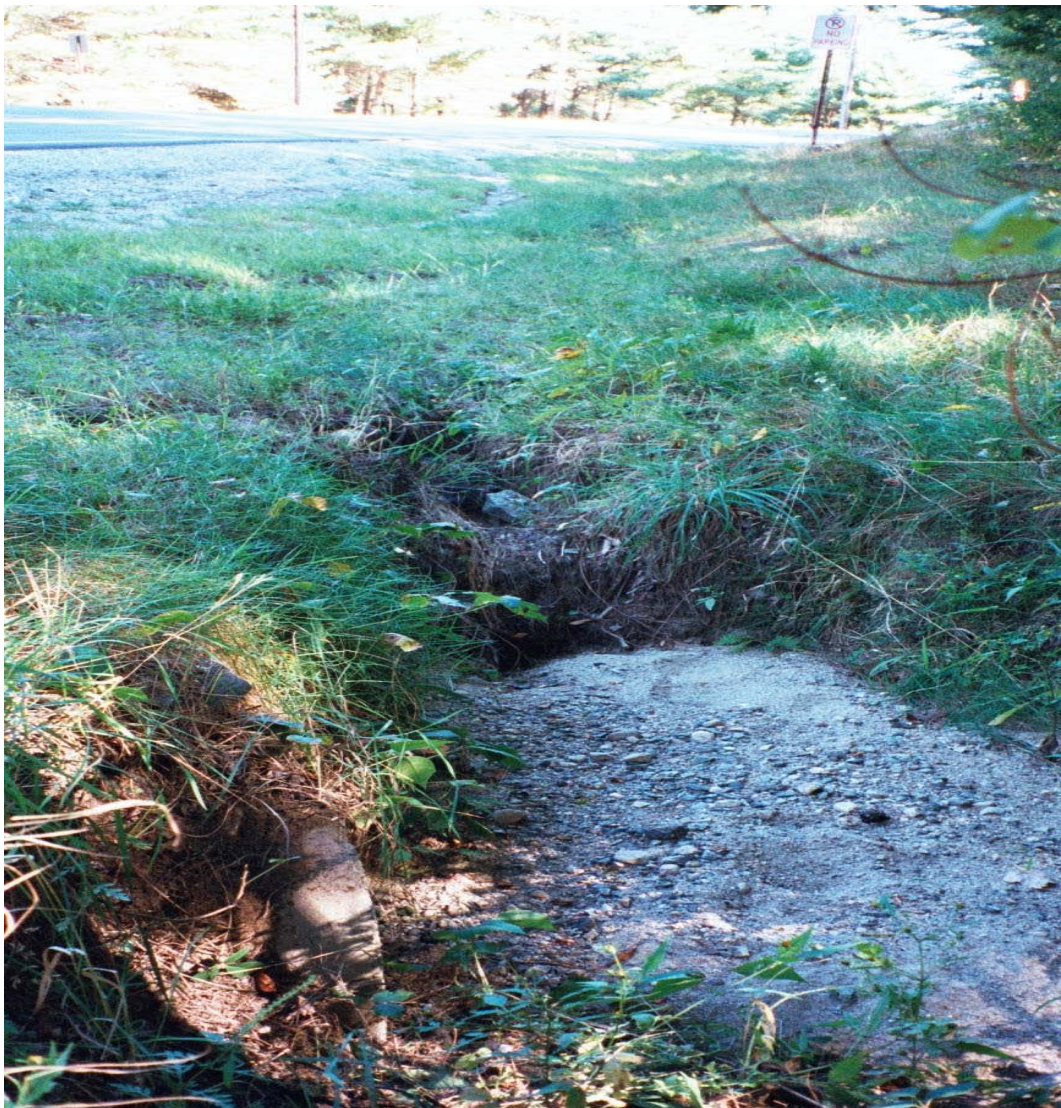
Figure 2-18. A large sediment delta observed before the 18'' culvert beneath Route 122.

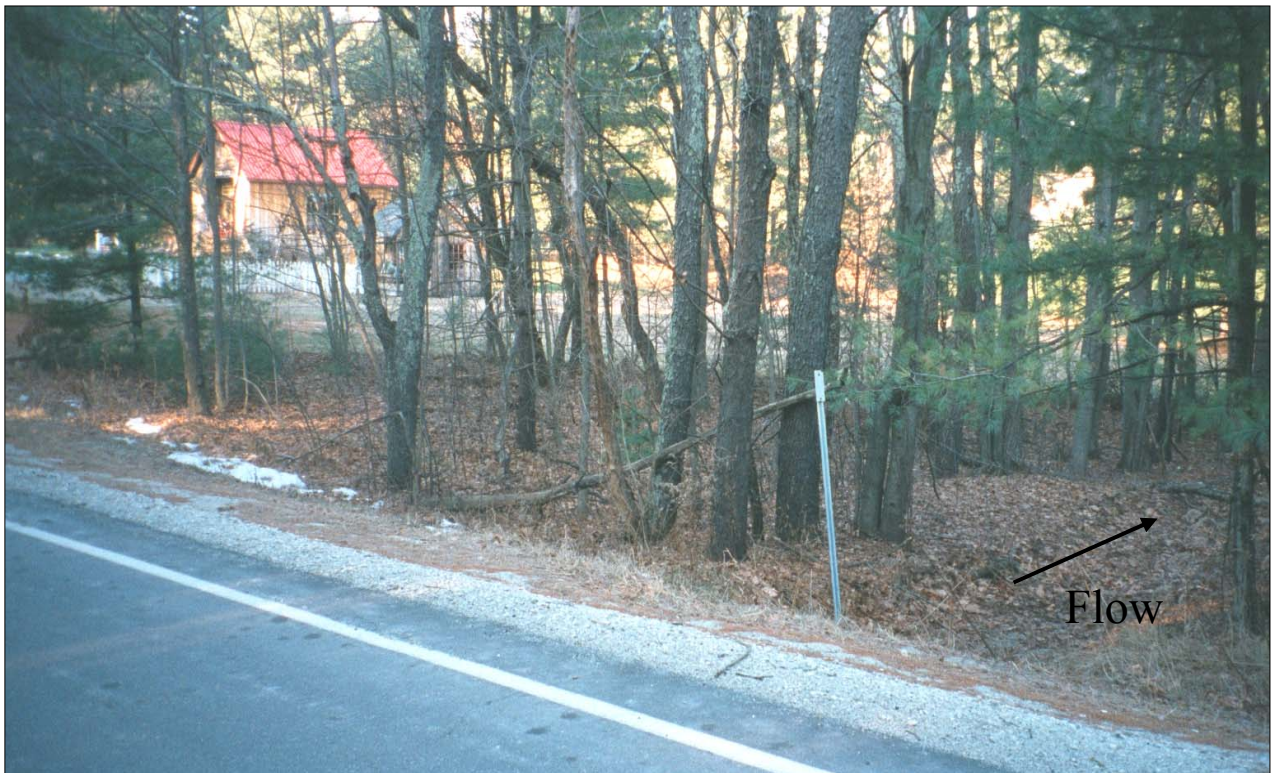
Figure 2-19. Lowland area between residential property and forested area receiving discharge.

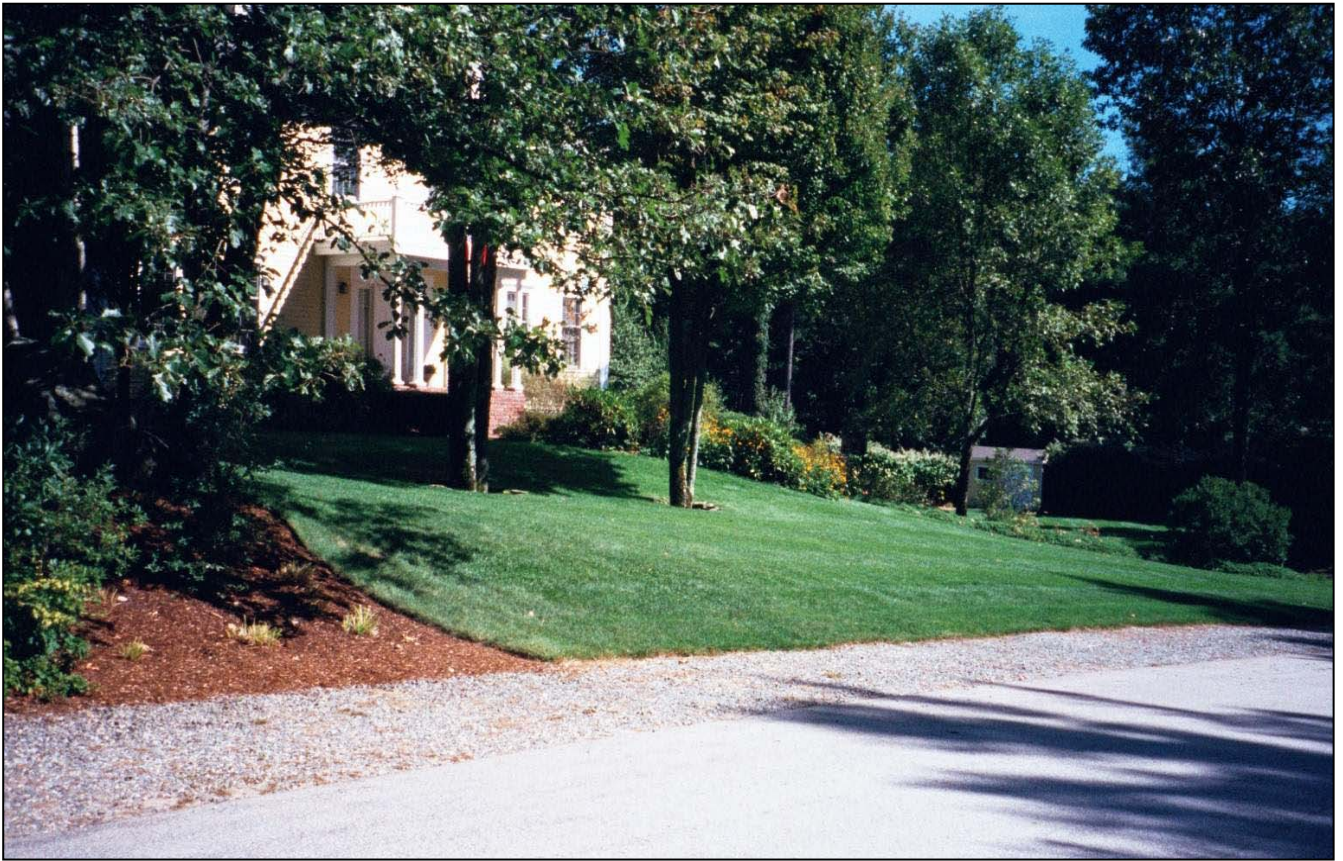
Farmington Road is a short, dead-end road off Ponemah Hill Road in Amherst, servicing a few residential properties. Runoff from this area contributes to the small tributary formed by the drainage mentioned in Section 2.2.1. Residential properties in this area have well-manicured lawns (Figure 2-20) and as such represent the typical hazard of nutrient and pesticide input to local runoff. The potential for contamination exists, although the level of risk associated with this area is relatively low due to the travel time of runoff to major tributaries and the well-vegetated conveyances that runoff must travel through.

Figure 2-20. A residential property with a well-manicured lawn, which poses a risk of nutrient and pesticide input to local runoff.

Recommendations to address these concerns can be found in Section 3.1.1.

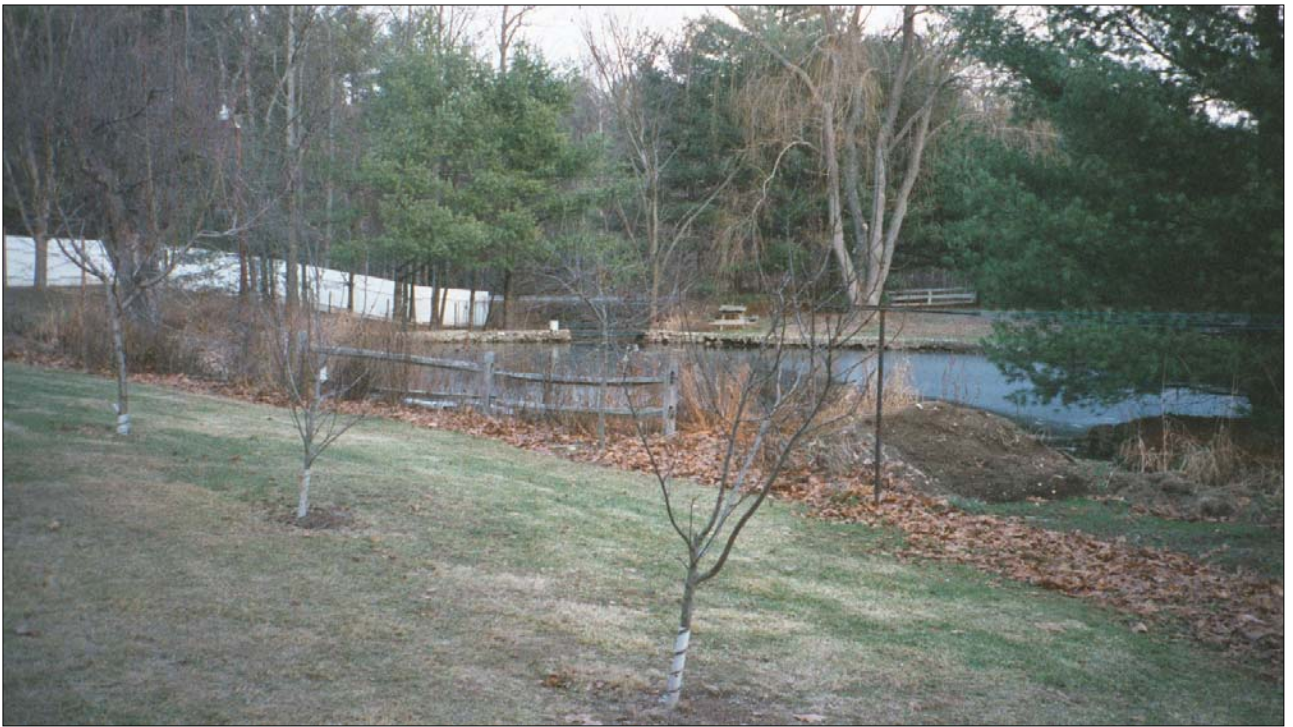
Figure 2-21. A man-made pond associated with the agricultural lands southwest of the intersection of Ponemah Hill Road and Route 122 in Amherst.

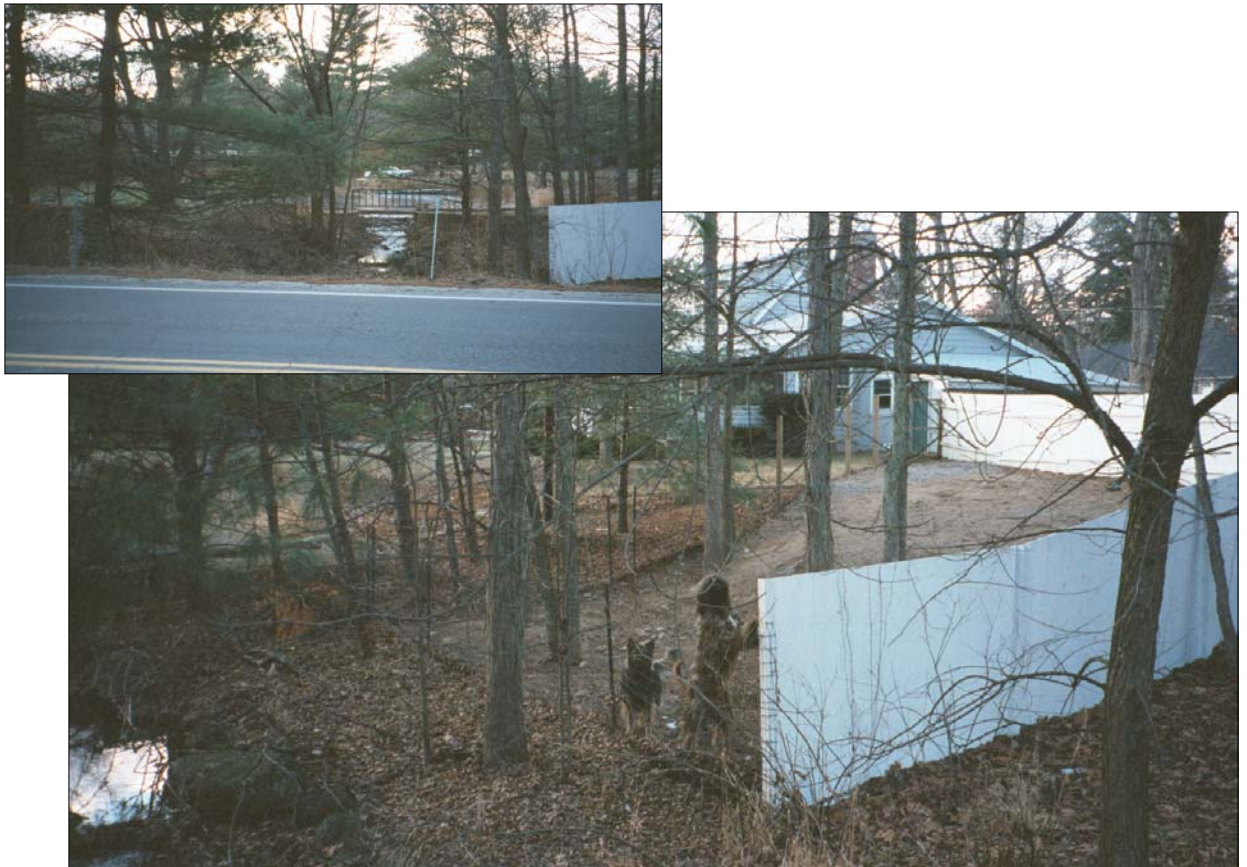
Figure 2-22. The unvegetated dog pen which is located downstream of the pond's outlet and within ten feet of the brook is an exposure point of bacteria to the brook.

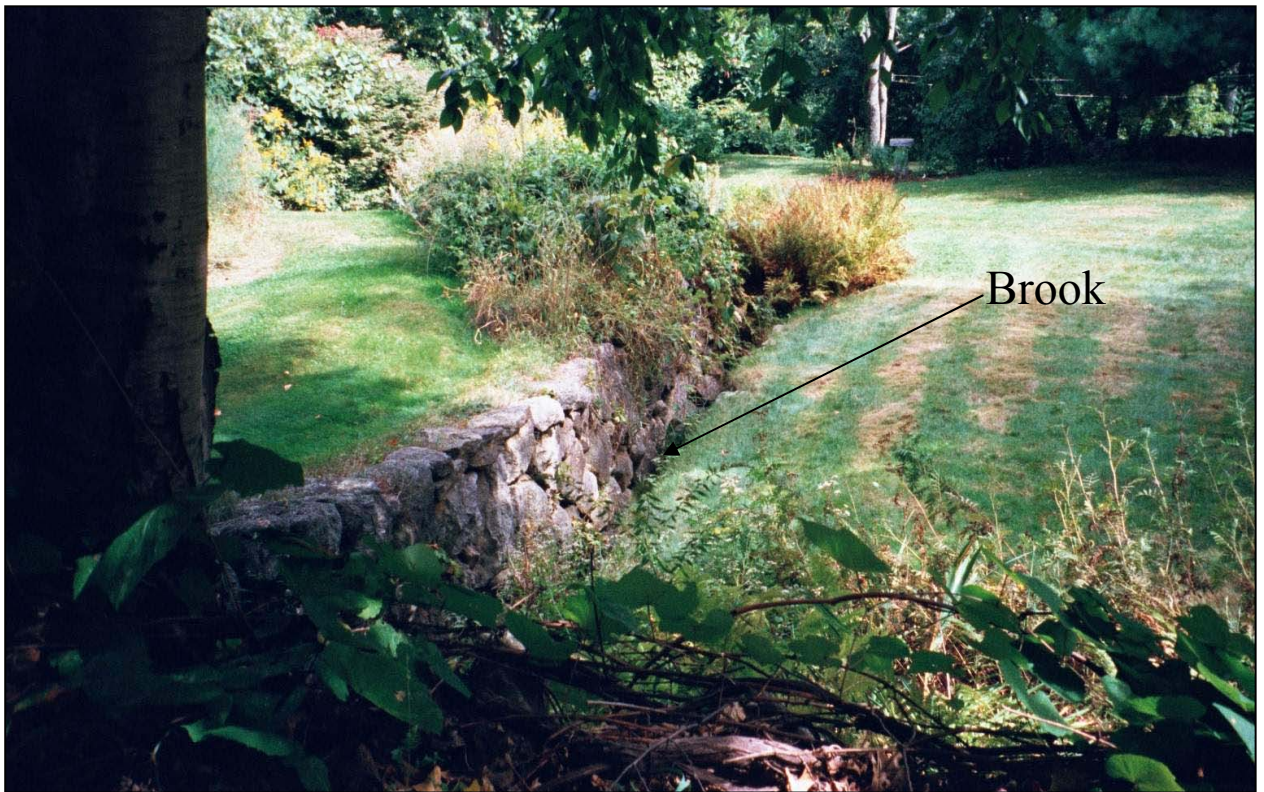
Figure 2-23. A residential property adjacent to Ponemah Hill Road. The surrounding lawn is a potential source for nutrients and pesticides.

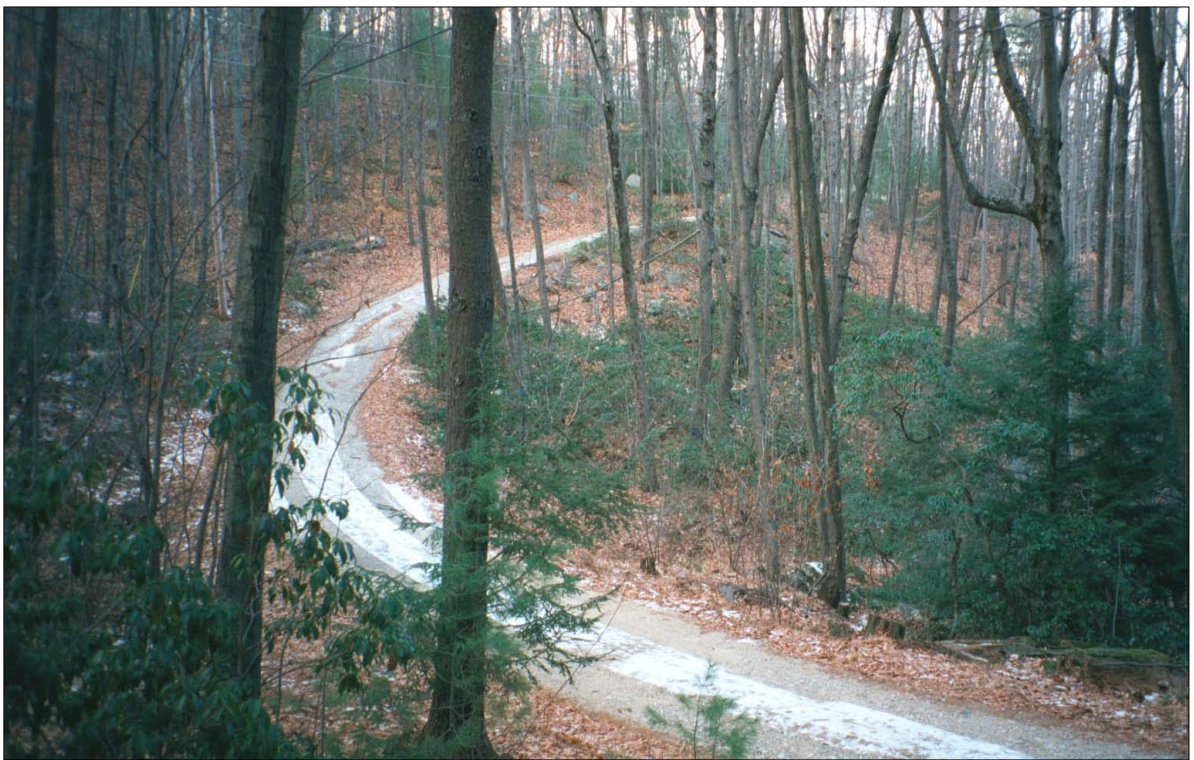
Figure 2-24. Steep hills and valleys creating a great deal of runoff surround the low-density residential areas and vacant lands along Ponemah Hill Road.

The steep slopes found in Milford along Ponemah Hill Road will be subject to substantial erosion unless the town takes steps to protect this fragile area. Milford allows 70% of residential lots to be covered with impervious surfaces (minimum 30% open space). While it is unlikely that a residence would approach this massive an area, accessory structures such as large storage building or barn could generate a lot of runoff from the site. Adjusting the lot coverage downward (or required open space upwards) would be an effective way to address single family homes as most will not be held to stormwater standards if they are not part of a subdivision (see Section 3.1.2.) A more reasonable number would be to prohibit impervious surfaces in excess of 2,500 s.f. or 10% unless recharge is provided.

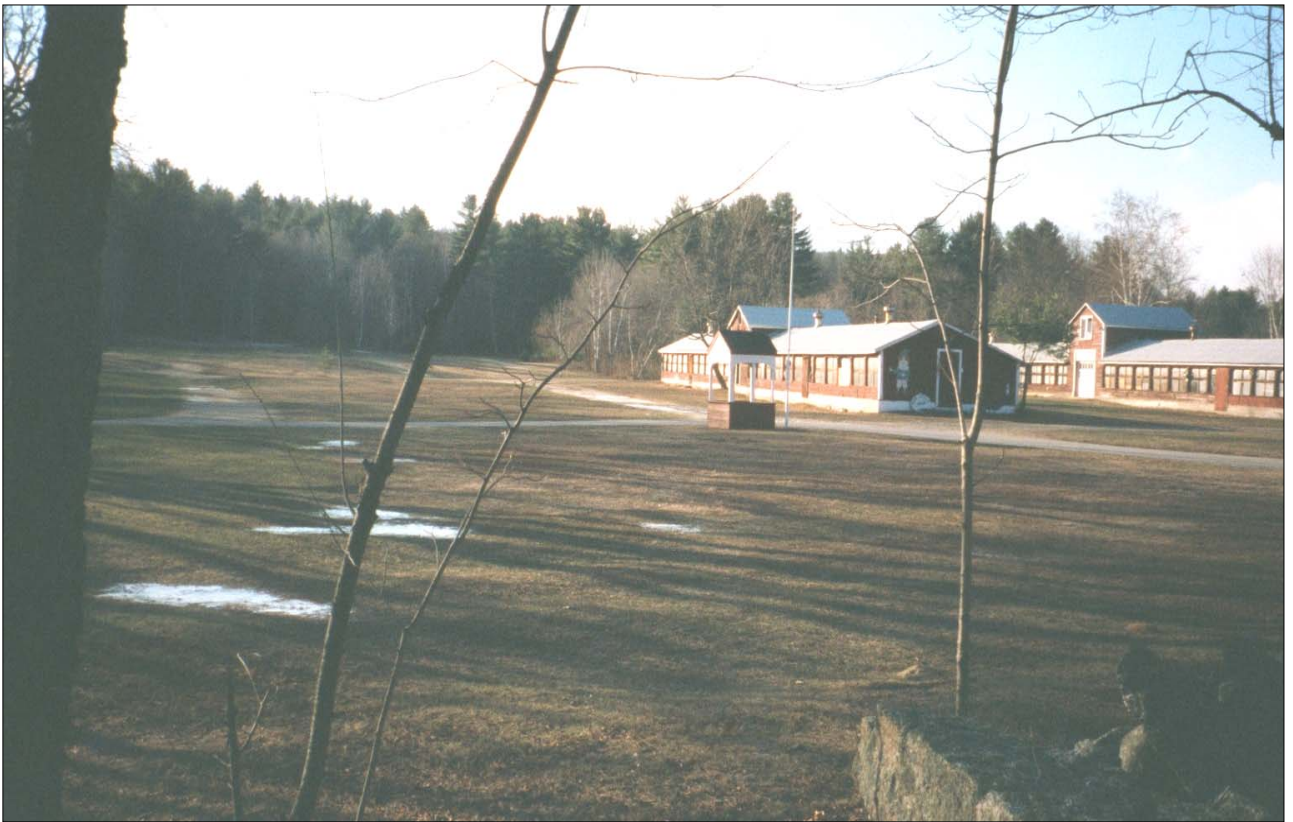
Figure 2-25. The flea market and antique sales areas. In the future these areas may pose a potential water quality threat to the brook if paved.

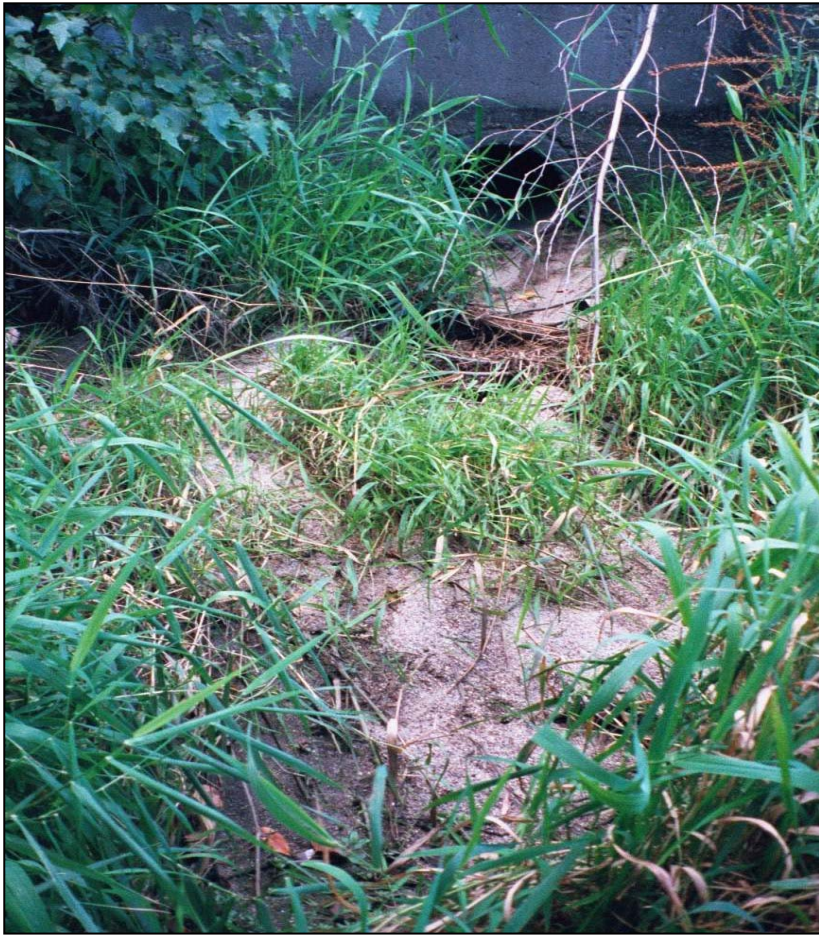
parking area. This outlet discharges into the same wetland area (Figure 2-30) mentioned in Section 2.3.1. A small sediment delta was observed below the outlet. Minimal impact to the surrounding wetlands was observed. However, the outlet represents a discharge through which others might connect when surrounding areas become more developed.

Figure 2-30. The outlet discharges into the wetland area.

Recommendations to address these concerns can be found in Section 3.1.2, which encourages town-wide stormwater infiltration. This would lessen the burden on existing structures to handle upstream drainage.

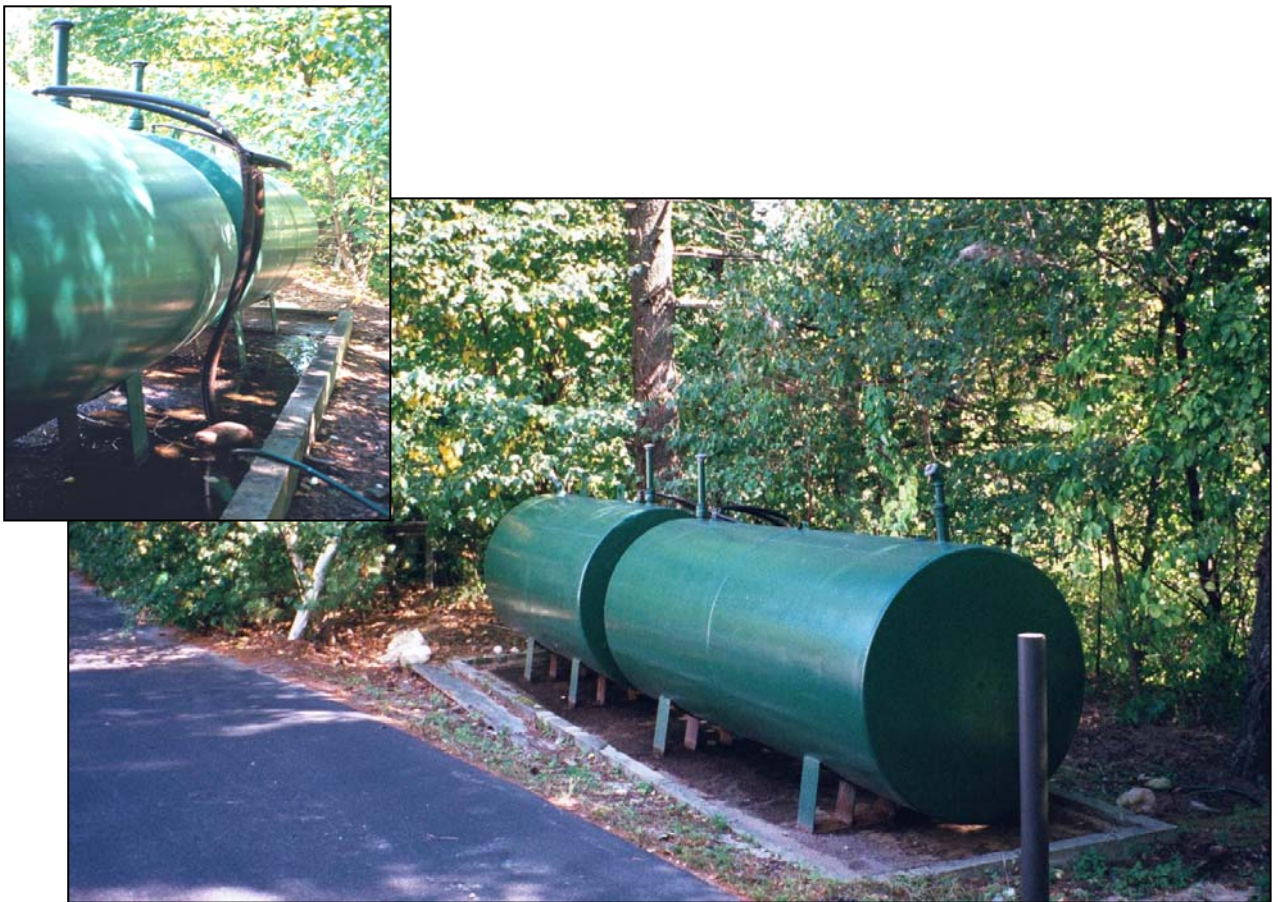
The church off Patricia Lane in Amherst has two 500-gallon Aboveground Storage Tanks (ASTs) (Figure 2-31) located at the southern portion of the property. Runoff from this area flows south to Peacock Brook. The close proximity of the ASTs to Peacock Brook (<200 feet) warrants an evaluation of the petroleum storage at the property. Currently, there is not adequate spill containment for the two tanks or proper stormwater control. The tanks are not adequately protected against damage from vehicular traffic. At the time of inspection, there was very faint petroleum sheen on the standing water within the containment walls. The petroleum sheen appears to be from the feed lines, on which an oily residue was also visible.

Figure 2-31. Two 500-gallon ASTs located at the southern portion of the property.

Recommendations to address these concerns can be found in Section 3.2.3.

*Recommend additional safeguards for oil tanks*

The ASTs at the church are exempt from state and federal regulations (see Appendix A) however their close proximity to surface water suggest that they could still voluntarily implement some of the more important features found in those requirements.

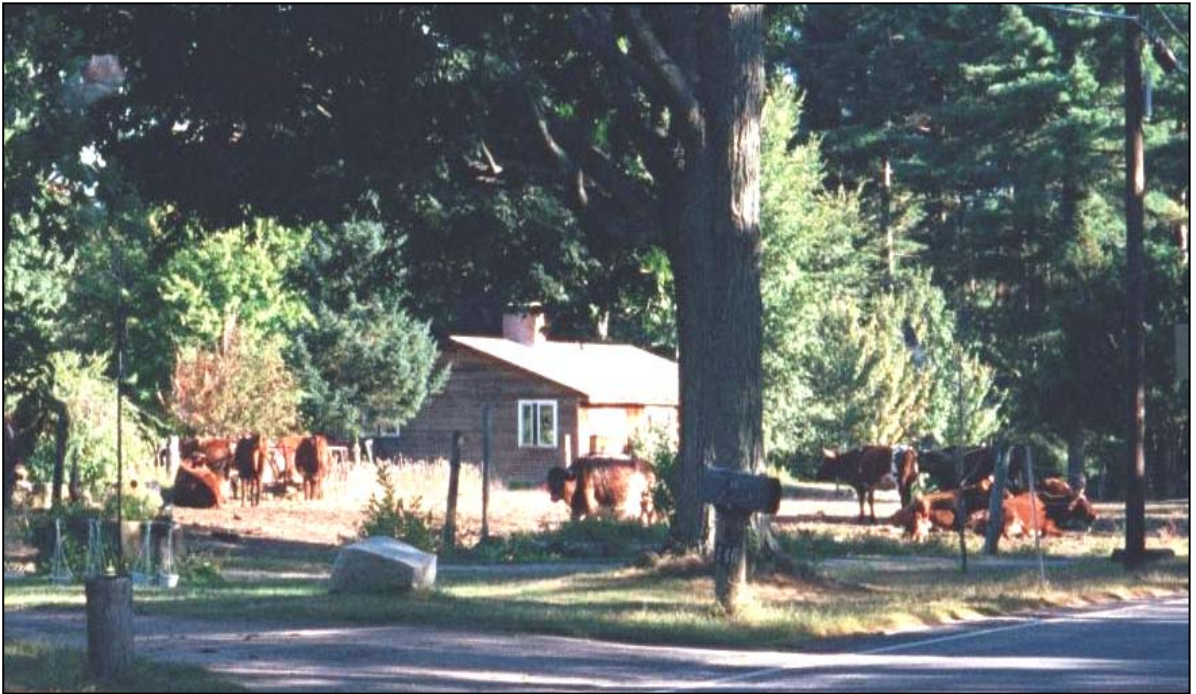
Figure 2-32. A grazing area. The cows represent a threat of bacteria to the brook due to their proximity.

Recommendations to address these concerns can be found in Section 3.2.1.

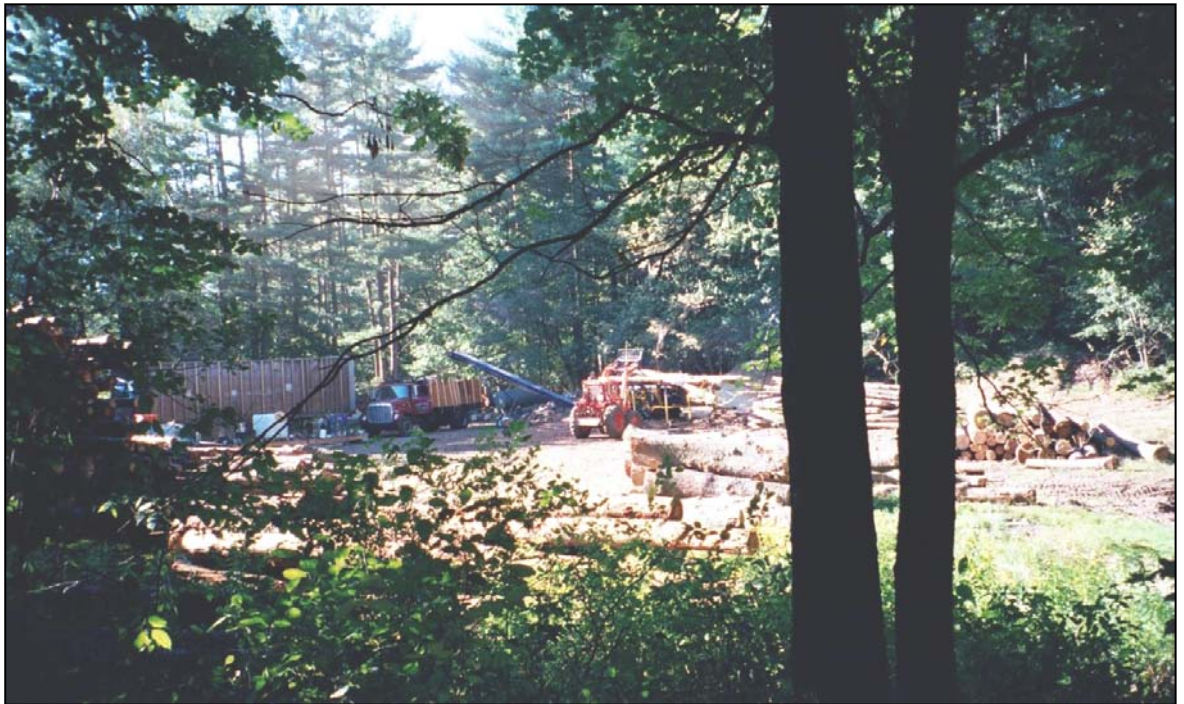
lumber as well as log-cutting operations (Figure 2-33). The machinery used in such operations can represent a water quality threat due to the risk of petroleum releases. However, runoff from this area cannot reach either brook since the entire area is a depression that has no outlet. During rain events, local runoff ponds at the eastern portion of the site and slowly infiltrates the soils. Consequently, water quality threats from this site relate to the potential for groundwater contamination. Due to the close proximity to Peacock and Rainbow Brooks, there is a potential for site operations to pose a threat to the water quality of the brooks via groundwater.

Figure 2-33. Log-cutting operations in the sawmill area. The machinery can pose a water quality threat due to the risk of petroleum releases.

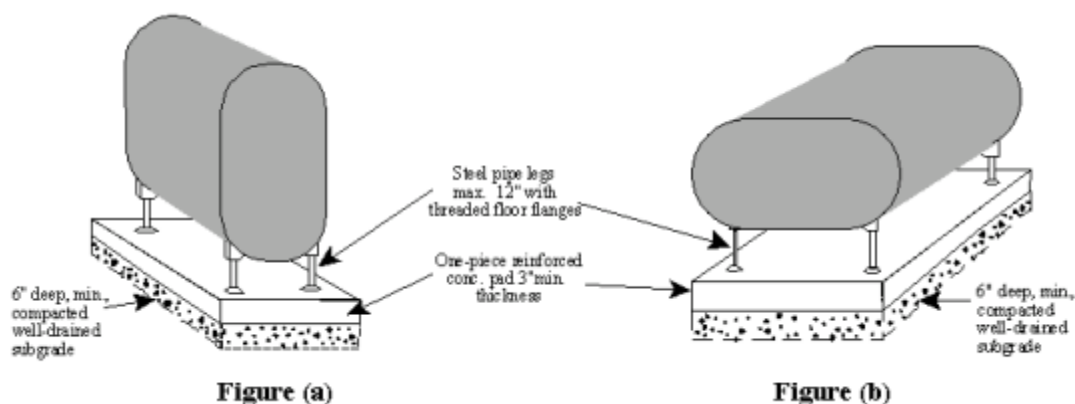
**LEGS AND FOUNDATIONS:** Tanks of either upright (vertical) or horizontal configuration shall be mounted on steel pipe legs not exceeding 12 inches in height and fitted with threaded floor flanges at the base of each leg. The legs shall rest on a minimum 3-inch thick reinforced concrete pad. The length and width of the pad shall be equal to or larger than the dimensions of the tank. The pad shall rest on a bed (6" minimum) of compacted well-drained gravel, crushed stone, coarse sand or other acceptable subgrade. See figures (a) and (b) below.

With either vertical or horizontal tanks, the leg brackets that are welded to the bottom of a tank shall not be used as a leg and shall not rest directly on the concrete pad. Some tanks, such as UL 142 tanks, are designed and manufactured to be supported by cradles, saddles or other similar supports. These supports shall be placed on concrete pads as described above. In all cases, there shall be a minimum of 4 inches of clearance from the bottom of the tank to any other surface.
