# **Reservoir Storage Estimates & Tributary and Pond Sediment Accumulation Monitoring**

**Final Report**

**September 30, 2017**

# Reservoir Storage Estimates & Tributary and Pond Sediment Accumulation Monitoring

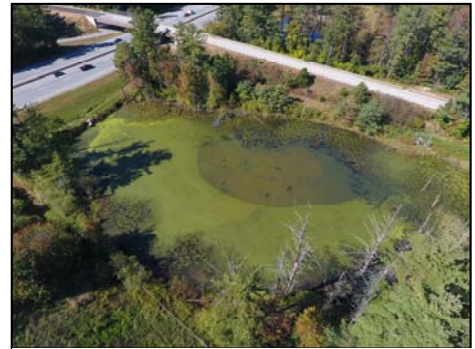
*Tinker Pond aerial drone imagery  
algal bloom & infill*

Drone imagery of the Tinker Road Wet Pond BMP identified the need for ongoing maintenance to ensure optimal performance for control of sediment and nutrients. A large volume of stormwater runoff from the Everett Turnpike and Tinker Road flows into this treatment system, transporting both sediment and nutrients into the pond. At the time of the drone flyover, Tinker Pond appeared to be experiencing a bloom of cyanobacteria (blue-green algae) and had significant areas of shallow depth with dense growth of water lilies and other aquatic vegetation. The presence of cyanobacteria has not been confirmed with additional sampling.

Tinker Pond functions essentially as a settling basin, allowing for pollutant attenuation prior to discharge to Harris Pond, located to the north across Tinker Road. The importance of Tinker Pond and its Wet Pond BMP are heightened by its location in relatively close proximity to the downstream supply pond and water supply intake. Given the conditions observed at Tinker Pond, an engineering evaluation is necessary to determine recommendations for ongoing maintenance of the BMP to ensure optimal performance for pollutant attenuation. In order to determine feasibility of a maintenance dredge process, several tasks should be completed, including (1) collection of a screening-level sediment sample to determine the most likely options and costs for dredged material disposal and re-use, and (2) bathymetry and sediment mapping of Tinker Pond to establish storage volume estimates and rate of infill. It is recommended that a meeting with stakeholders be held to identify local concerns, obstacles and permit constraints associated with future maintenance dredging. Based on these results, a dredging feasibility study can be completed to evaluate the options, logistics, and costs of dredging to restore depth and water storage volume in Tinker Pond. If maintenance dredging is deemed feasible and an appropriate time frame is established, the design and required permitting according to the recommended options could be completed.

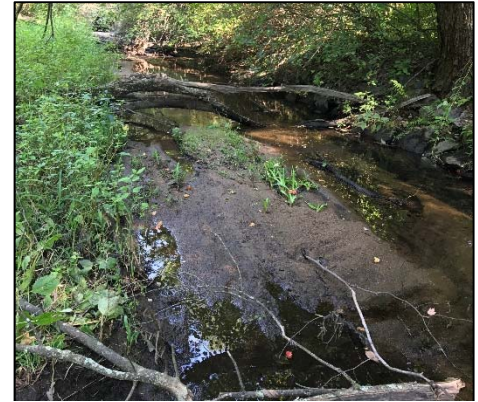
*Sediment deposit at Boire Field Brook  
adjacent to Tinker Road*

During field investigations, a large sediment deposit was discovered immediately upstream of a culvert located on Tinker Road in Nashua, NH. Boire Field Brook is the tributary that flows through the culvert under Tinker Road, and discharges into Harris Pond approximately 1/3-mile downstream. Upstream of this culvert are several major roadways including Somerset Parkway and the southbound off ramp from the Everett Turnpike. This area has been built-out over the years with several large commercial developments all of which drain to Boire Field Brook.

As evidenced by the sediment accumulation, there have been significant impacts to this area from stormwater runoff. It was also noted that downstream of the Tinker Road culvert near the end of Boire Field Brook, stormwater from the Everett Turnpike drains directly into the brook with minimal treatment or protection against accidental spills prior to reaching Harris Pond. It was noted that Pennichuck owns most of the land adjacent to the Boire Field Brook corridor and portions of this area may have been historically designed as a stormwater control for the future upstream development along Somerset Parkway and Route 101A.

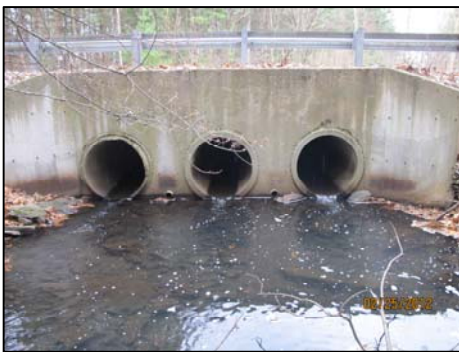
*Culvert Crossing of Boire Field Brook at  
Tinker Road*

Culverts are located all throughout the Pennichuck Brook Watershed, including a large number that are proximal to the water supply reservoirs. Based on the sediment deposits discovered immediately upstream of some of the culverts seen during this study, a culvert investigation and assessment is recommended for some certain portions of the Pennichuck Brook Watershed that if clogged might result in a roadway washout that would end up with extensive sediments in the supply ponds. The work could be done in phases, including an initial watershed community outreach and to identify the location of unknown culverts, a fieldwork effort to thoroughly inspect a number stream crossings (15-20), and a prioritization of high-risk culverts to provide precautionary solution recommendations.

Developing an inventory that contains culvert data (quantity, location, age, etc.) in key areas of the watershed is an important project both for PWW and the towns involved. Once culverts are mapped and an inventory has been established, field inspections can then be completed to prioritize culverts that are undersized, in critical structural condition, or at risk of washout of the roadway bedding.

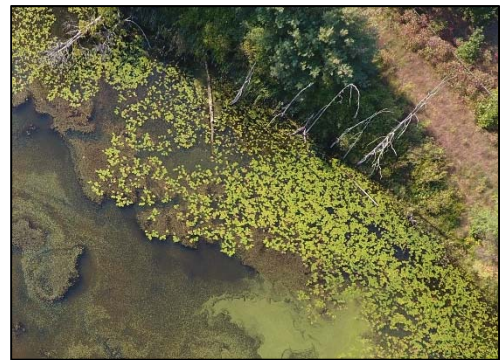
*Drone imagery showing dense growth of white water lily within Tinker Pond.*

CEI's field investigations have documented abundant aquatic vegetation within the supply ponds and their tributaries, including significant areas dominated by dense growth of floating-leaf species such as white water lily (*Nymphaea odorata*) and a variety of submerged species such as coontail (*Ceratophyllum demersum*) and ribbon-leaf pondweed (*Potamogeton epihydrus*).
