## Assessment of Public-Private Partnership Opportunities for Pennichuck Watershed Water Quality Protection

**PENNICHUCK**

## INTRODUCTION

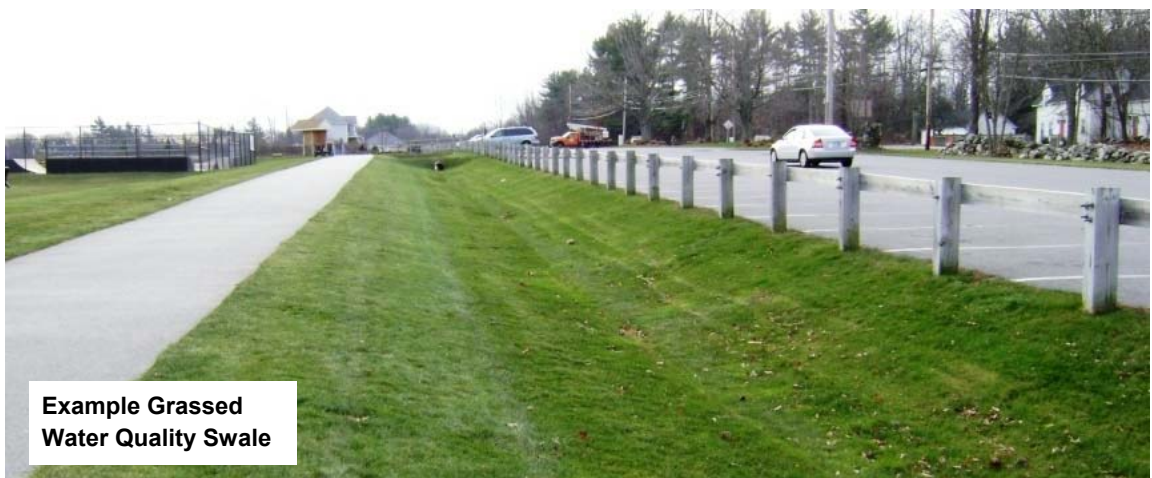
3. **Water Quality Swale:** Install a road edge vegetated water quality swale along the eastern side of Hansom Drive (west/northwest of the pond). This BMP will capture, infiltrate, and treat stormwater runoff draining directly from the road. This BMP could be enhanced by constructing the swale as a series of linear bioretention cells connected by sections of vegetated swale. Shown below is an image of a typical water quality swale.

Water quality swales are vegetated open channels designed to treat the required water quality volume and to convey runoff from the 10-year storm without causing erosion. Unlike drainage channels, which are intended to be used only for conveyance, water quality swales and grass channels are designed to treat the required water quality volume and incorporate specific features to enhance their stormwater pollutant removal effectiveness. Water quality swales have higher pollutant removal efficiencies than grass channels

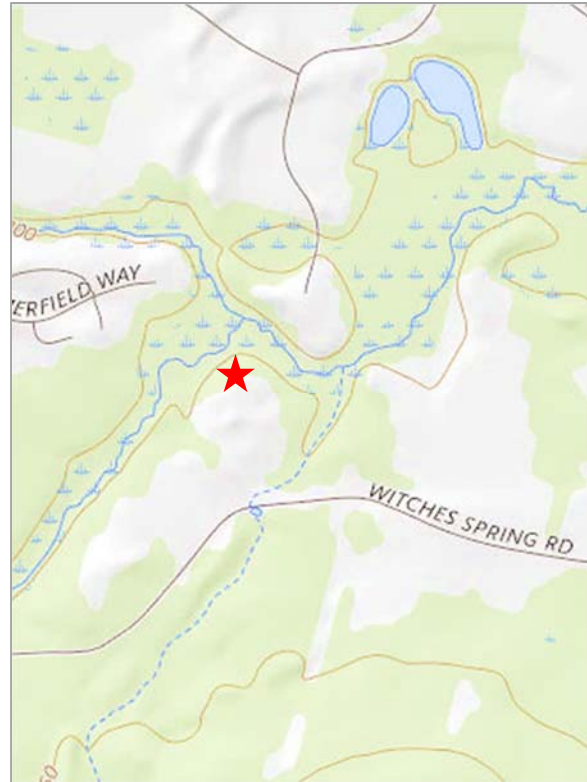
**AREA 3:**  
**Junkyard, 80 Witches Spring Rd., Hollis, NH**

The junkyard at this property is bordered by Witches Brook to the north and northeast and is located across the brook from the Area 2 parcel at 30 Northern Boulevard. The junkyard area is approximately 9.2 acres and the property parcel is 58.9 acres. Witches Brook flows through the northern extent of the parcel, immediately adjacent to the junkyard. The parcel also includes forested and emergent wetland areas to the north of Witches Brook and agricultural land south and east of the brook. Owner information was obtained on the online Nashua Regional Planning Commission property database.

Based on CEI's review of aerial imagery, the parcel includes several exposed stockpile/storage areas, dirt paths, and sparse vegetation. Well over one hundred junked vehicles appeared to be stored at this site at the time the aerial imagery was taken. There is a relatively narrow strip of vegetated buffer separating the junkyard area from Witches Brook, with several gaps in the buffer. During storm events, sediment and pollutants from the junkyard and stockpile areas may be transported into Witches Brook due to the limited vegetated buffer.

CEI recommends the following to improve the quality of the vegetated buffer to Witches Brook, thereby reducing pollutant loading to the Pennichuck water supply system:

- **Buffer Zone Plantings:** Improve the width and continuity of the vegetated buffer along the northern and western boundary of the junkyard area bordering Witches Brook. This BMP will slow down stormwater runoff, and capture sediment and contaminants before they enter the brook. CEI will work with Pennichuck to reach out to the landowner in order to discuss potential options for implementing buffer improvements (including plant species selection and other design factors such as buffer width) under a future project, if desired.

- **Public Education:** Provide the landowner with relevant information on storage of materials with the potential to pollute, such as oil, antifreeze, fuel, etc. Also emphasize that any maintenance of vehicles should be performed under cover and on an impervious surface where possible, and that liquids should never be drained into the ground waterbody, or drainage system.

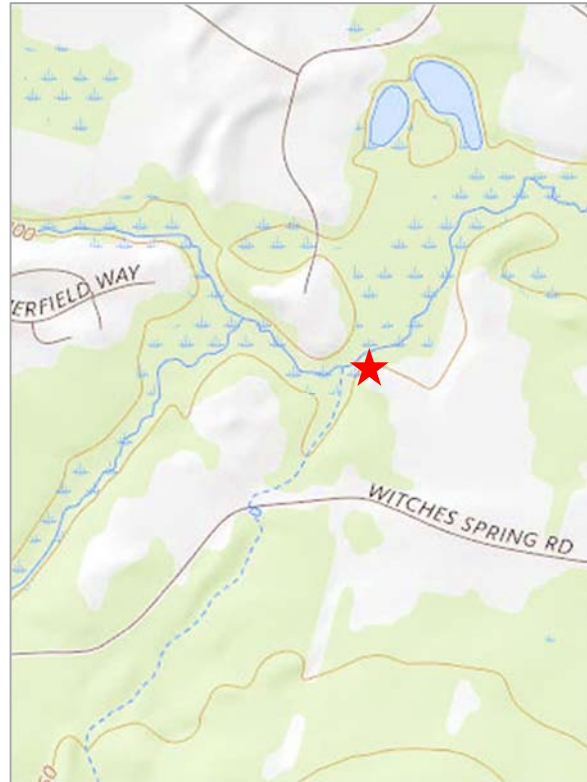
**AREA 4:**  
**Open Land Adjacent to Farm, 100 Witches**  
**Spring Rd., Hollis, NH**

An area of open land (approximately 2.8 acres) at this site is located just south of Witches Brook and adjacent to a wheat farm (106 Witches Spring Road, owned by Gerald C. and Marie C. Glover).

The open land area is located across the brook from the vacant lot on Northern Boulevard (Area 2) and adjacent to the junkyard to the east (Area 3). The 9.4-acres property consists of a residence closer to Witches Spring Road, south of the open area. Owner information was obtained on the online Nashua Regional Planning Commission property database.

Based on field observations and review of aerial images, the backyard area is comprised of mowed grass, vehicle paths, some exposed sandy soils, and sparse vegetation. There is generally a narrow buffer (single layer of trees) separating the open land area from Witches Brook, although there are several gaps in the buffer.

CEI recommends the following to improve the quality of the vegetated buffer to Witches Brook, thereby reducing pollutant loading to the Pennichuck water supply system:

- **Buffer Zone Plantings:** Reestablish buffer zone along the extents of the property bordering Witches Brook. This BMP will slow down stormwater sheet runoff, and capture any sediment and contaminants before they enter the brook. CEI will work with Pennichuck to reach out to the landowner to discuss potential options of implementing buffer improvements (including plant species selection and other design factors such as buffer width) under a future project, if desired.

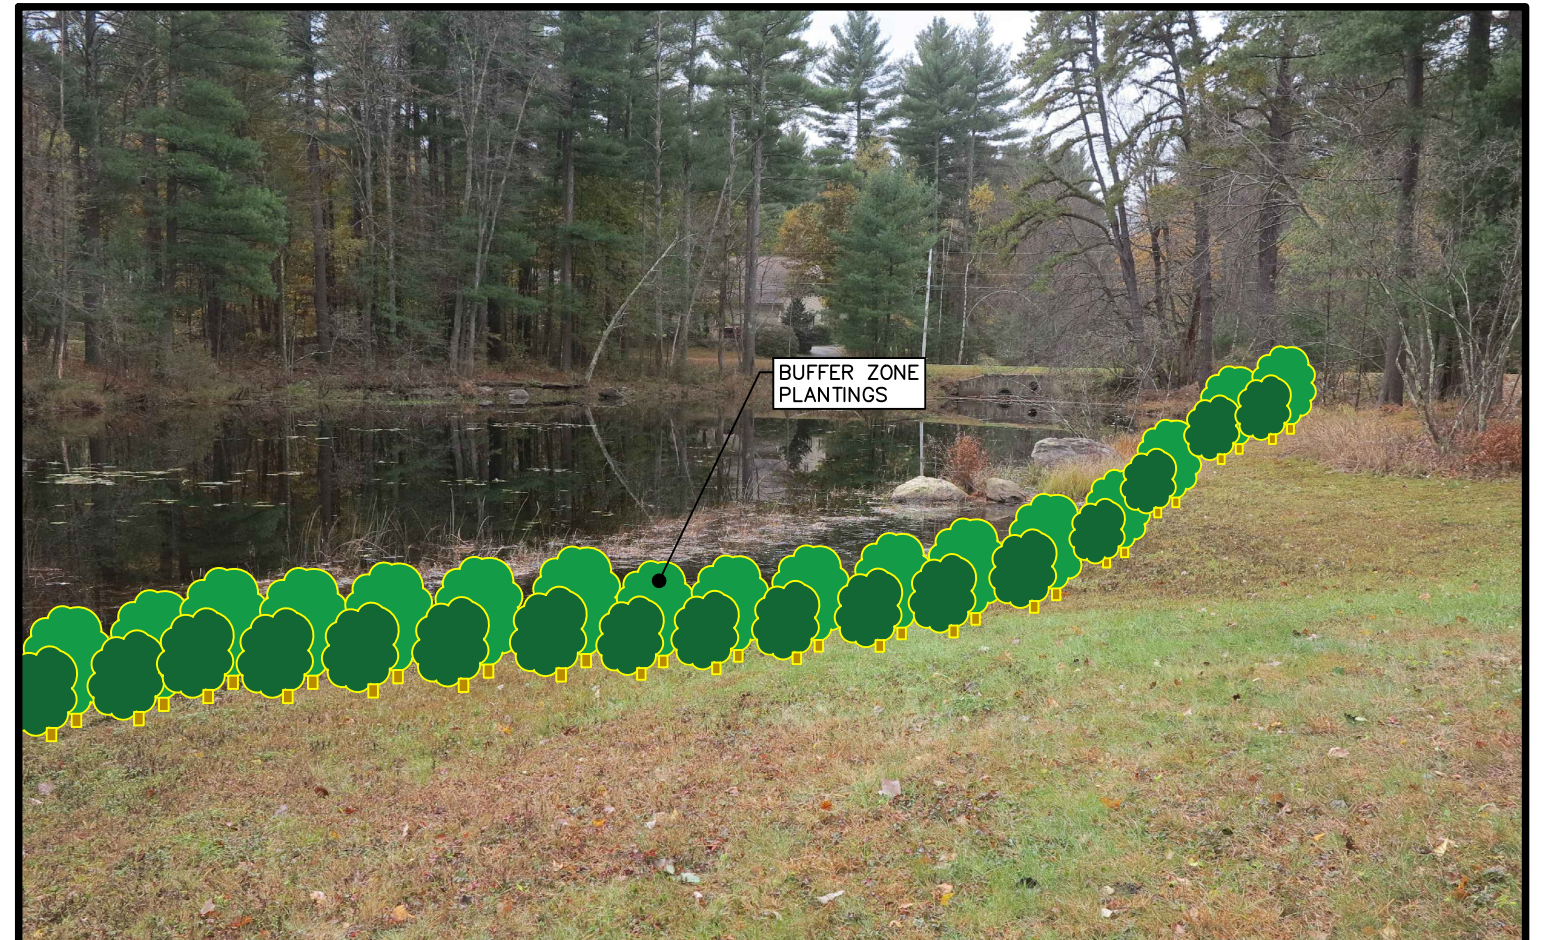
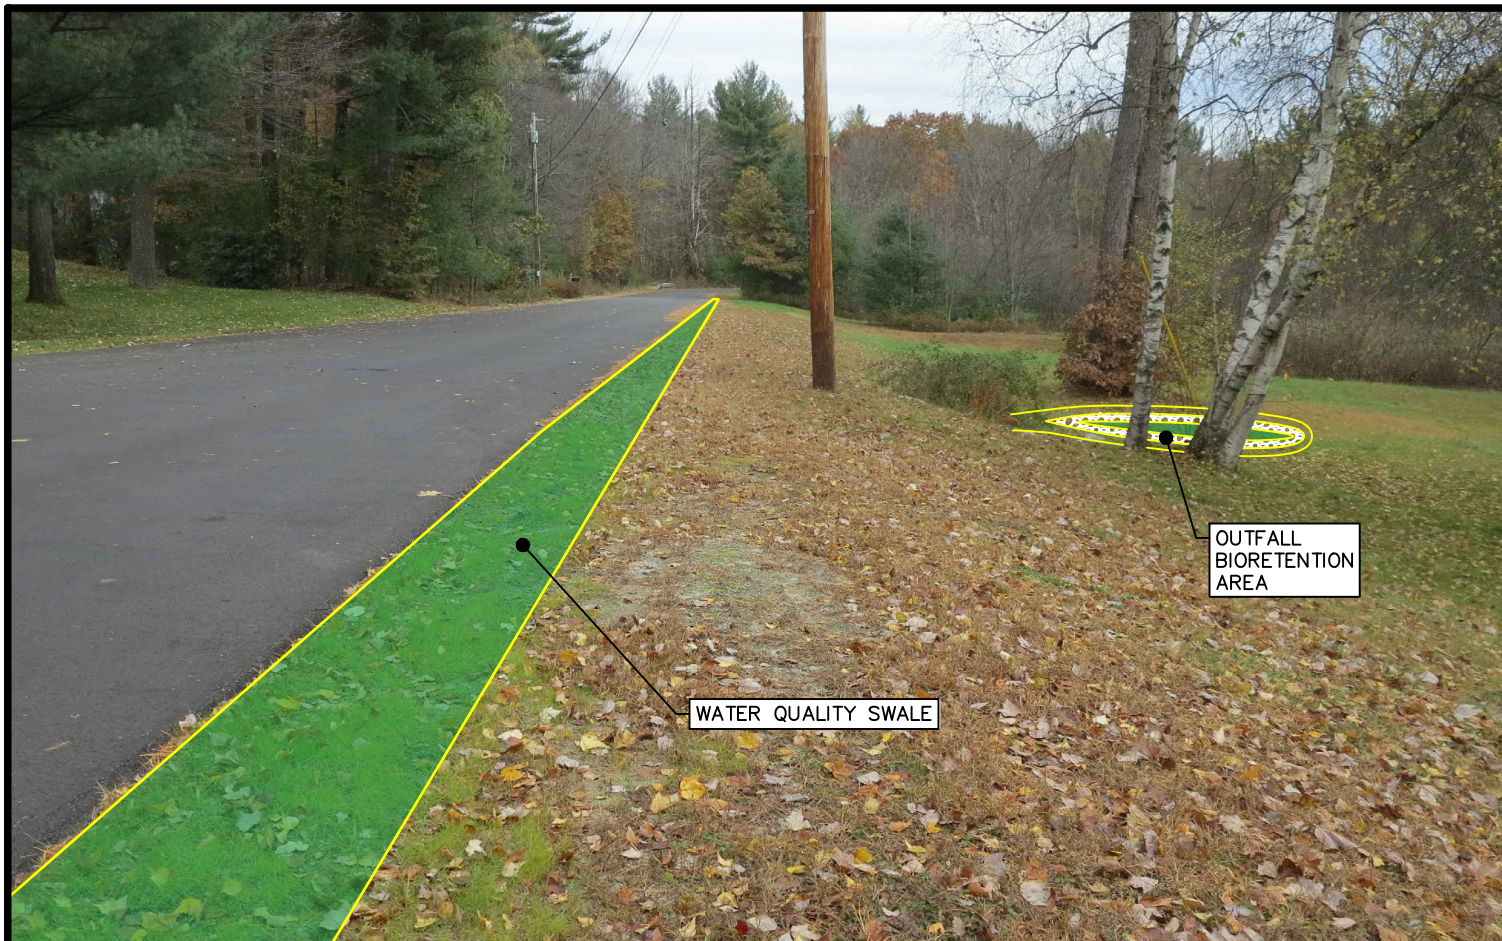
See attached Sheets C-1A and C-1B for the conceptual renderings of the BMPs described above.

1. **Buffer Zone Plantings:** Install woody (tree/shrub) buffer zone plantings to improve pollutant attenuation along the west/northwest side of the pond. This BMP will slow down stormwater runoff, improve infiltration, and increase vegetative uptake of nutrients and other pollutants before they can enter the pond. The buffer plantings can be designed to be an aesthetically pleasing landscaping amenity to this park-like area, while still allowing views of the pond and easy water access in specified areas. CEI will work with Pennichuck and neighborhood landowners to develop a preferred planting list and finalize other design factors (e.g., buffer width, pond access points, etc.) under a future project, if desired.

2. **Outfall Bioretention Area:** Install a bioretention area at the drainage outfall located on the west side of the pond. In addition to treating and infiltrating water from drainage outfall, this BMP will also capture a portion of stormwater sheet runoff from the road. The bioretention area will also provide aesthetic benefits to this common area. CEI will work with Pennichuck and neighborhood landowners to discuss plant species selection (e.g., woody shrubs, perennial flowers, etc.) and other design factors (e.g., bioretention area extents, capacity/design storm, etc.) under a future project, if desired. Shown below is a cross section of a typical bioretention area.

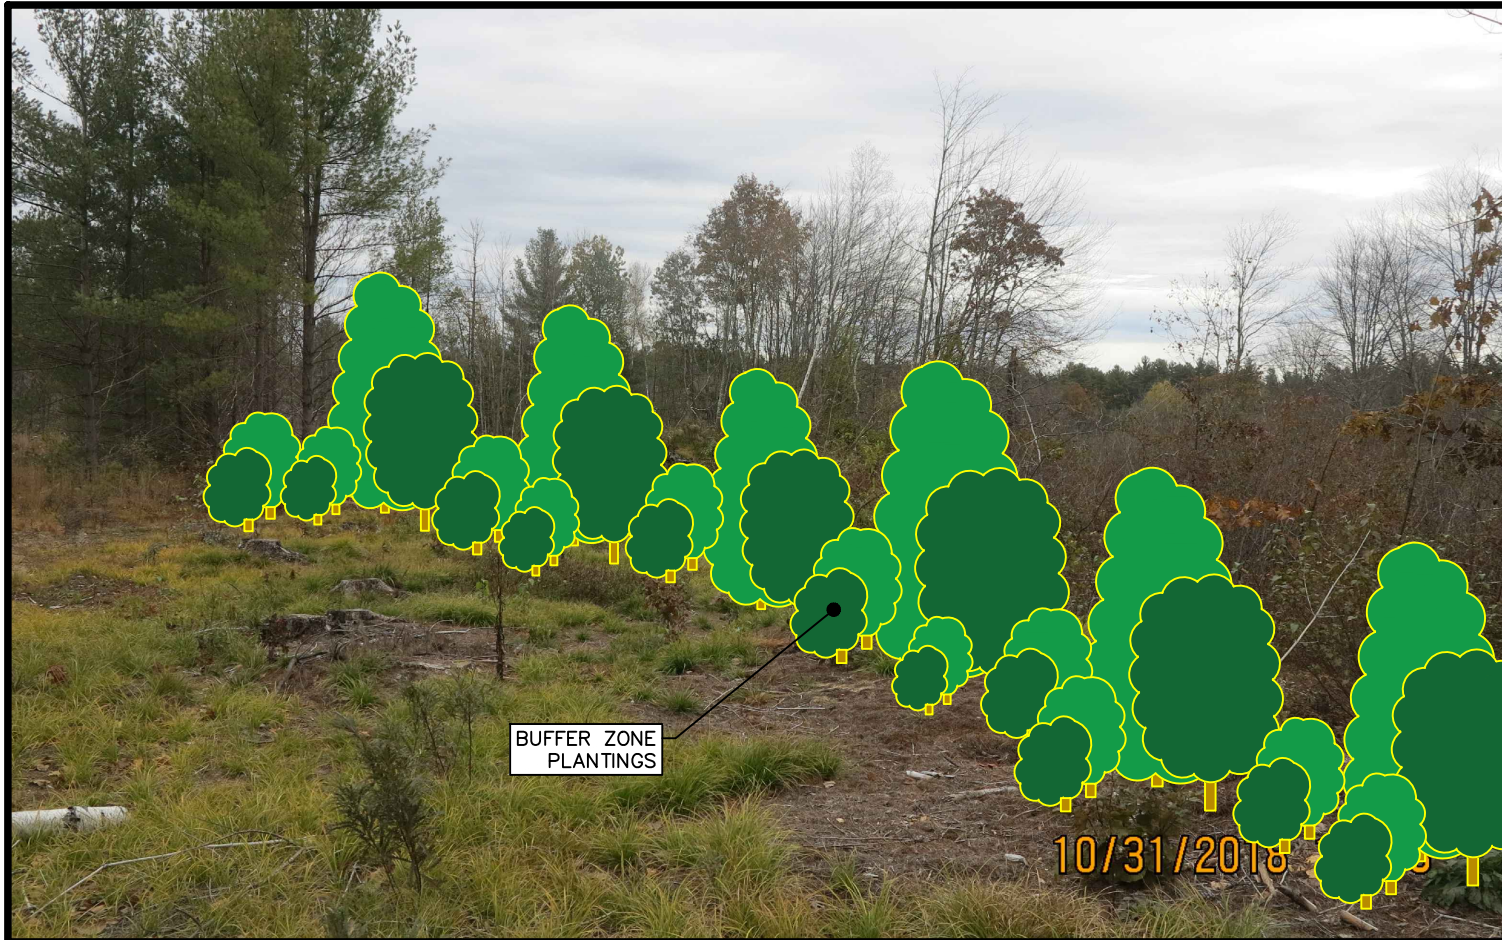
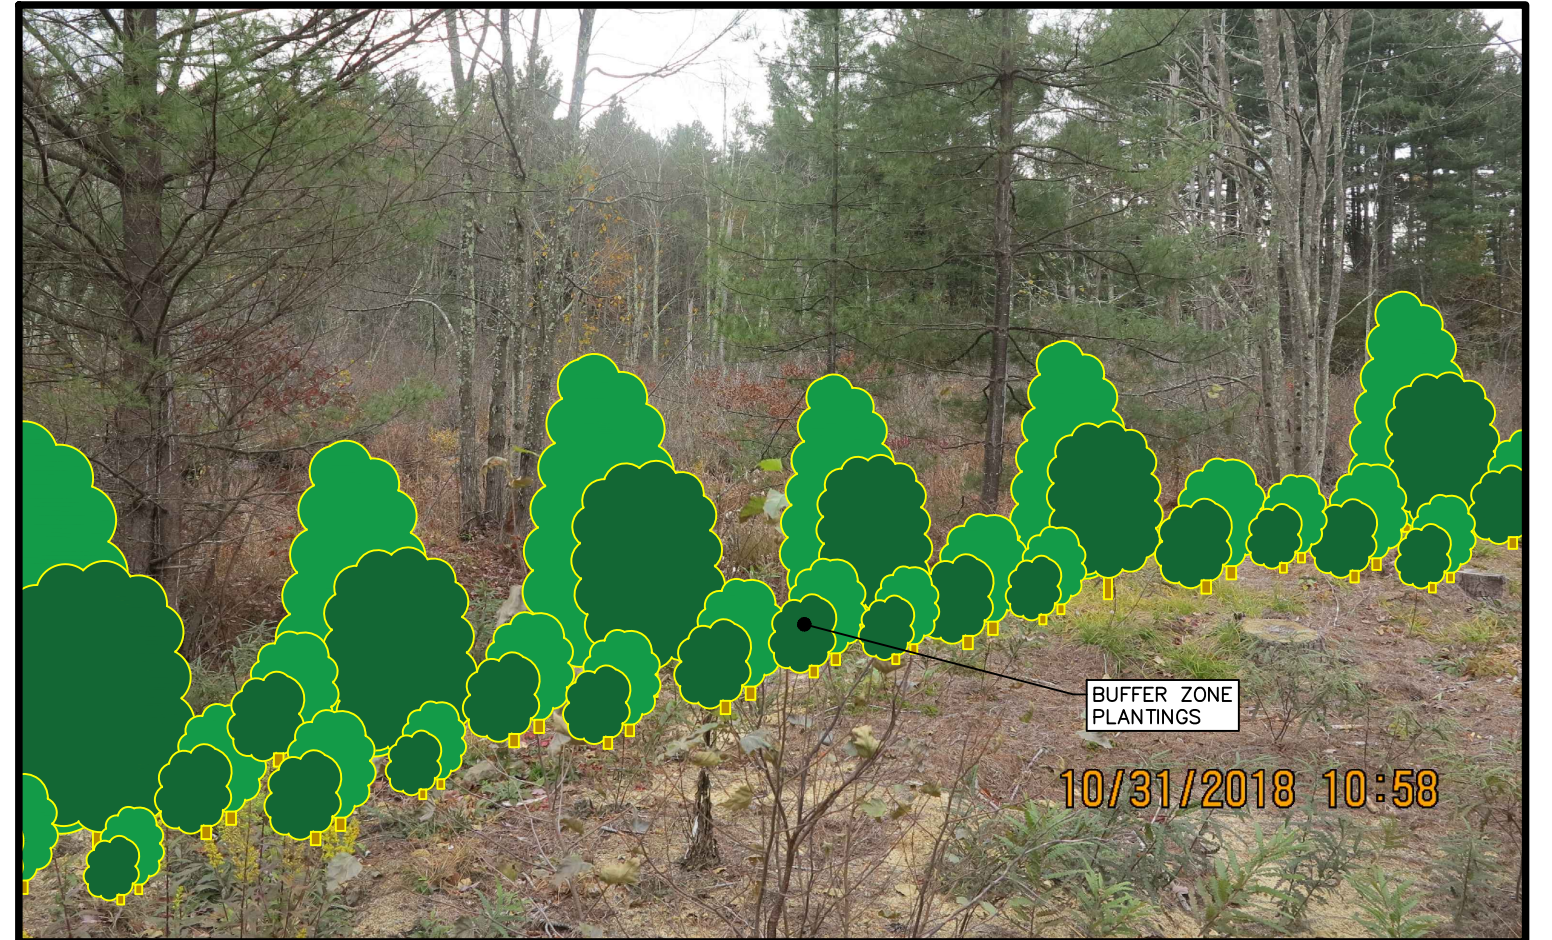
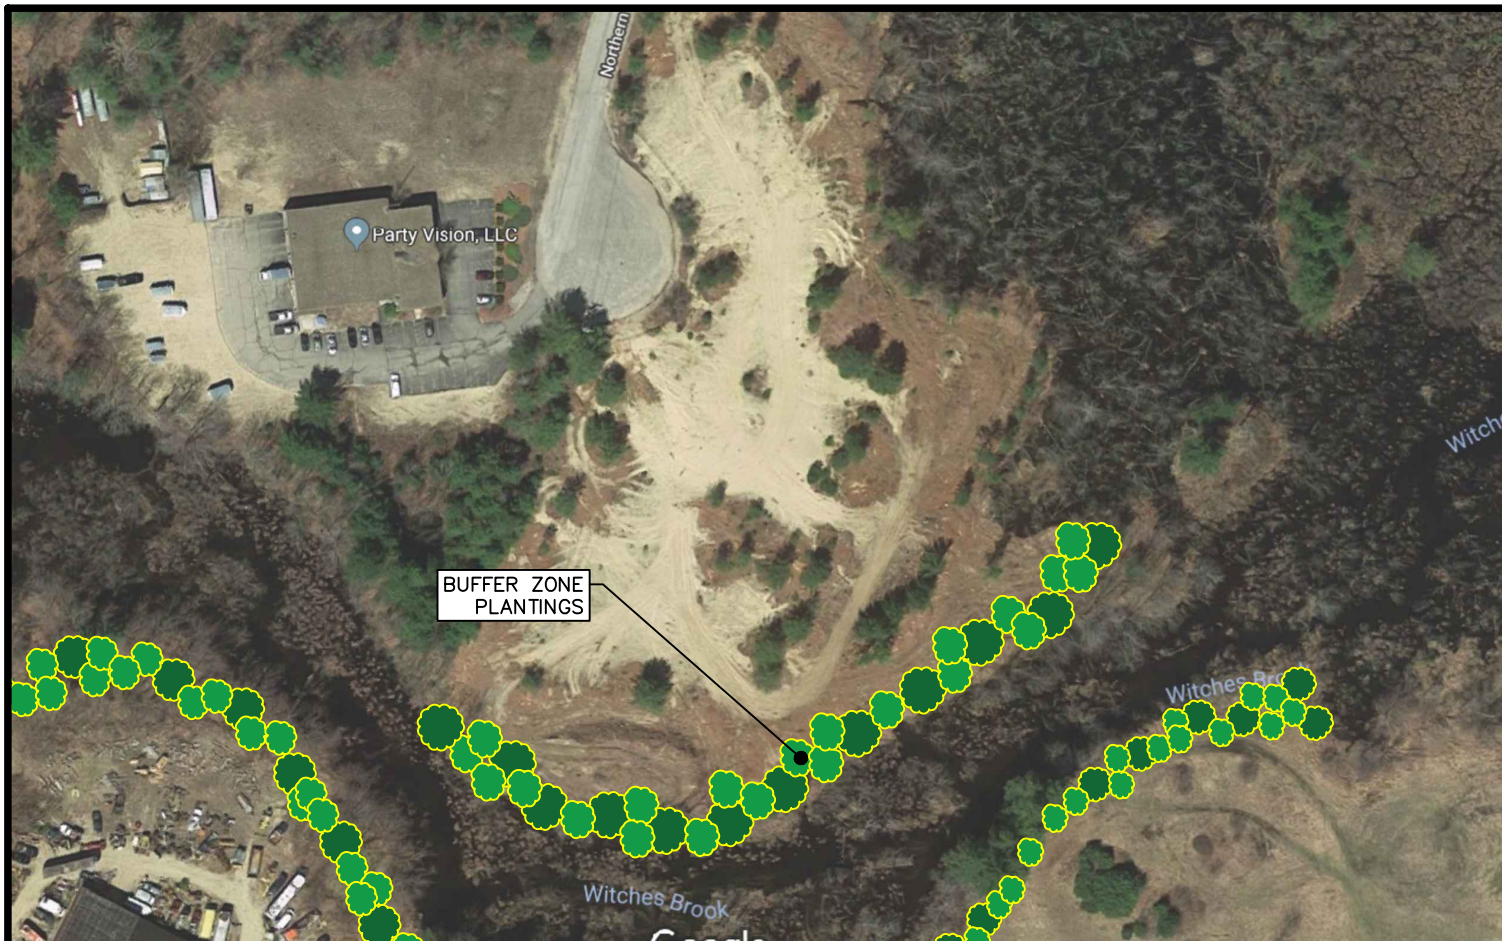
| <p>Project No.: 131-62<br/>Date: DECEMBER 2019<br/>Drawn By: PD<br/>Checked By: RH<br/>Scale: N.T.S.</p> | <p>Sheet No.:<br/><br/>C-2</p> |

See attached Sheet C-2 for the conceptual drawing of the aforementioned buffer zone improvements.

- **Revegetation:** Expand and re-establish a vegetative buffer along the southern extents of the property bordering Witches Brook. This BMP will slow down stormwater sheet runoff, and reduce sediment and pollutant loading to the brook. CEI will work with Pennichuck to reach out to the landowner in order to discuss potential options for implementing buffer improvements (including plant species selection and other design factors such as buffer width) under a future project, if desired.

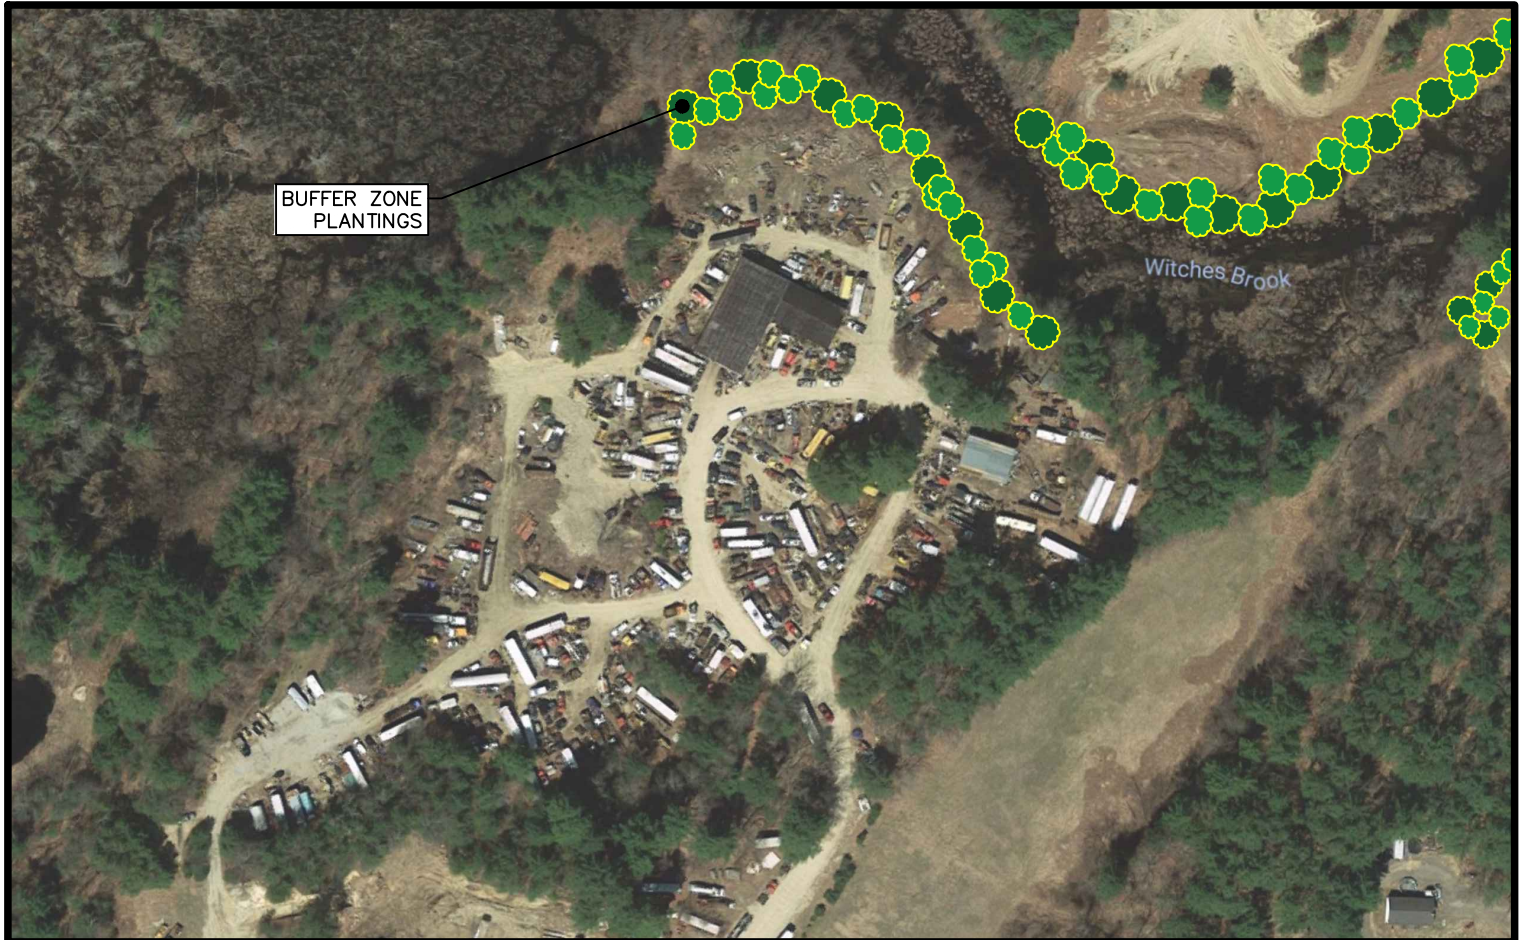
Sheet No.:  
**C-3**

See attached Sheet C-3 for the conceptual drawing of the aforementioned buffer zone improvements.

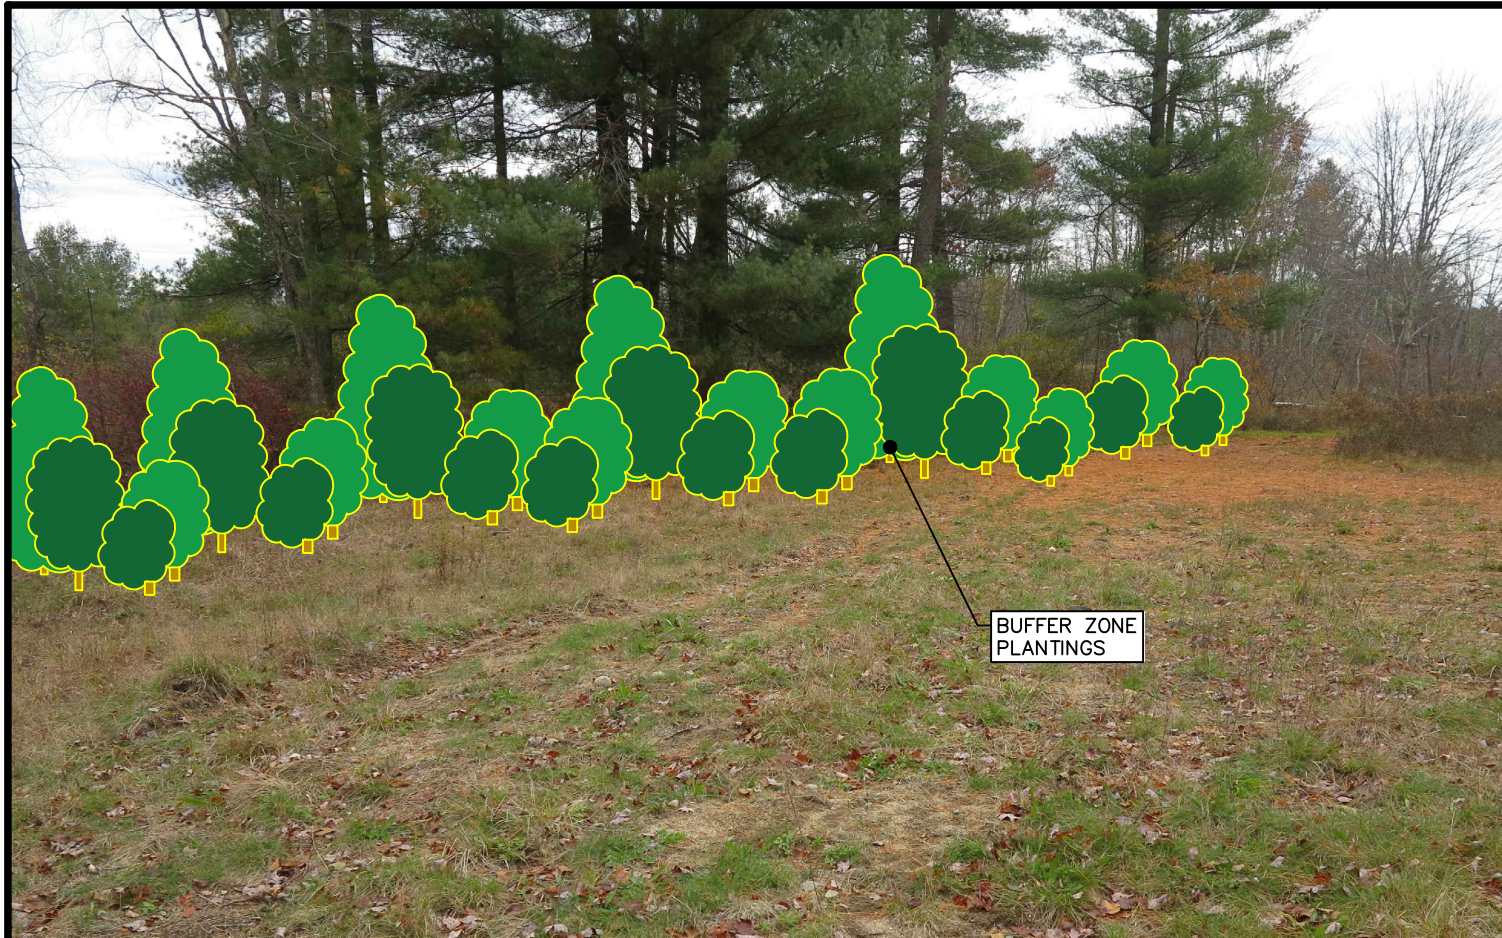
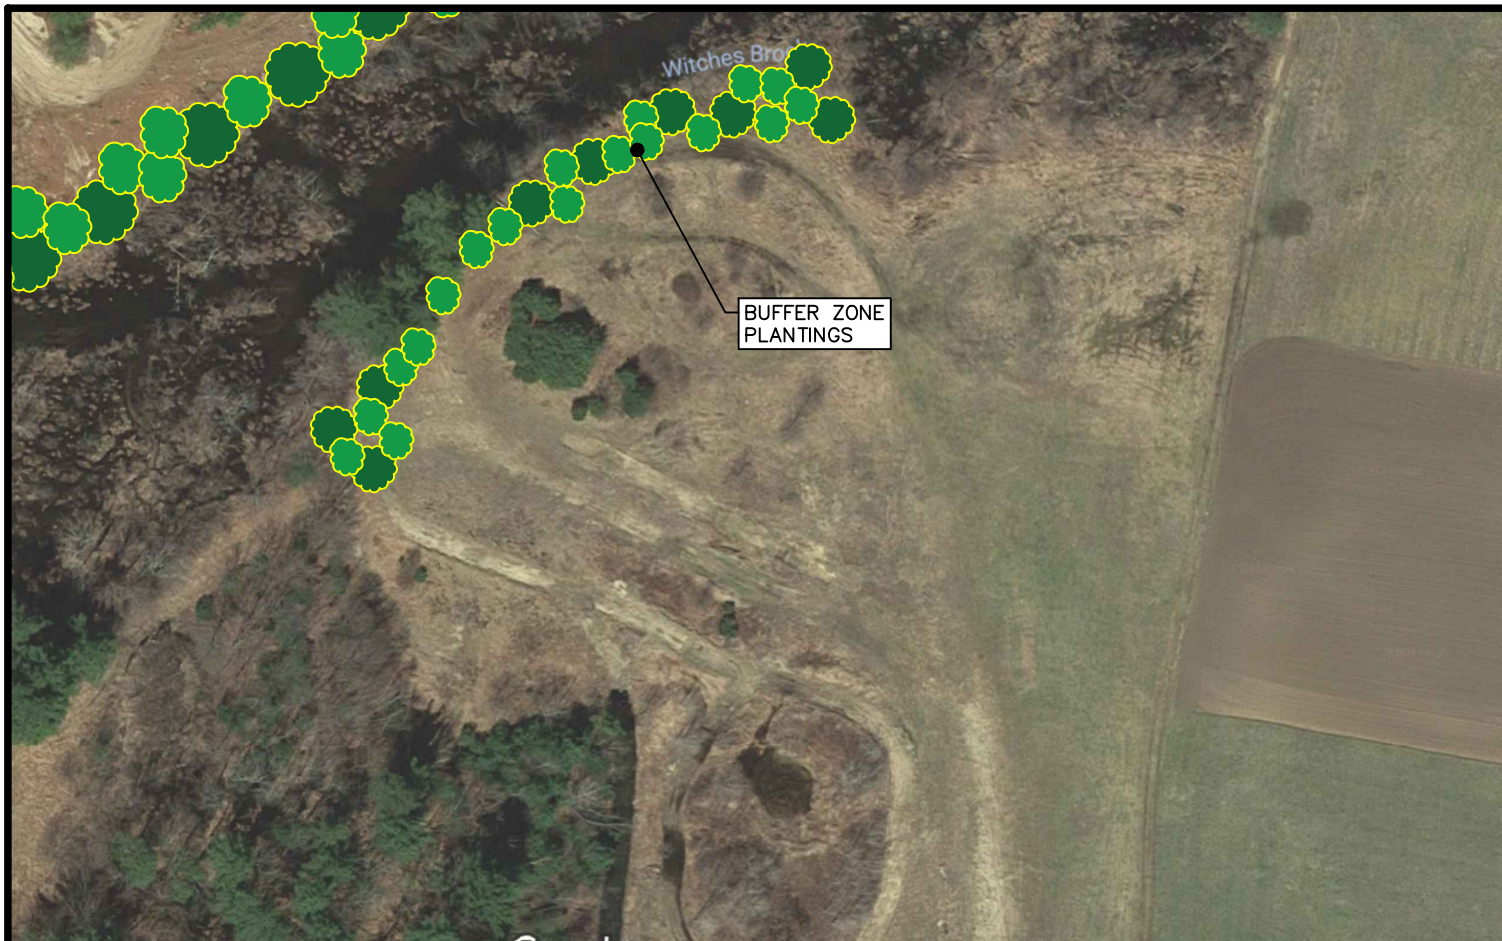
See attached Sheet C-4 for the conceptual drawing of the aforementioned buffer zone improvements.
