# Comprehensive Environmental Inc.

## Study of Urban Non-Point Source Pollution Stump Pond Brook Subwatershed

### PENNICHUCK WATER WORKS SUMMER/FALL 2002

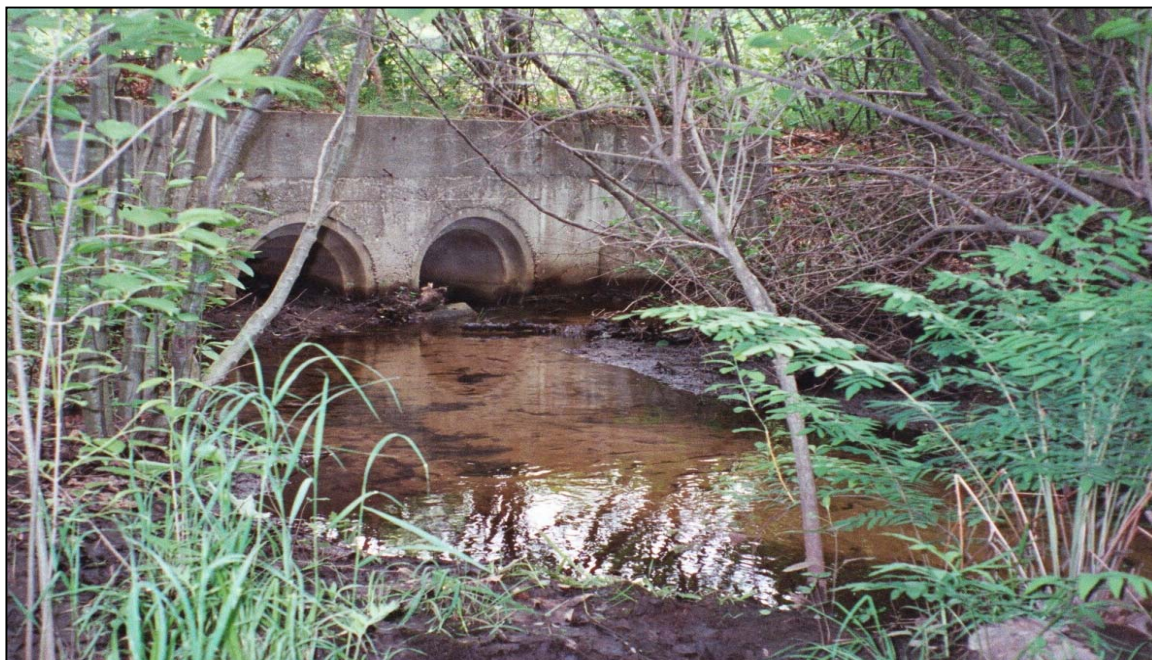
**Figure 2-4.** Bates Road Tributary Passing under Hansom Drive

The portion of Bates Road that lies north of Charles Road drains to the south. Stormwater from Bates Road and fifty feet of Charles Road discharges on the second property south of Charles Road, feeding a small tributary that passes beneath Bates Road between Four Winds Road and Hansom Drive. The remainder of the Bates Road drainage feeds this tributary, along with Blueberry Court and a portion of Four Winds Road. Figure 2-4 shows Bates Road tributary crossing under Hansom Drive before entering the pond.

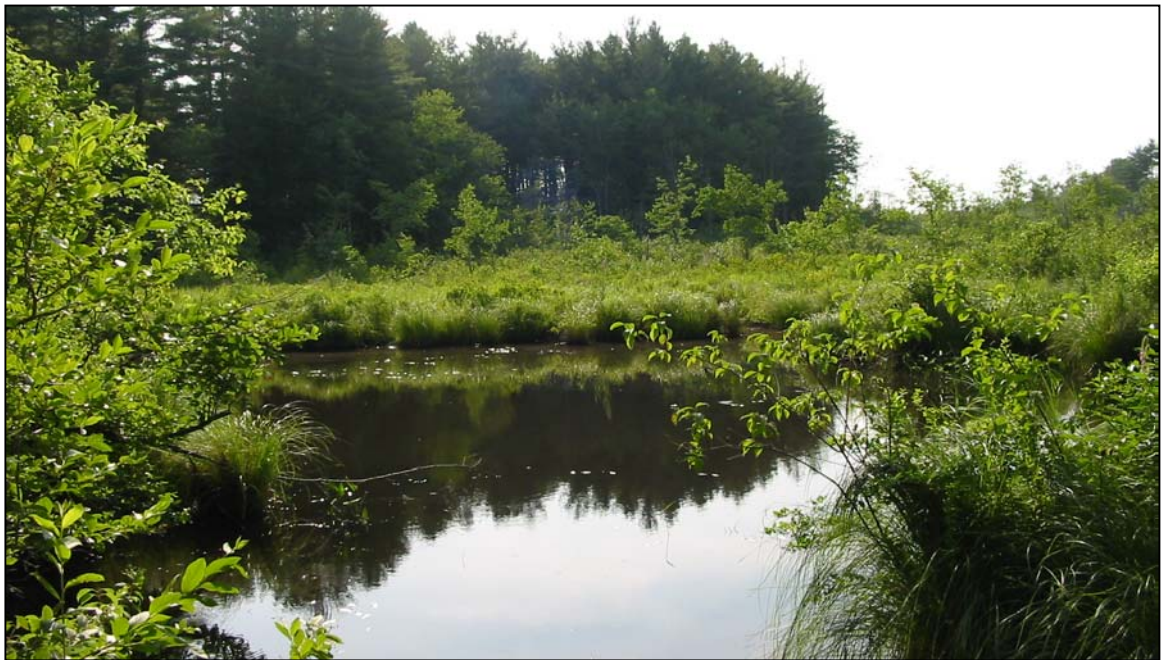
**Figure 2-13.** Confluence of Stump Pond Brook and Witches Brook

The sparsely populated triangular tip of the drainage area that lies to the south of Route 101A includes Merrimack Village District wellhead No. 6. This well is located near the confluence of Stump Pond Brook and Witches Brook, which is the most downgradient point for all drainage within the SPB subwatershed (Figure 2-13).

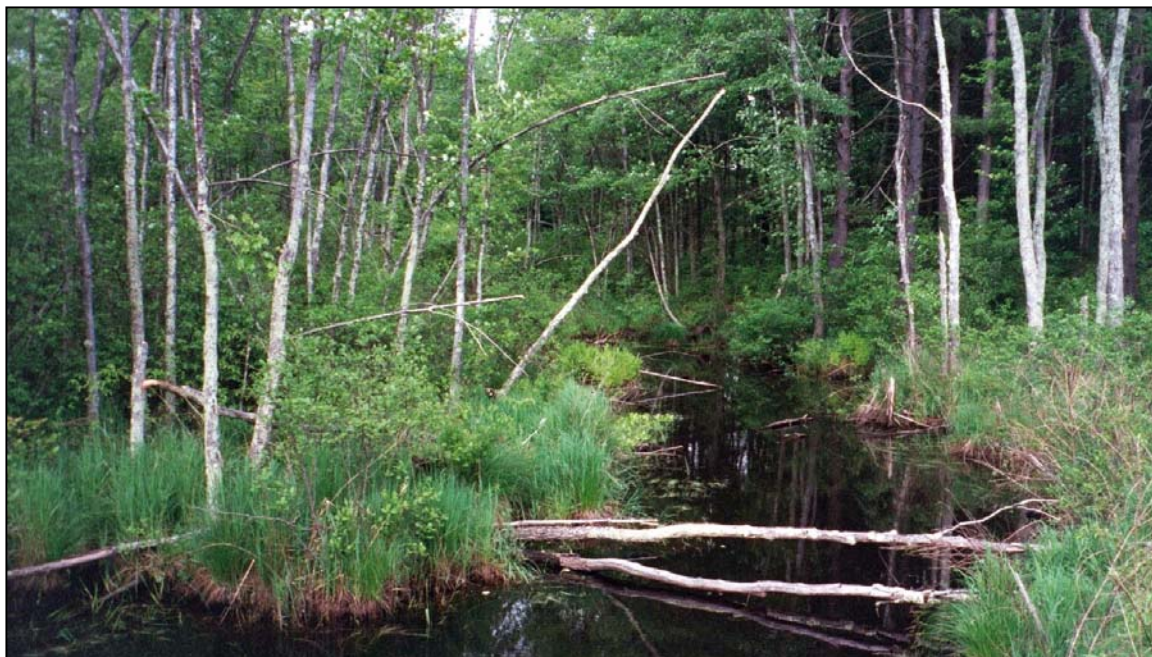
**Figure 3-10.** Stump Pond Brook Channel with Buffer

Figure 3-10 and 3-11 demonstrates the difference between a healthy stream channel and a vulnerable one. It is remarkable that these two scenes are only thirty feet apart. The Seaverns Bridge Road resident has chosen to clear and establish a lawn right up to the edge of the water. This practice leaves little protection for the water body from runoff, the sun's heat, UV radiation, pesticides and fertilizers that may be used by the resident. On the other side of the bridge, there are trees and healthy undergrowth providing shade, diverse wildlife habitat, soil stabilization and nutrient uptake to protect against runoff. While this site provides a rather stark example of buffer loss, the entire subwatershed faces the water quality threat of buffer loss.
