## PENNICHUCK WATER WORKS BOIRE FIELD BROOK SUBWATERSHED EVALUATION 2019

**PENNICHUCK**

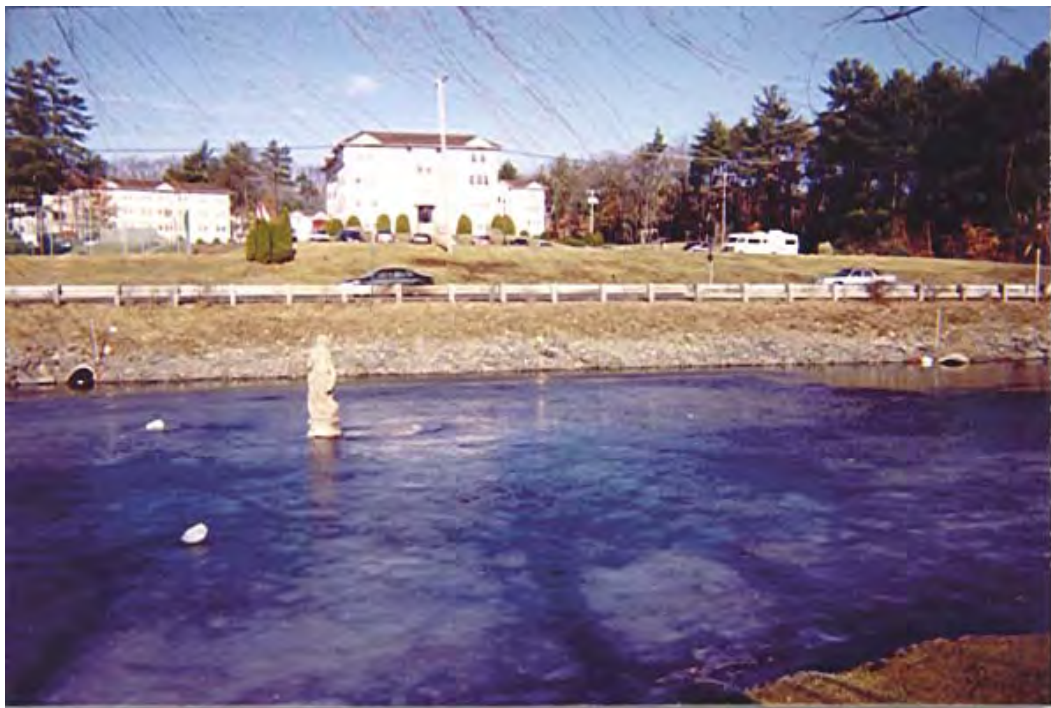
Stormwater from the southern aspect of the Kessler Farm development and access drive does not benefit from as long a detention time as it short circuits the flow path seen in green on Figure 2-1 and instead discharges directly into the last detention pond (Figure 2-5) before crossing under Somerset Parkway.

Figure 2-5. Stormwater Discharges to  
Crowne Plaza Detention Pond

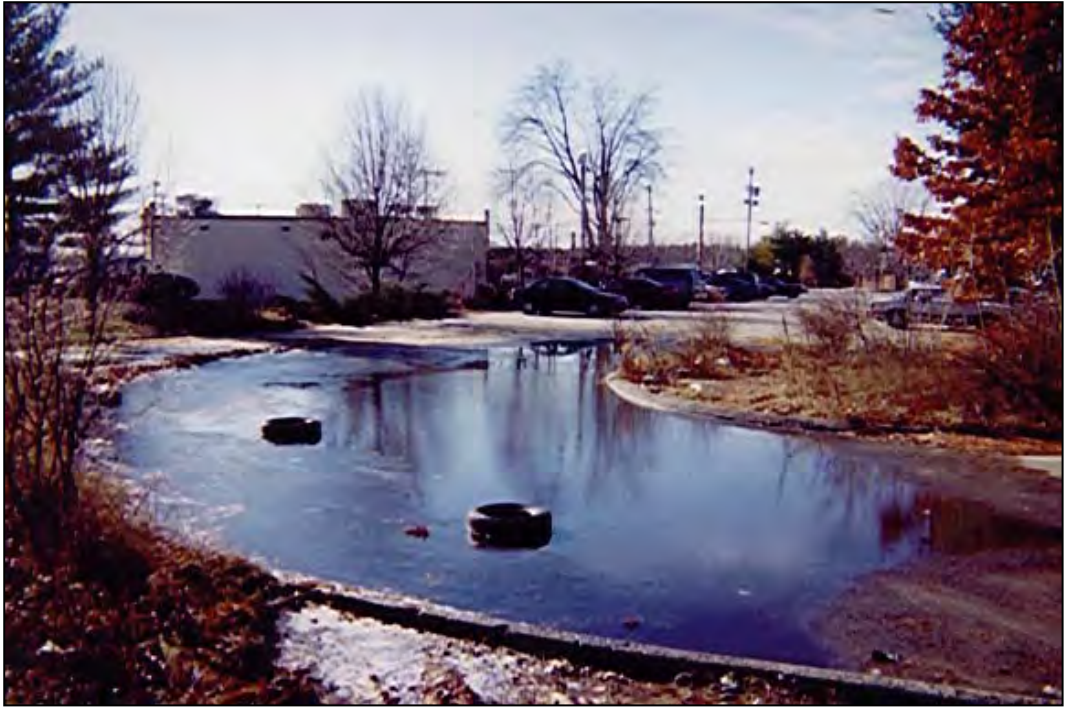
Figure 2-8. Sullivan Tire Runoff

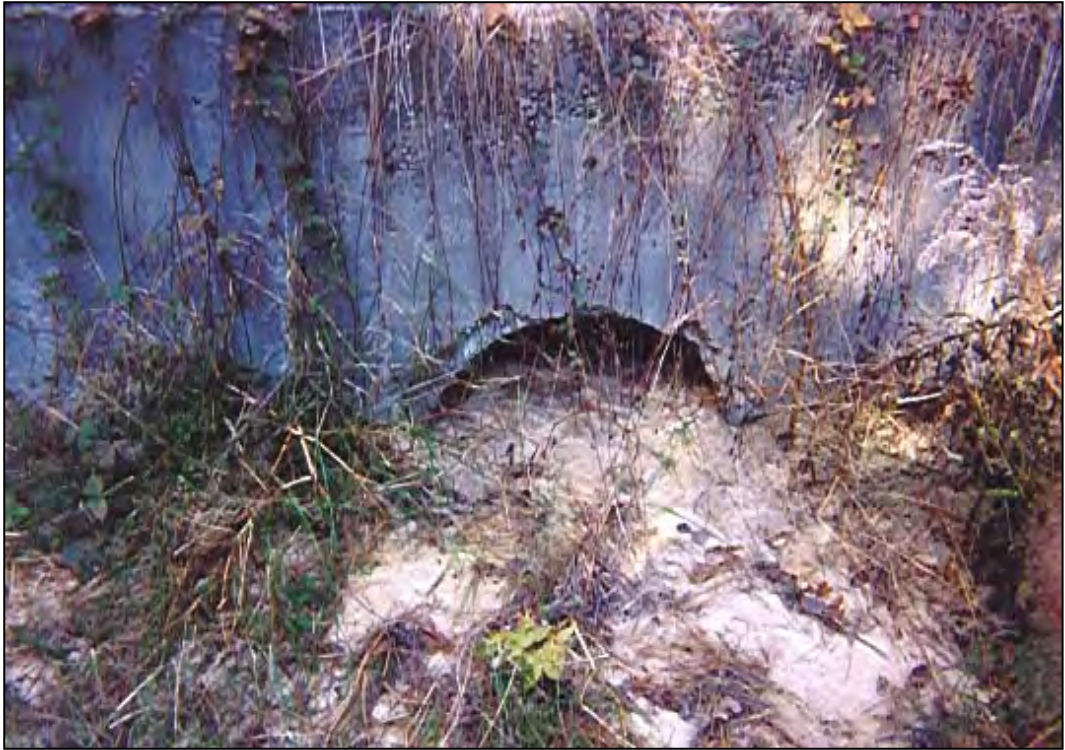
Figure 2-16. Cornerstone Discharge Blockage

The swale is in need of some minor regrading to re-establish its original design slope (See figure 3-4). Cleaning accumulated sediments from the pipes discharge (as shown in Figure 2-16) should be done at this time.

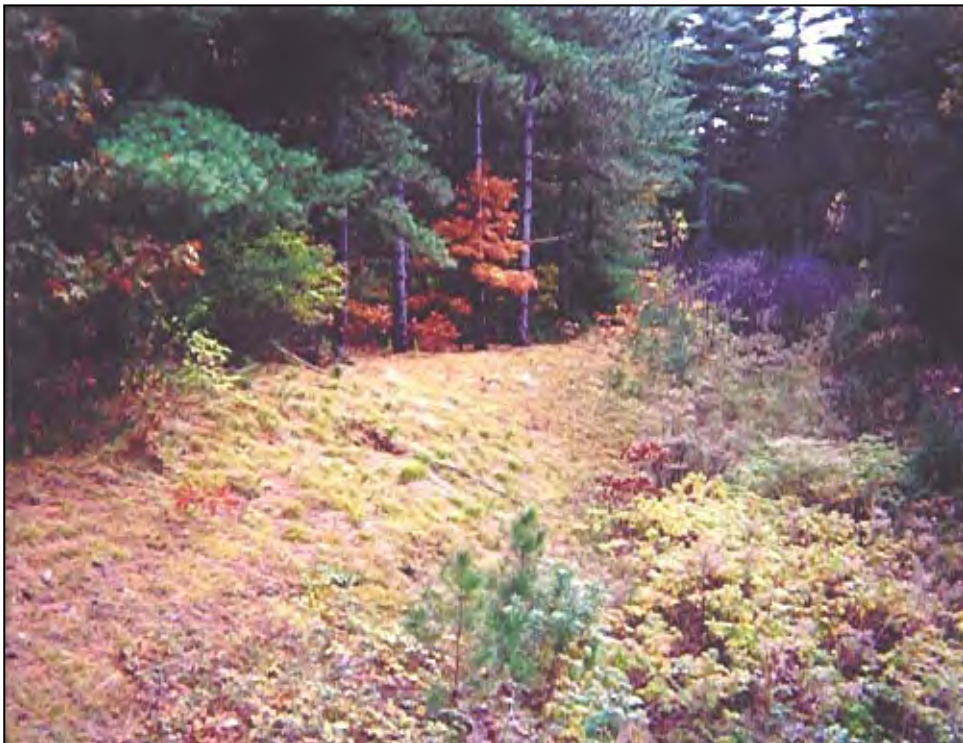
Figure 2-17. Existing Grass Swale

Stormwater generated on the impervious surfaces at the Cornerstone Computer Facility receives some treatment from an existing grass treatment swale before it enters Pennichuck Brook. However, the grass treatment swale has been choked with sand and sediments contained in the stormwater and possibly the side slopes of the swale itself. While some infiltration exists in the sandy soils that underlie the swale, it appears that high velocity stormwater flows down through the swale as noted by the settling (Figure 3-1 located at the end of this section) of large particles quite a distance from the pipe's discharge.

This discharge site (Figure 2-17) and an upstream collection junction (Figure 2-18) were picked for installation of BMPs and are described in greater detail in section 3.1.

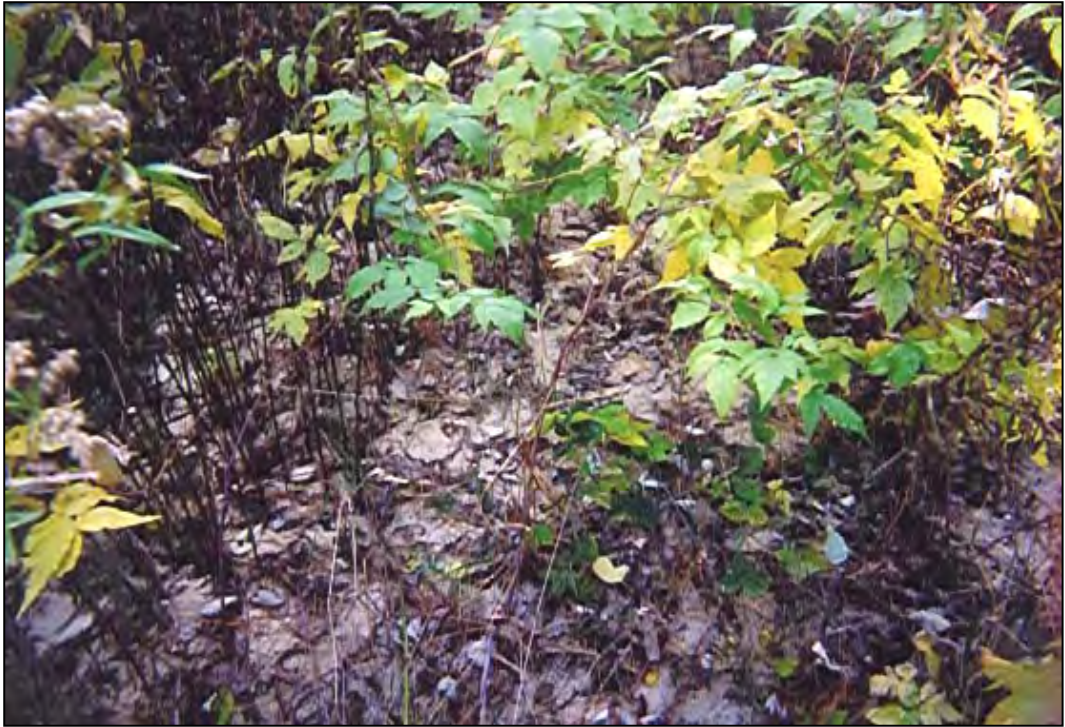
Figure 3-1. Settling of Large Particles

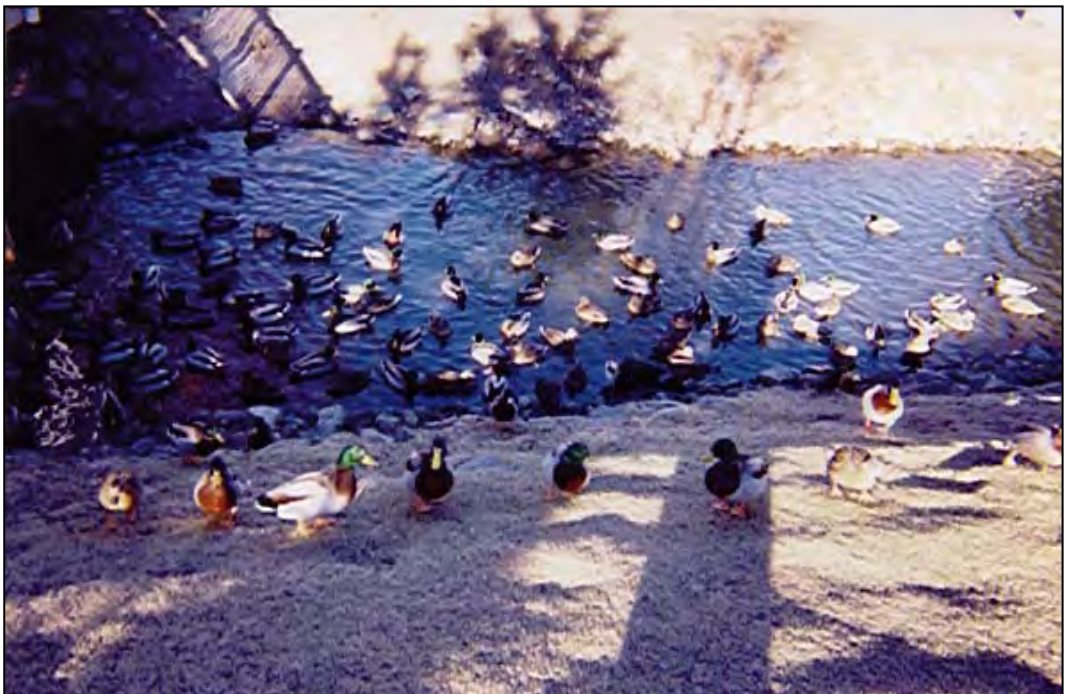
The abundance of waterfowl (see Figure 3-6) that defecate both in and along the banks of the Crowne Plaza detention ponds are a source for both bacteria and phosphorus. Currently, both bacteria and phosphorus pose the most significant threat to Pennichuck's water supply. The reasons for this are twofold.

Figure 3-6. Typical Waterfowl Concentrations in Crowne Plaza Pond

If substantial reductions in waterfowl are not noted despite successful public cooperation, a structural method of deterrent should be used. Gridding or another low cost option that has the effect of inconveniencing the waterfowl should be the next step. Lastly, Bird Shield or a similar product might be tried on the grass to make the grass surrounding the pond unpalatable to the ducks. The marketers of Bird Shield confirmed that Bird Shield is food grade, however, other manufacturers should be contacted to assure their products are drinking water compatible when applied to grass.

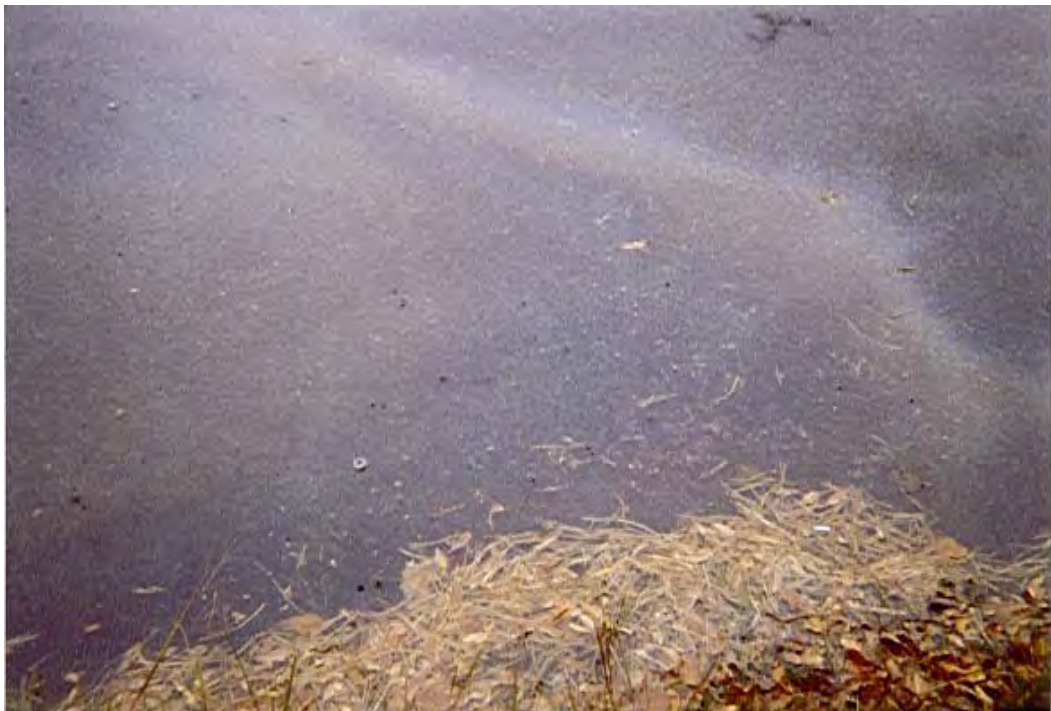
Figure 4-2. Petroleum Sheen at Sullivan Tire

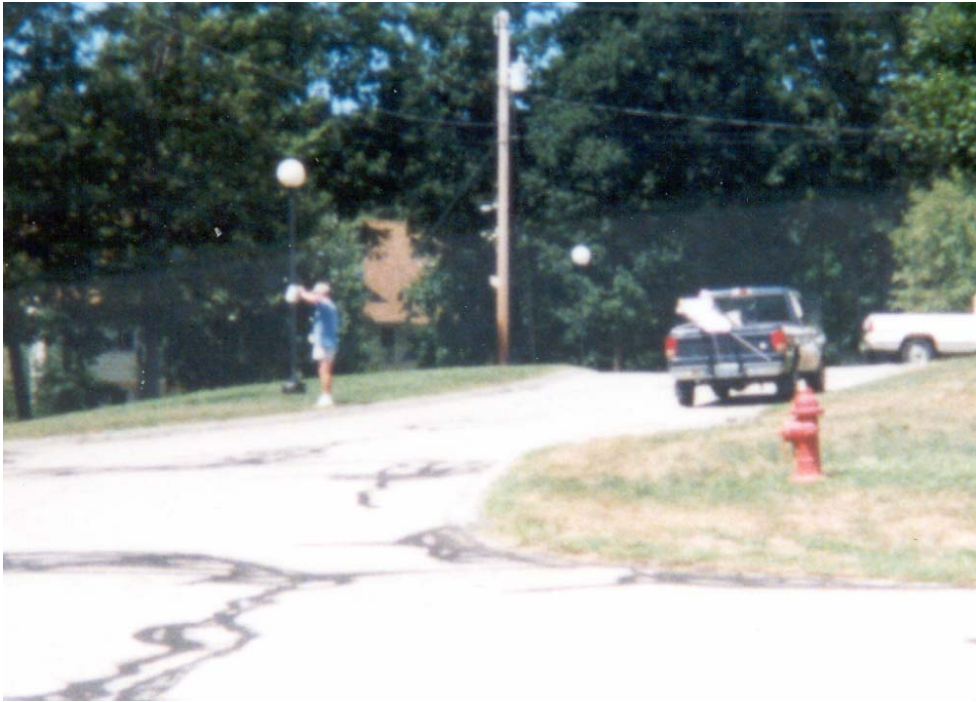
Figure 4-3. Paint Thinner Being Dumped in Catchbasin

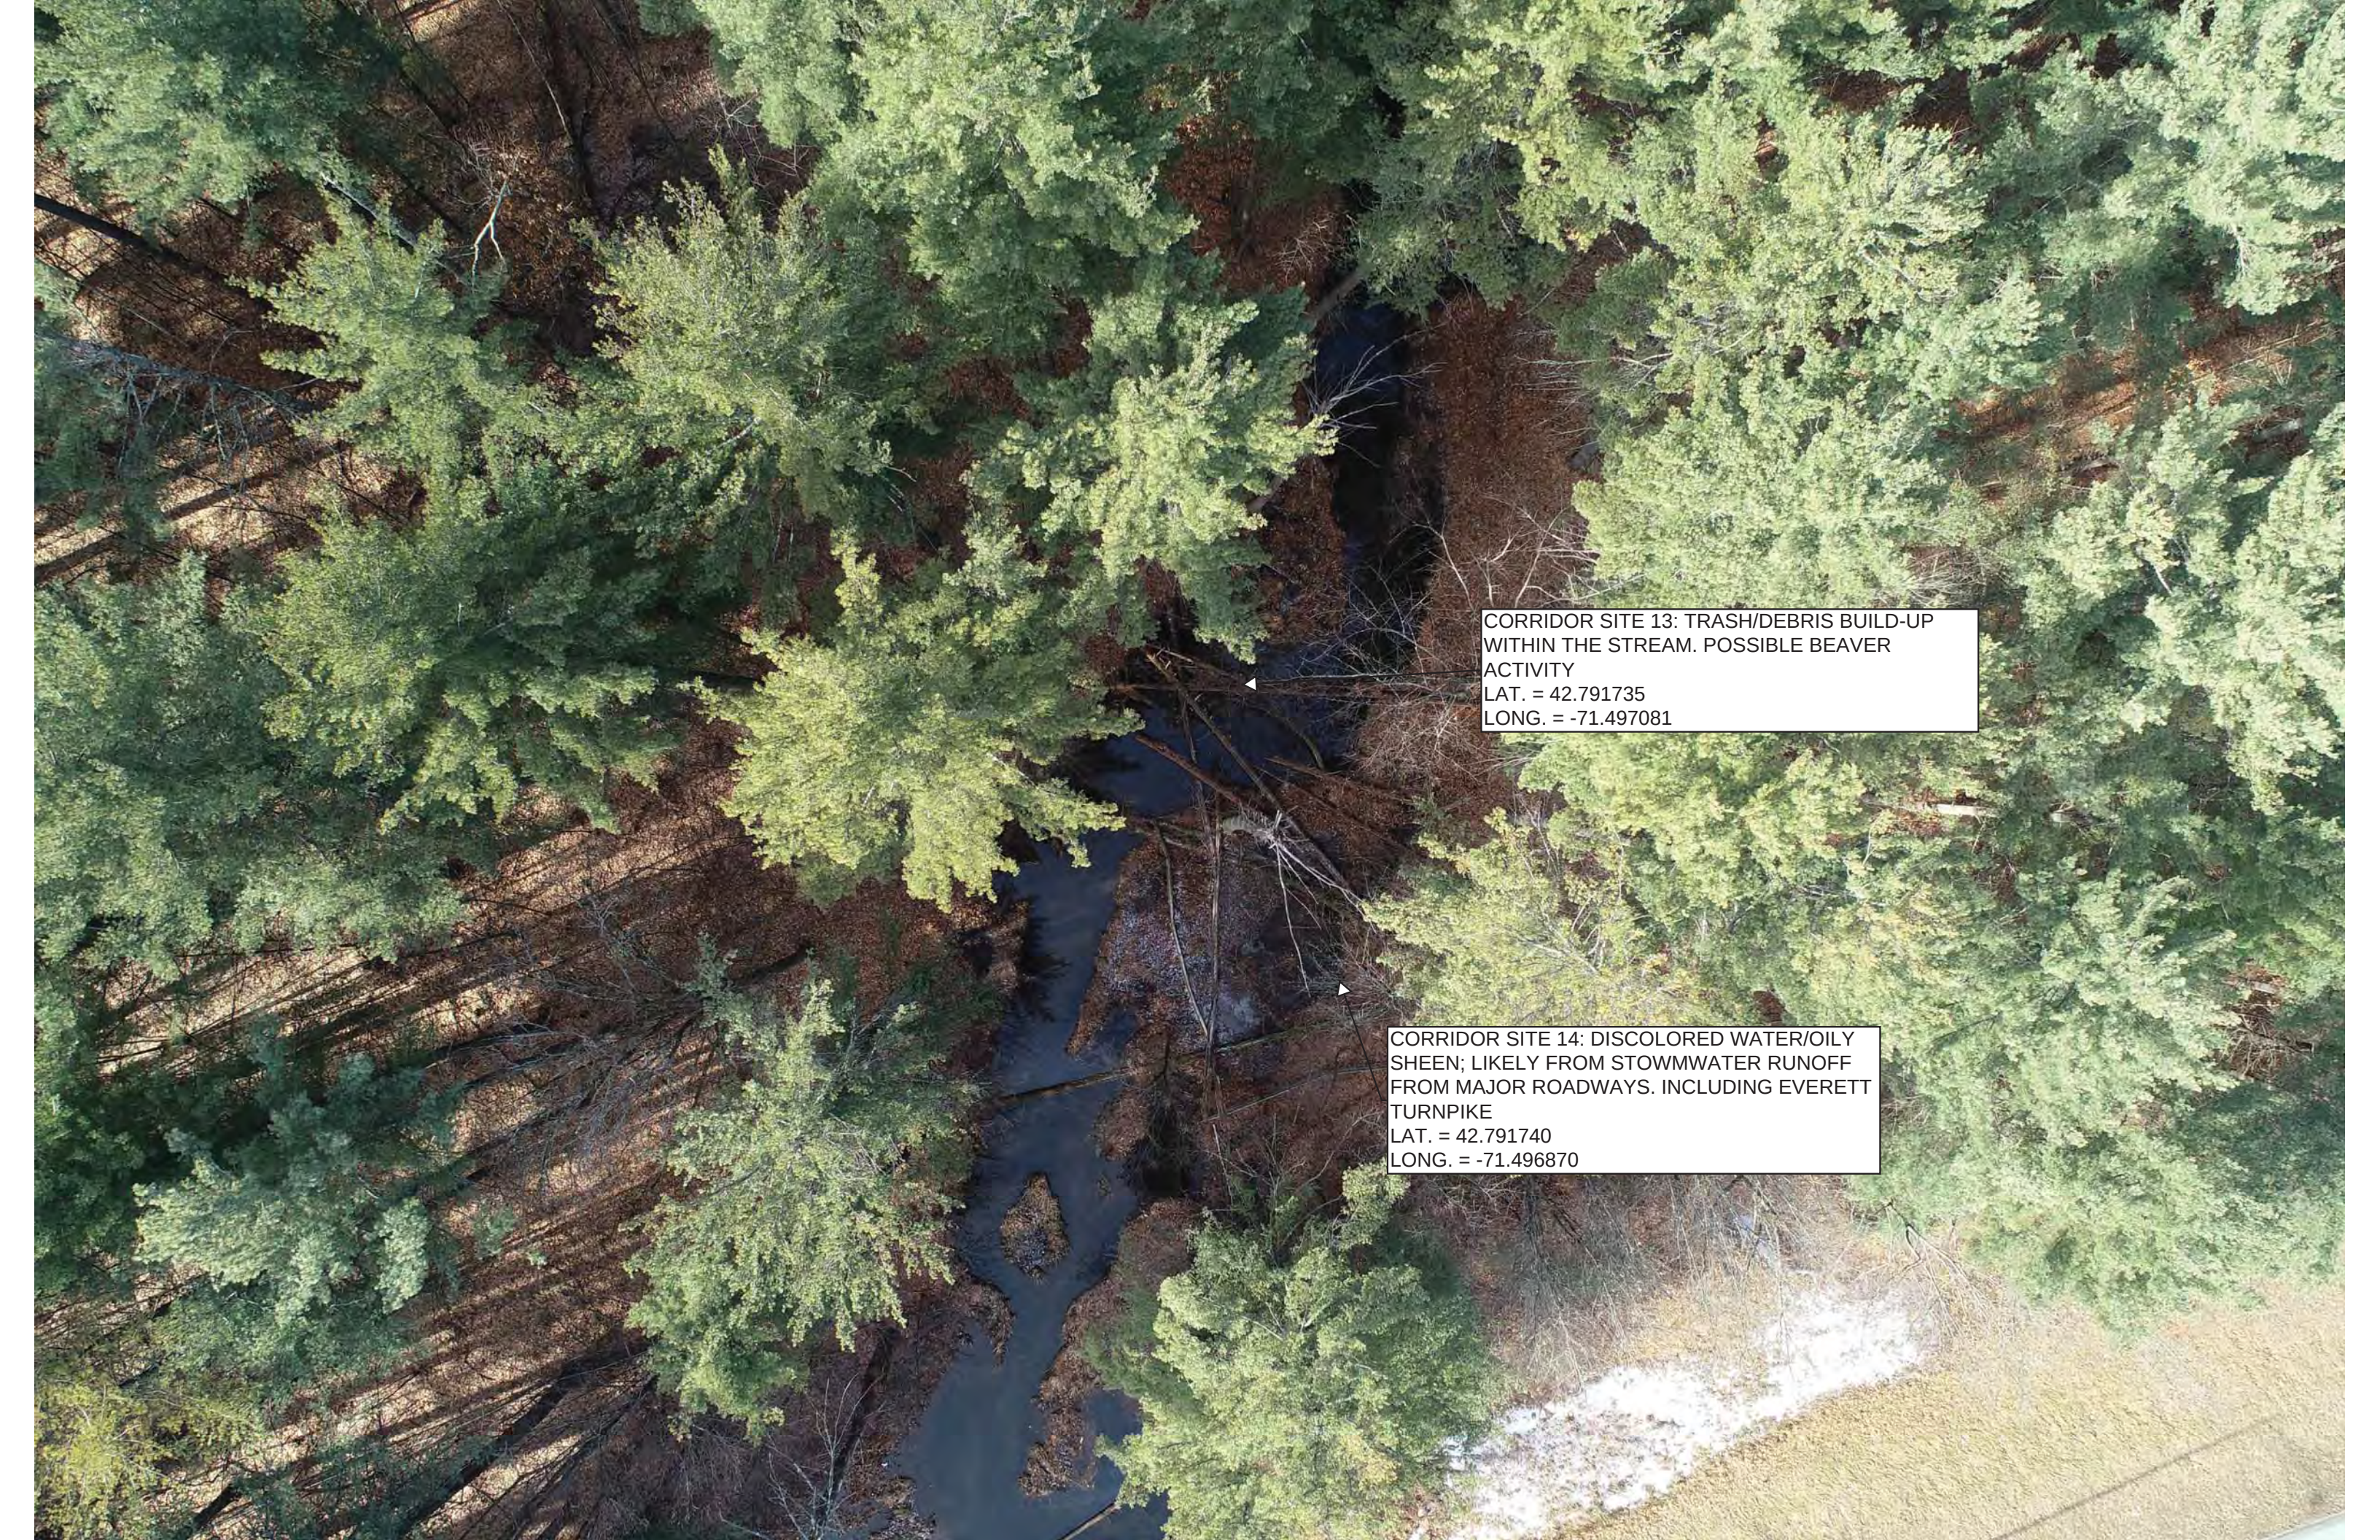
CORRIDOR SITE 13: TRASH/DEBRIS BUILD-UP  
WITHIN THE STREAM. POSSIBLE BEAVER  
ACTIVITY  
LAT. = 42.791735  
LONG. = -71.497081

CORRIDOR SITE 14: DISCOLORED WATER/OILY  
SHEEN; LIKELY FROM STORMWATER RUNOFF  
FROM MAJOR ROADWAYS. INCLUDING EVERETT  
TURNPIKE  
LAT. = 42.791740  
LONG. = -71.496870

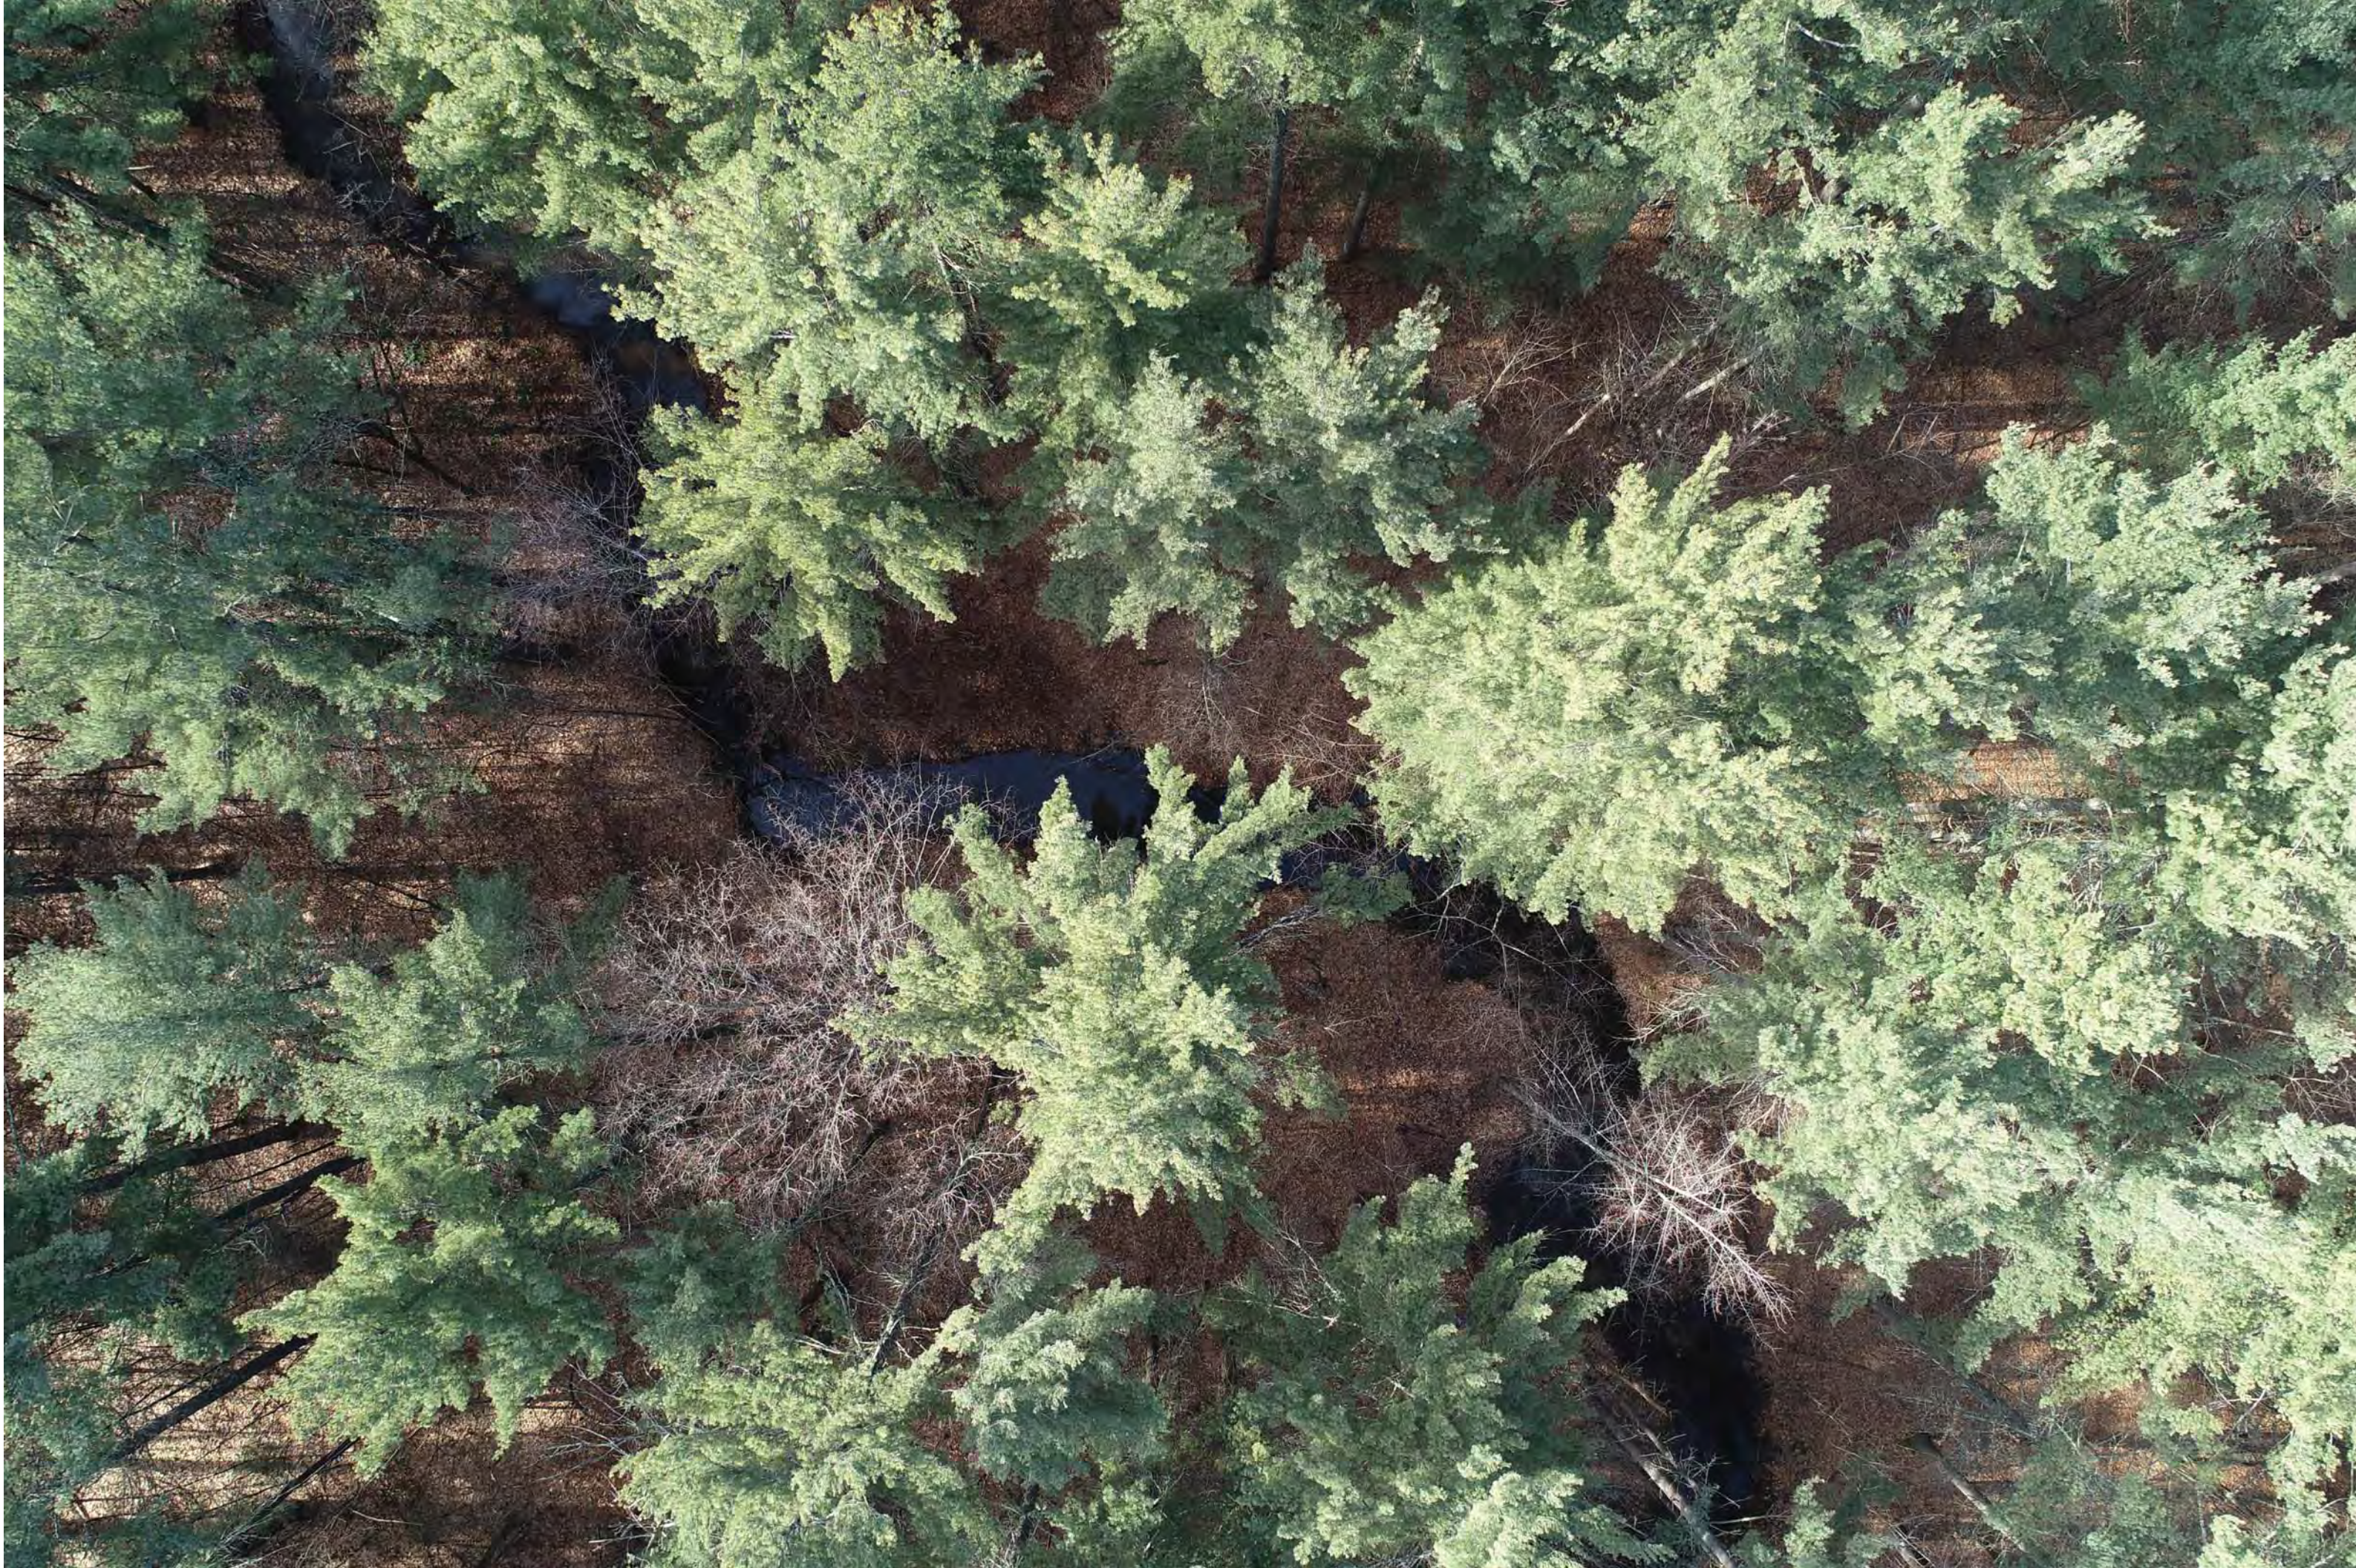
CORRIDOR SITE 12: BANK EROSION AND  
UNDERCUTTING DUE TO LARGE FLOWS  
LAT. = 42.791837  
LONG. = -71.497859

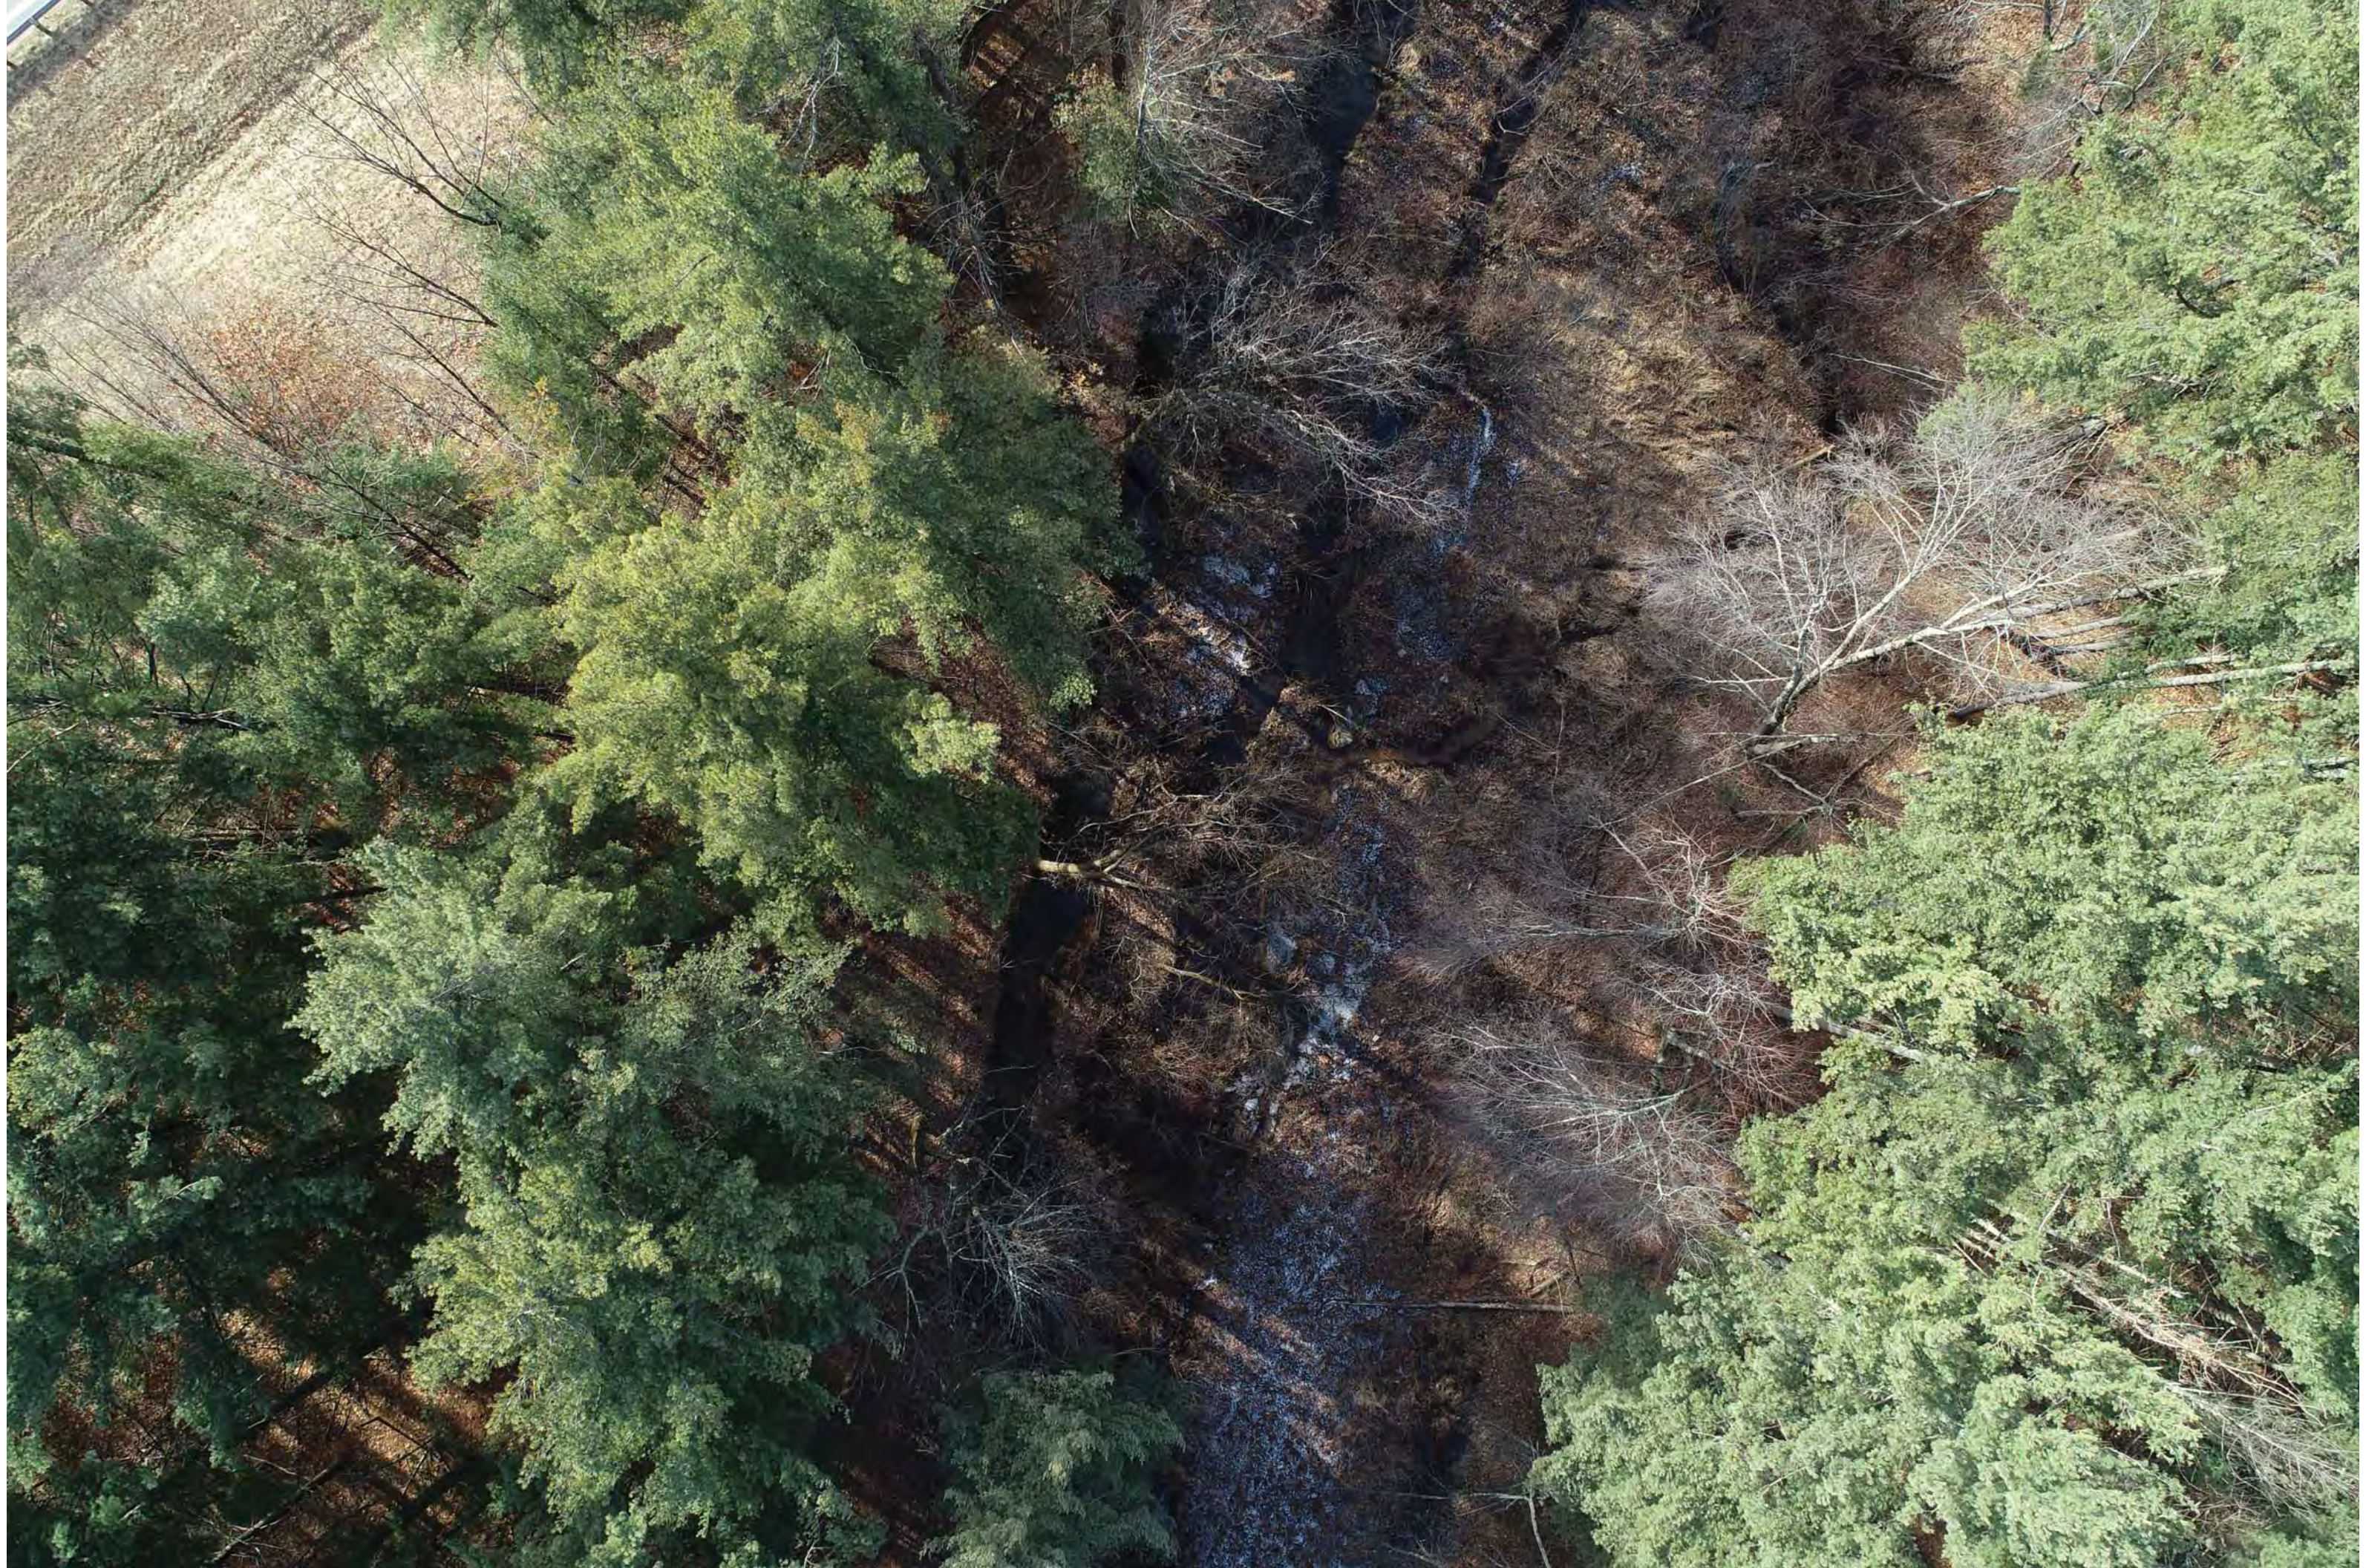
CORRIDOR SITE 6: SEDIMENT/DEBRIS BUILD-UP  
WITHIN THE STREAM. POSSIBLE BEAVER ACTIVITY  
LAT. = 42.790417  
LONG. = -71.500453

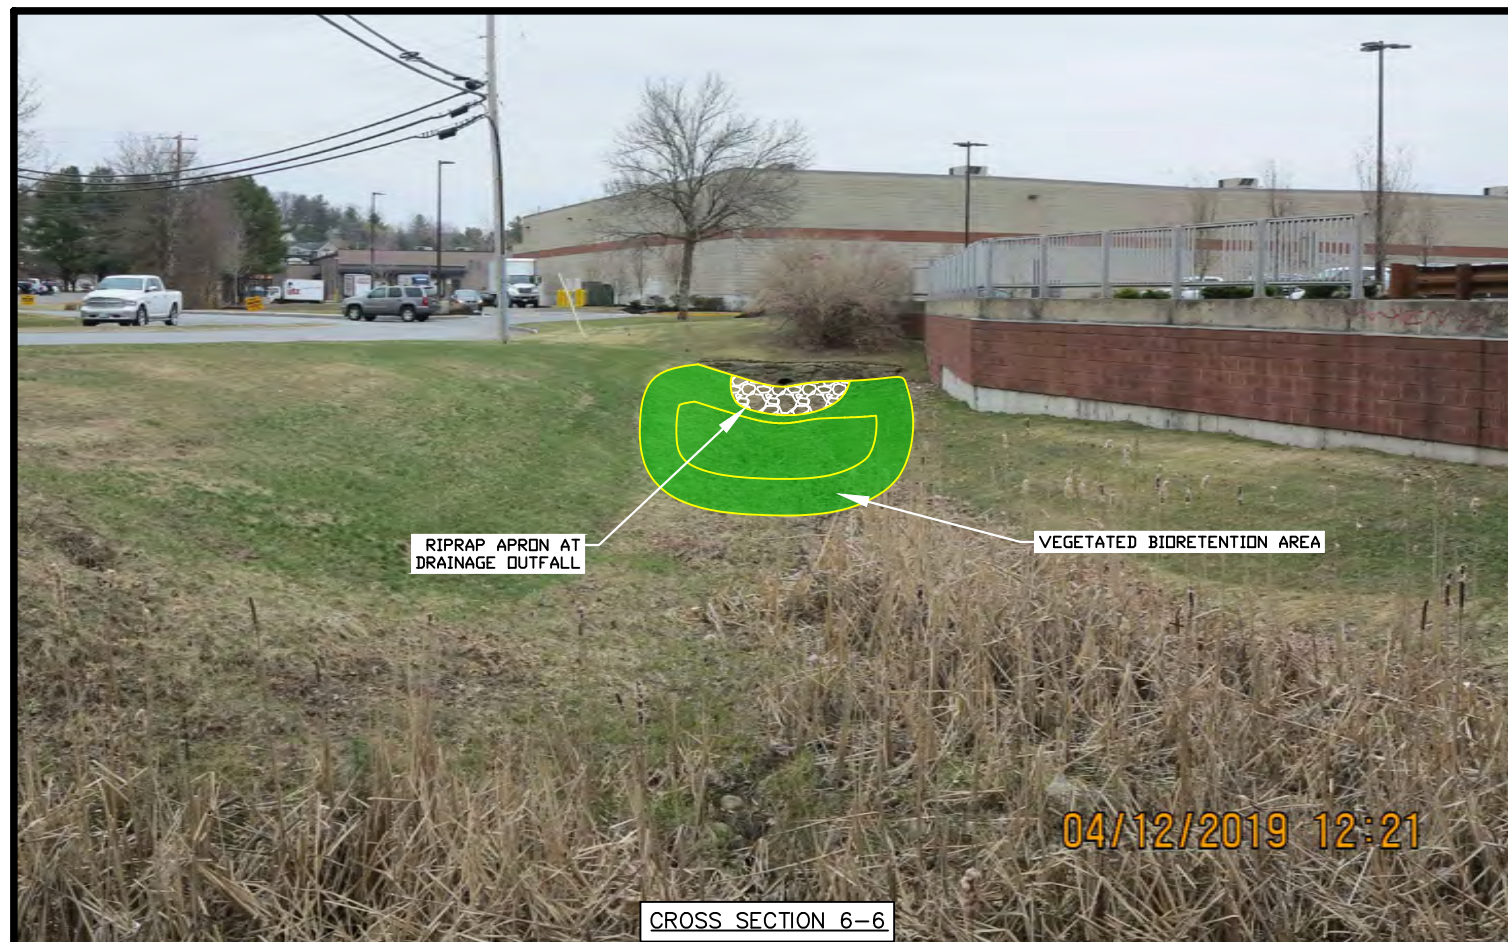
C-6B

CONCEPTUAL PLANS  
BMP SITE 6 - SOMERSET PLAZA PERIMETER  
SWALE  
BOIRE FIELD BROOK SUBWATERSHED

| Boire Field Brook BMP Retrofits/Implementations Recommendations Summary | | | | | | | |
|---|---|---|---|---|---|---|---|
| 2 | BMP 6 | Somerset Plaza Perimeter Swale | Biofilter Swale;<br>Sediment Forebay;<br>Bioretention Area | 42.785816, -71.505659 | 1. <b>Vegetated Riprap Bank Stabilization:</b> Reestablish existing vegetated riprap slopes to decrease downstream sedimentation from bank erosion, slow runoff velocities from paved areas, and promote infiltration.<br>2. <b>Revegetate Swale:</b> Revegetate eroded areas of the swale channel to decrease downstream sedimentation.<br>3. <b>Stormwater Inlet Stabilization:</b> Install a riprap apron at the existing stormwater inlet to decrease downstream erosion.<br>4. <b>Curb Installation and Riprap Spillways:</b> Remove and replace granite curbing with breaks at existing riprap spillways; re-stabilize riprap spillways to promote designated stormwater entry points and decrease slope erosion.<br>5. <b>Vegetated Bioretention Area:</b> Install vegetated bioretention areas/raingardens at drainage outfalls from Somerset Plaza Perimeter Swale. Install native plant species that are resistant to wet and dry environments.<br>6. <b>Riprap Sediment Forebay:</b> Install a riprap sediment forebay with a vegetated bottom at the existing drainage outfall in the center of the swale to trap sediment and provide easier swale maintenance. | N/A | Permitting: ---<br>Design: \$21,000<br>Construction: \$97,000<br>Total: \$118,000 |

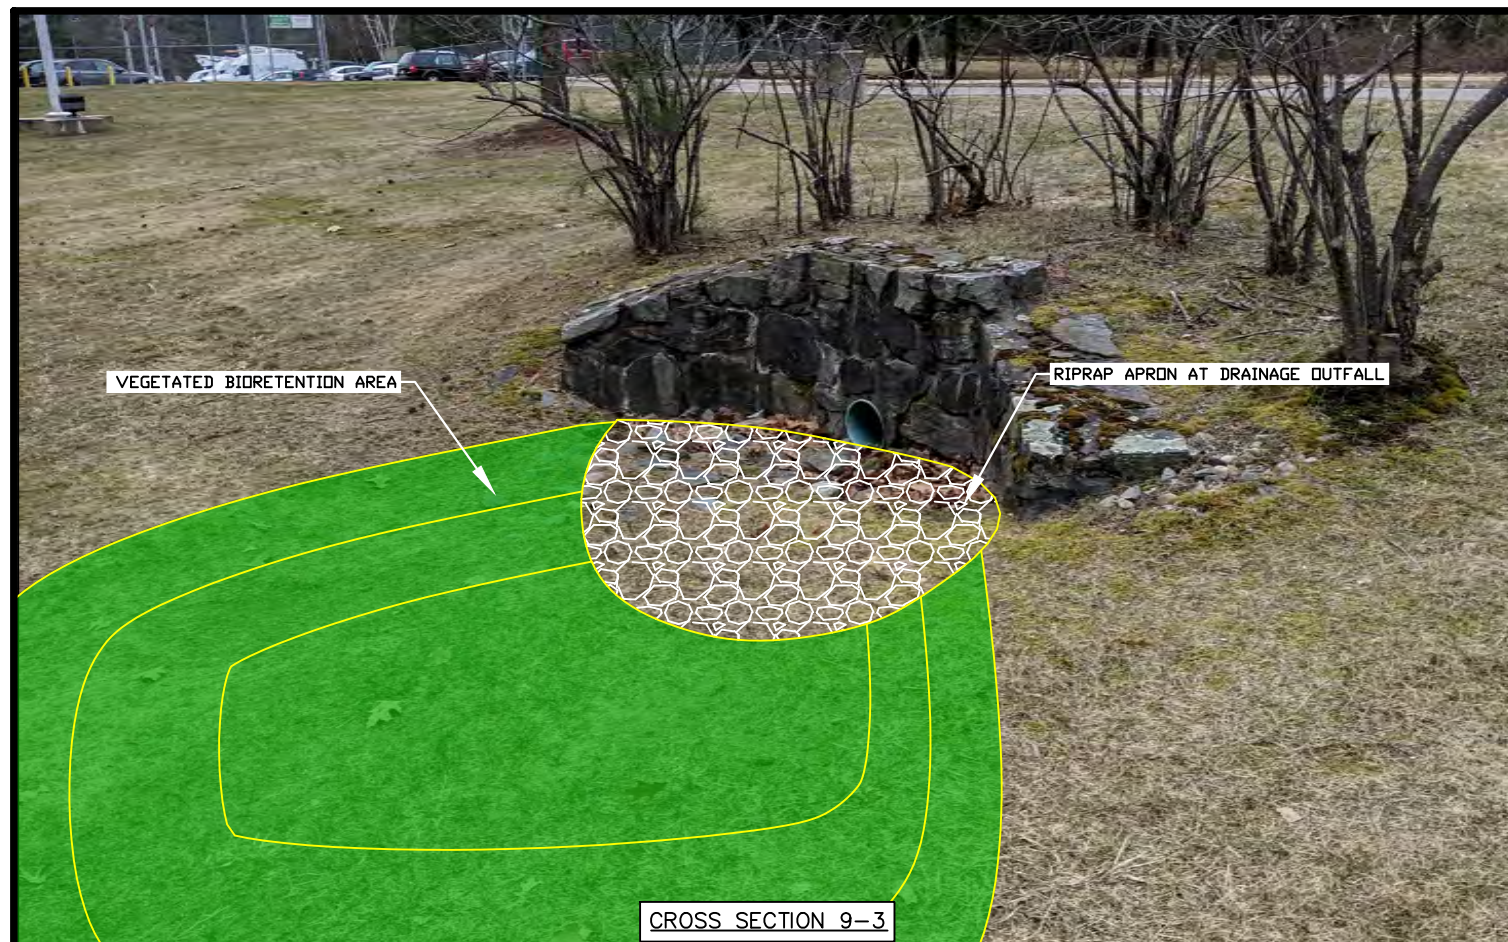
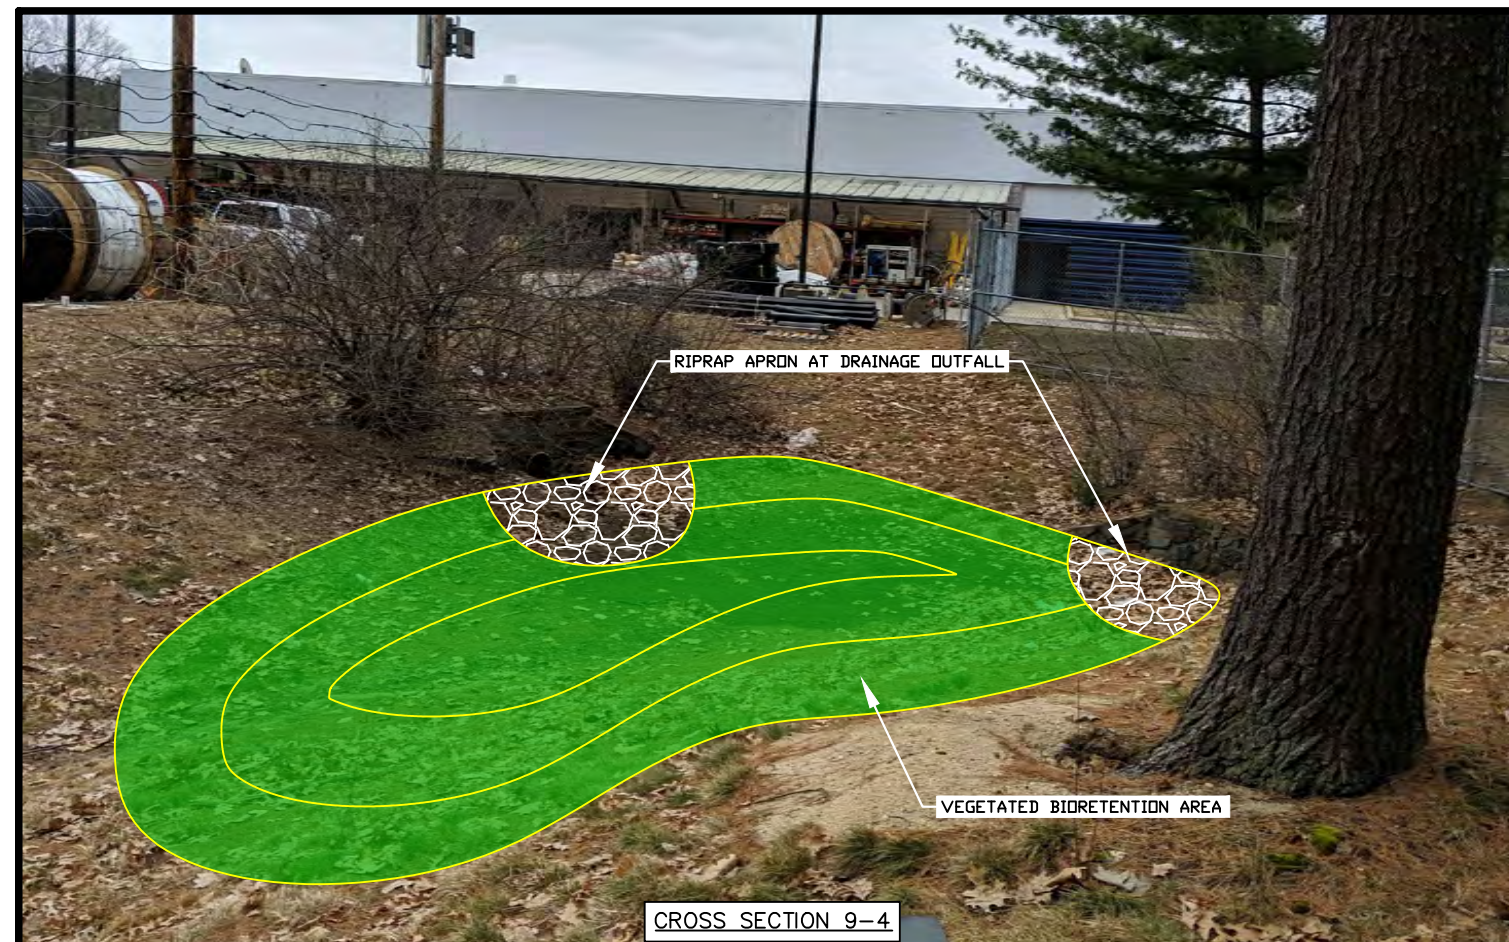
Sheet No.:  
**C-9A**

CONCEPTUAL PLANS  
BMP SITE 9 - POSTAL SERVICE  
VEGETATED AREAS  
BOIRE FIELD BROOK SUBWATERSHED
