## PENNICHUCK WATER WORKS BOIRE FIELD BROOK SUBWATERSHED EVALUATION 2019

**PENNICHUCK**

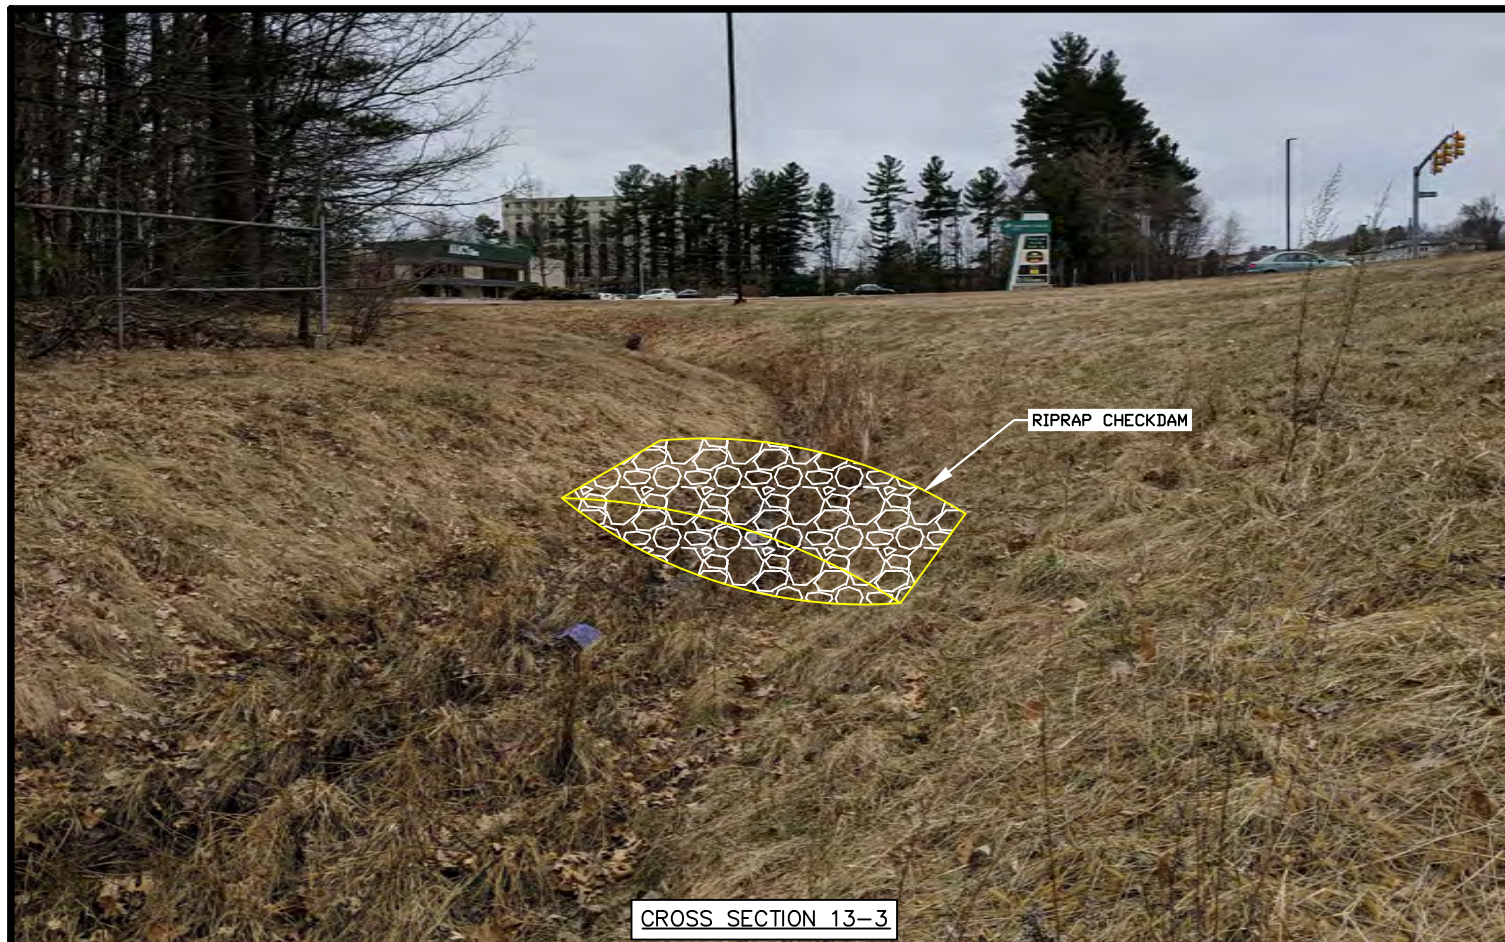
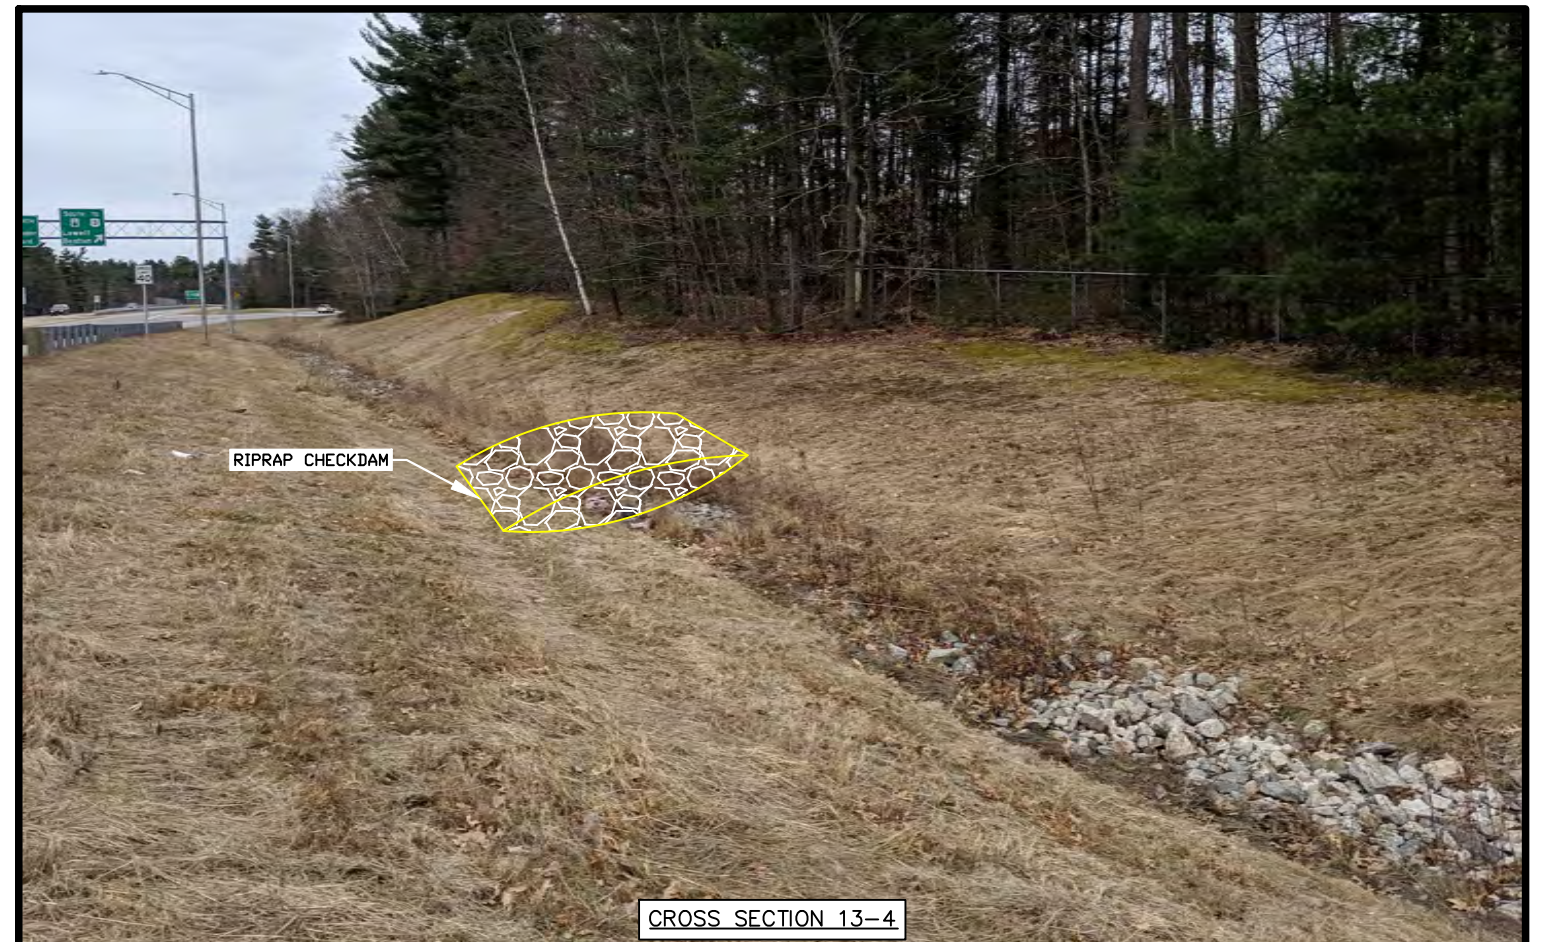
**Sheet No.:**  
**C-13A**

CONCEPTUAL PLANS  
BMP SITE 13 - SOMERSET PARKWAY /  
SOUTHWOOD DRIVE SWALES  
BOIRE FIELD BROOK SUBWATERSHED

| Boire Field Brook BMP Retrofits/Implementations Recommendations Summary | | | | | | | |
|---|---|---|---|---|---|---|---|
| 7 | BMP 13 | Somerset Parkway /<br>Southwood Drive Swales | Biofilter Swale;<br>Check Dams | (1) 42.788471, -71.502197<br>(2) 42.788915, -71.500559 | 1. <b>Riprap Check Dams:</b> Install riprap checkdams throughout the swales to slow down stormwater flow, promote infiltration, and minimze erosion within the swales. | N/A | Permitting: ---<br>Design: \$4,000<br>Construction: \$5,000<br>Total: \$9,000 |
